COLORADO DIVISION OF RECLAMATION, MINING AND SAFETY
MINERALS PROGRAM INSPECTION REPORT
PHONE: (303) 866-3567

MINE NAME: Bunn Ranch Pit	MINE/PROSPECTING ID#: M-1980-131	MINERAL: Sand and gravel	COUNTY: Moffat
INSPECTION TYPE: Multi Person Inspection	INSPECTOR(S): Stephanie J. Mitchell	INSP. DATE: June 25, 2014	INSP. TIME: 11:30
OPERATOR: Elam Construction, Inc.	OPERATOR REPRESENTATIVE: Gayle Lyman	TYPE OF OPERATION: 112c - Construction Regular Operation

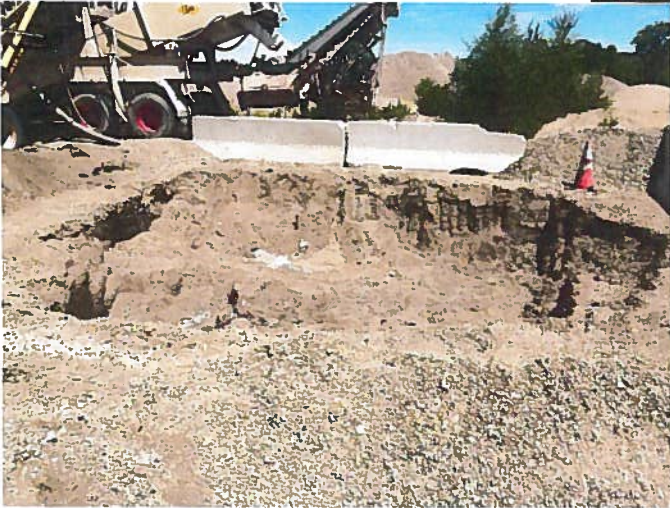
During the inspection, there was a small area of the excavation area that still looked moist and had a faint fuel smell. A mini excavator removed more material from the area, totaling 4 cubic yards.

Excavated area

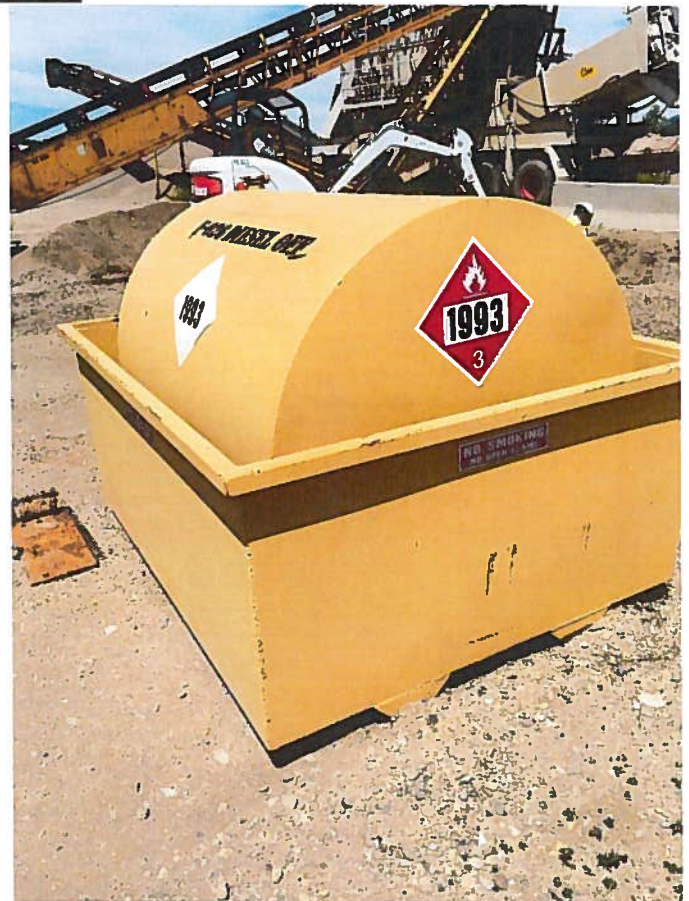
The site experienced a diesel spill near the wash plant on June 10, 2014. It was reported to the Division and CDPHE on the very same day, June 10, 2014 at 5:15 P.M. The Division also received a formal report from Elam Construction on June 20, 2014. Thiis report was placed in the Division's files. The total amount of diesel lost was 92 gallons. The fuel leak spill area (18'x20'x 3.5' deep) was properly excavated and placed in a lined area for re-processing and burning of hydrocarbons in the future. The excavated area was properly bermed and upon approval from CDPHE, the excavated area will be backfilled with natural fines.

Fuel tank- source of spill

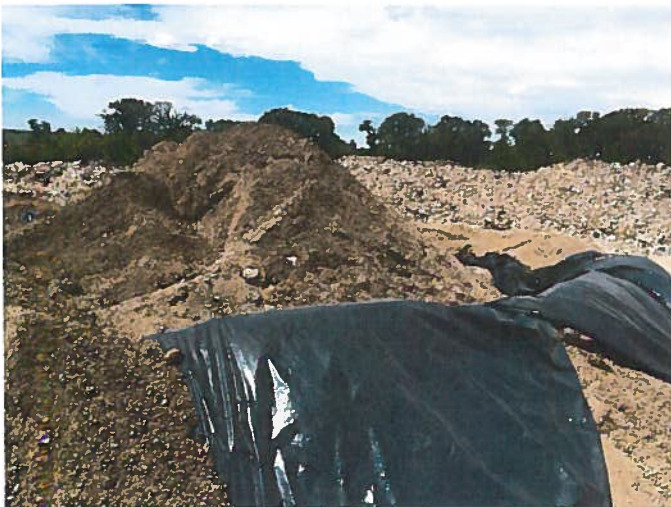
Excavated Material in liner
