**COLORADO DIVISION OF RECLAMATION, MINING AND SAFETY**  
**MINERALS PROGRAM INSPECTION REPORT**  
**PHONE: (303) 866-3567**

<b>MINE NAME:</b> Airport Pit	<b>MINE/PROSPECTING ID#:</b> M-1977-567	<b>MINERAL:</b> Sand and gravel	<b>COUNTY:</b> Saguache
<b>INSPECTION TYPE:</b> Monitoring	<b>INSPECTOR(S):</b> Bob Oswald	<b>INSP. DATE:</b> June 24, 2014	<b>INSP. TIME:</b> 13:00
<b>OPERATOR:</b> Saguache County	<b>OPERATOR REPRESENTATIVE:</b> Elvie Samora	<b>TYPE OF OPERATION:</b> 110c - Construction Limited Impact

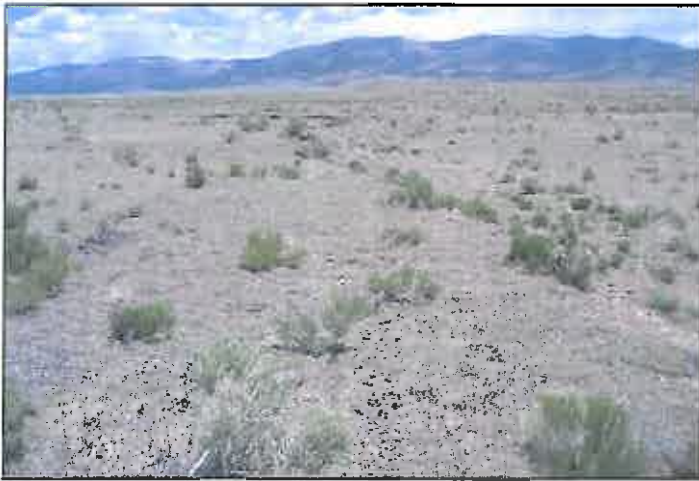
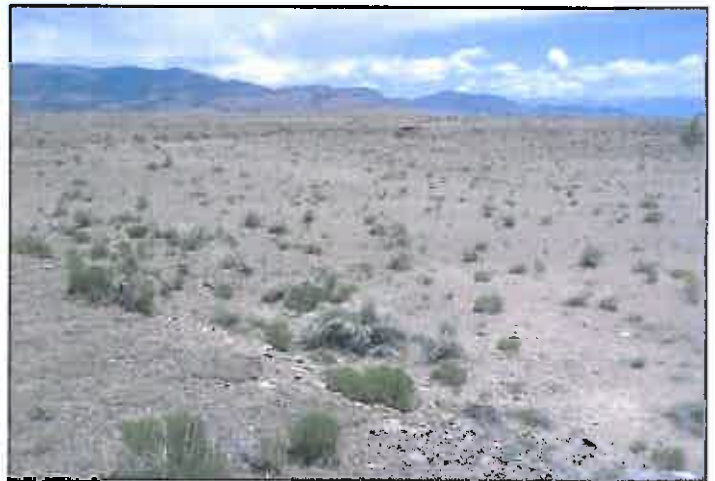
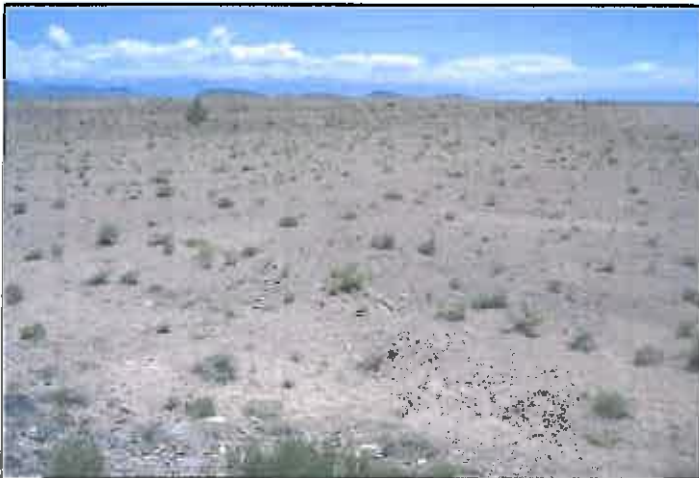
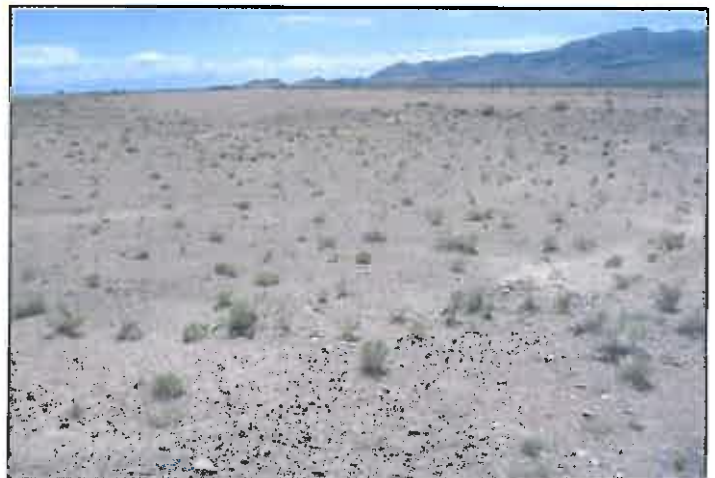
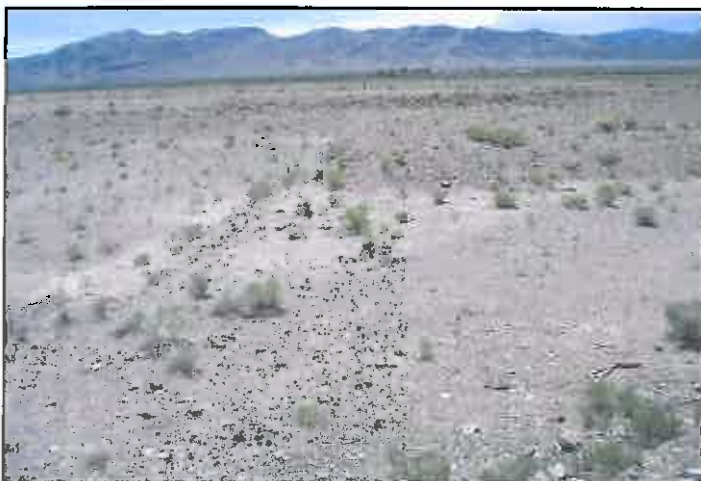
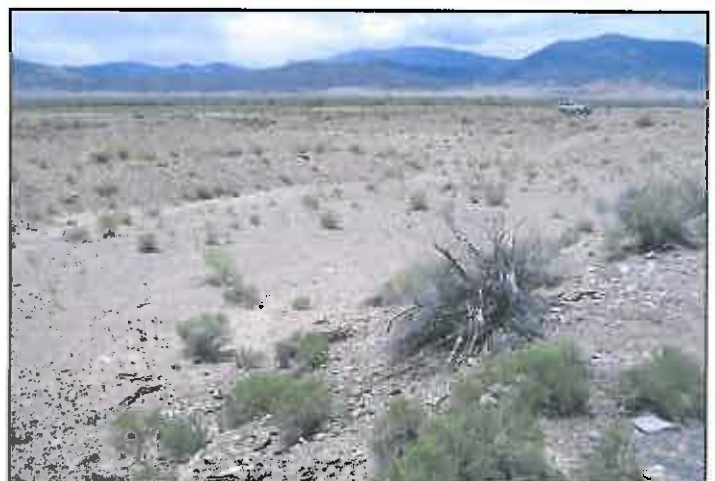
The permit ID sign was observed on the ground near the entrance gate to the permitted area, possibly having been knocked down by cattle. Posting the permit ID sign is a requirement, per Rule 3.1.12, so the operator must re-install it soon. Please ensure the ID sign contains all the required information, by referring to the rule cited above. Permit boundary markers, consisting of fencelines, were present along the south and east permit boundaries. The NW corner used to be marked by a steel T-post. The operator should ensure that this corner marker is re-installed in the correct location.

There has been very little recent activity, mostly limited to removal of stockpiled pitrun. There are several small existing stockpiles in the pit. The operator is reminded to include all site activities in the annual reports each year, including stockpiling, processing, excavation, hauling, reclamation, and weed control. There was some slope grading in the past on the south and east walls of the pit, and the resspreading of topsoil there. The other pit walls are mostly steeper than what is required in the approved reclamation plan, and will require grading to reduce them to the final gradient. The plan calls for 3:1 slopes on the west, south and east sides, and 5:1 on the north side.

The site is accessible to cattle (presumably the landowner's livestock). The landowner feeds cattle in the area lying to the west of the pit. The operator is reminded that when any phases of revegetation are to be carried out as part of the final reclamation on this permit, the operator must ensure that the seeded areas are fenced to exclude livestock, at least for the period needed to establish the vegetation.

There was no equipment, fuel, or debris on the site. There were no noxious weeds.
