COLORADO DIVISION OF RECLAMATION, MINING AND SAFETY
MINERALS PROGRAM INSPECTION REPORT
PHONE: (303) 866-3567

MINE NAME: Reclamation Pit No 1	MINE/PROSPECTING ID#: M-1977-153	MINERAL: Sand and gravel	COUNTY: Adams
INSPECTION TYPE: Monitoring	INSPECTOR(S): Tyler V. O'Donnell	INSP. DATE: May 14, 2014	INSP. TIME: 12:30
OPERATOR: Denver Water Department	OPERATOR REPRESENTATIVE: Greg Gulley	TYPE OF OPERATION: 112c - Construction Regular Operation

RECLAMATION PIT NO. 1
M-1977-153
RECLAMATION PLAN

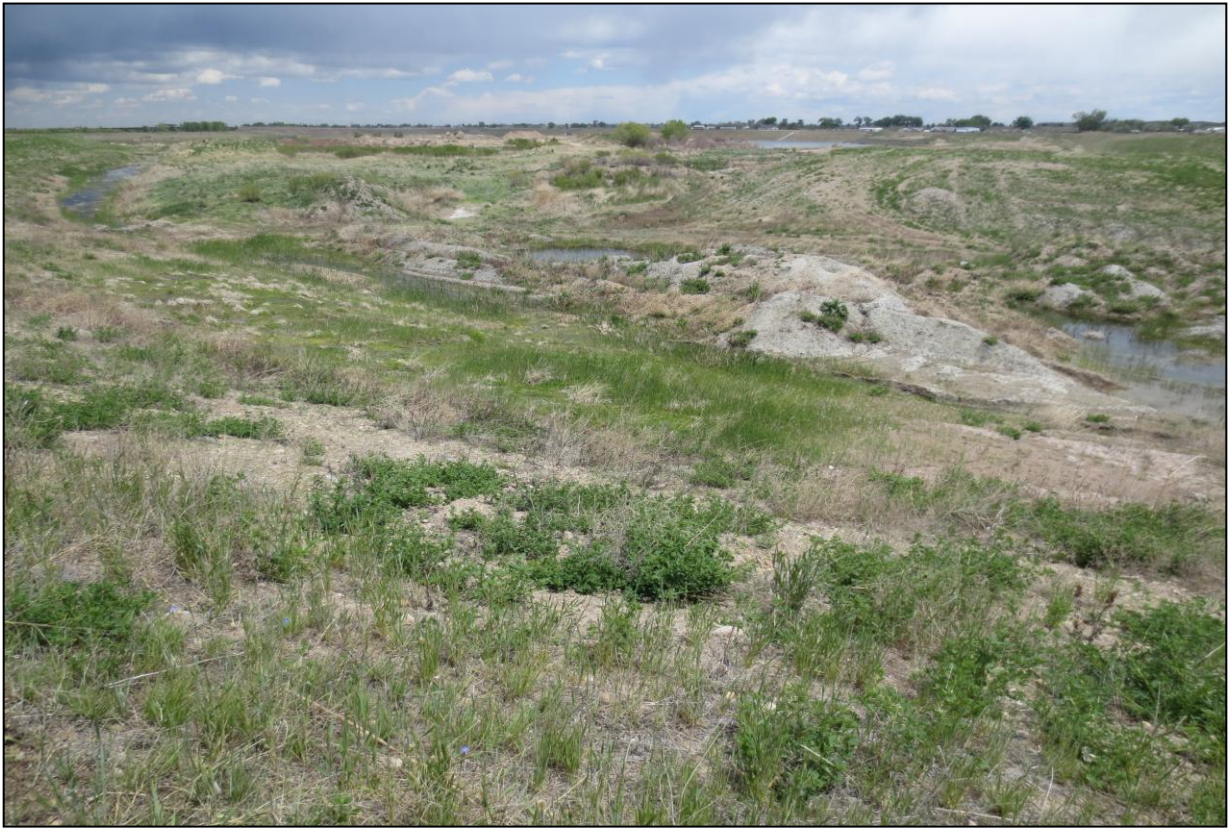
Photo 1: View looking northeast, processed stockpiles in foreground.

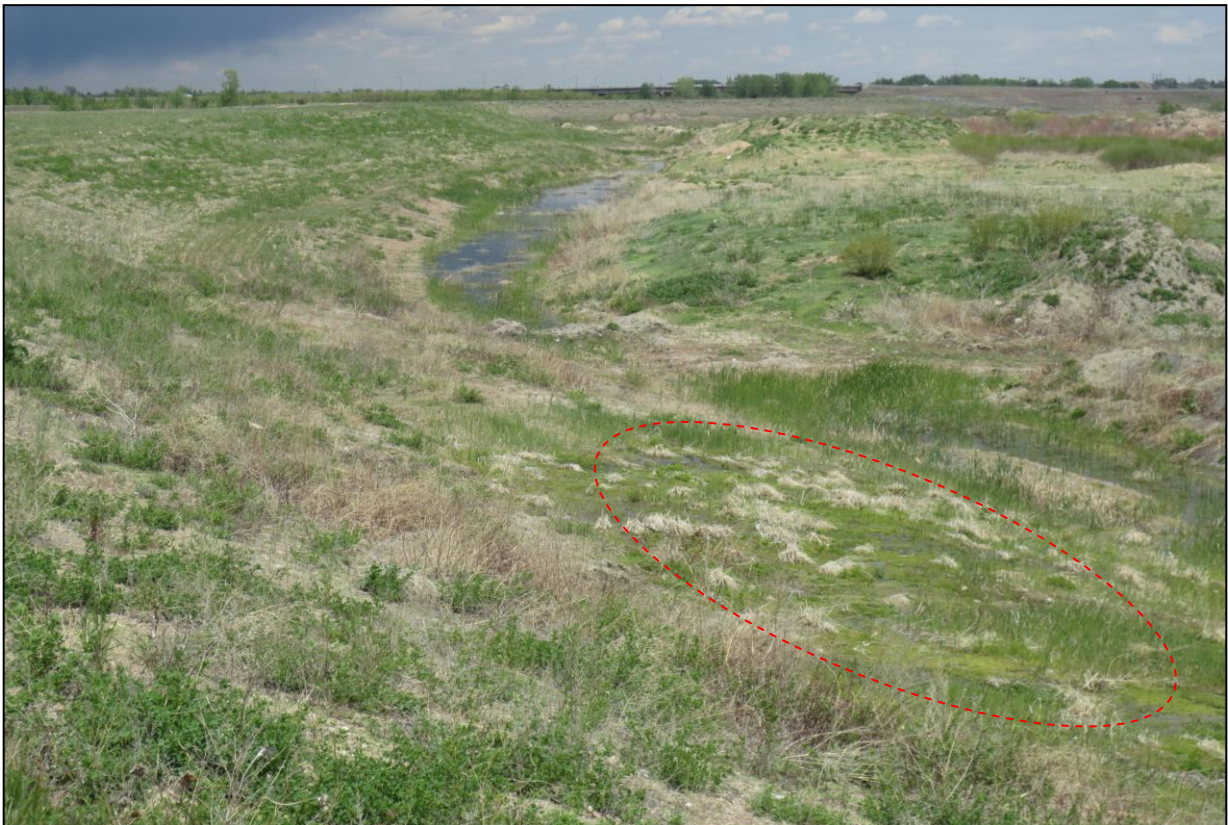
The pit is located just east of the South Platte River. The bottom of the pit was mostly dry. The Division observed a seep coming though the pit slope in the south western portion of the Reclamation Pit No.1. The Operator's representative stated that slurry was built where water in the bull seep could overtop the slurry wall. The Operator's representative stated that a slurry wall would be constructed to the east, where they could increase the elevation of the slurry wall to prevent it from being overtopped. The Operator is in the process of coming up with a revised plan to relocated the slurry wall. Once a plan has been established the Operator shall provide a revised Reclamation plan and Reclamation plan map. The liner has not passed the State Engineer's Leak Test.

Photo 2: Seep circled in red dashed line.

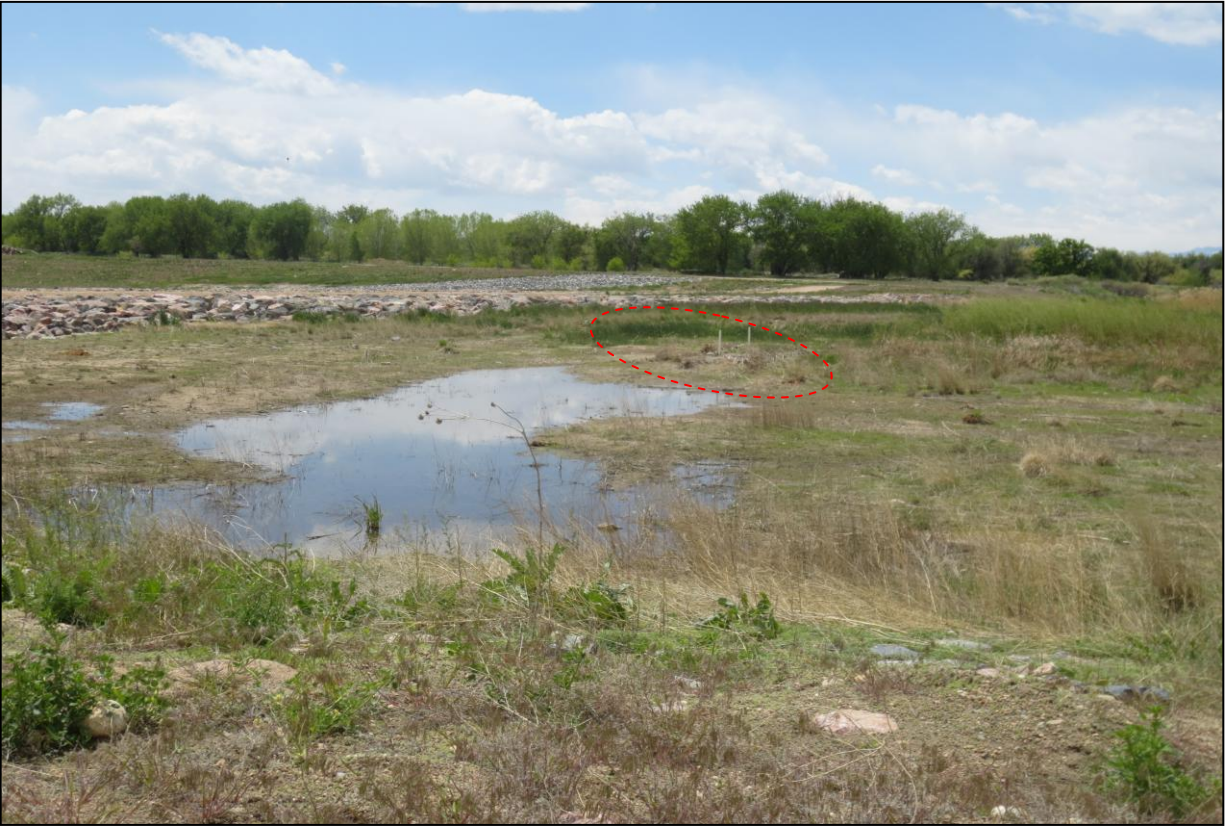
Photo 3: Location of slurry wall circled in red dashed line.

This Operation has conducted a lot of reclamation work, mining is occurring along the pit floor. The slopes have been graded and revegetated. If the Operator deviates from the approved reclamation plan the permit will need to be revised, to reflect the proposed changes. Changes include minor deviations to the proposed post-mining topography, location of the slurry wall, and structures that will remain after final reclamation.

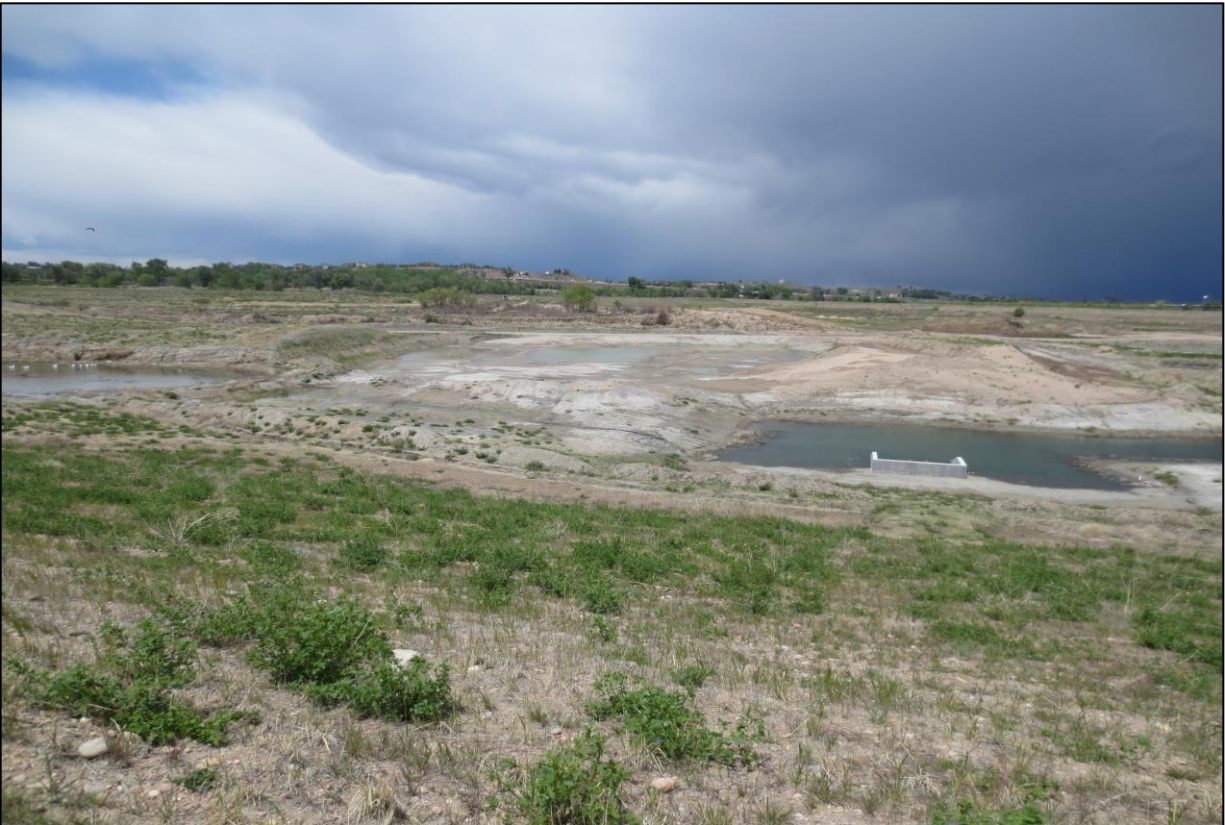
Photo 4: View looking northwest, processed stockpiles on the pit floor in background.
