**COLORADO DIVISION OF RECLAMATION, MINING AND SAFETY**  
**MINERALS PROGRAM INSPECTION REPORT**  
**PHONE: (303) 866-3567**

<b>MINE NAME:</b> Road Runner Rest	<b>MINE/PROSPECTING ID#:</b> M-1979-195	<b>MINERAL:</b> Sand and gravel	<b>COUNTY:</b> Adams
<b>INSPECTION TYPE:</b> Monitoring	<b>INSPECTOR(S):</b> Tyler V. O'Donnell	<b>INSP. DATE:</b> May 14, 2014	<b>INSP. TIME:</b> 13:00
<b>OPERATOR:</b> Denver Water Department	<b>OPERATOR REPRESENTATIVE:</b> Greg Gulley	<b>TYPE OF OPERATION:</b> 112c - Construction Regular Operation

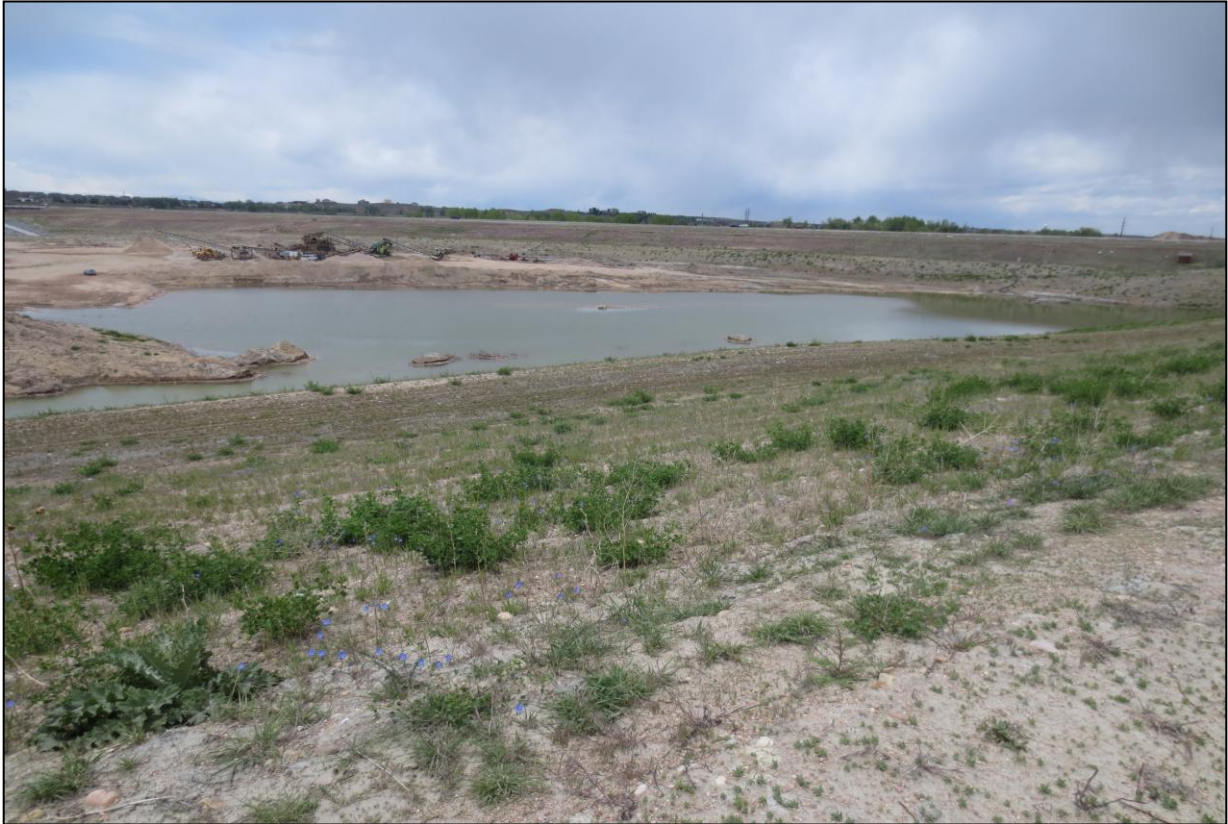
**Photo 1:** View looking northwest, processing plant in the background.

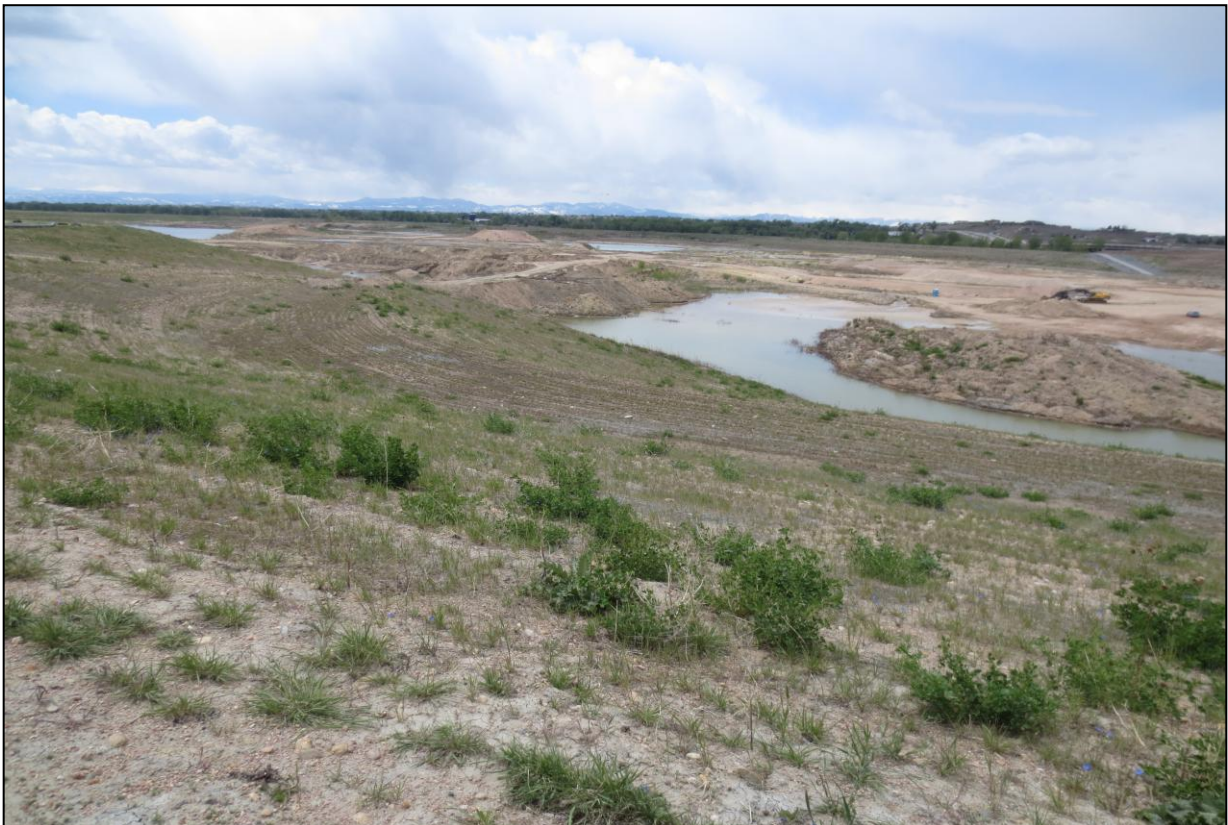
The slope of the reservoir sides were sloped at 3H:1V or flatter along the majority of the reservoir. All slopes appeared to be structurally stable.

**Photo 2:** View looking southwest, reclaimed pit slope in the foreground.

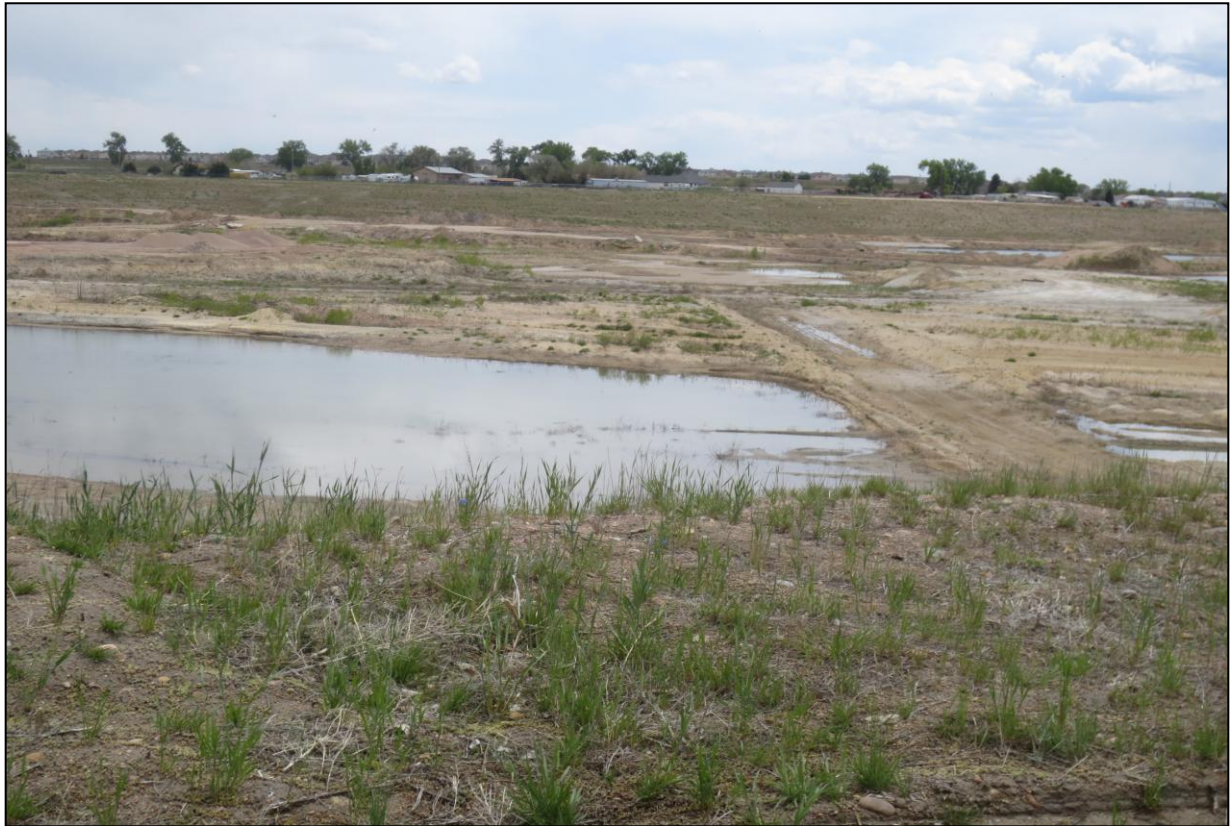
**Photo 3:** View looking east, reclaimed pit slope in the background.

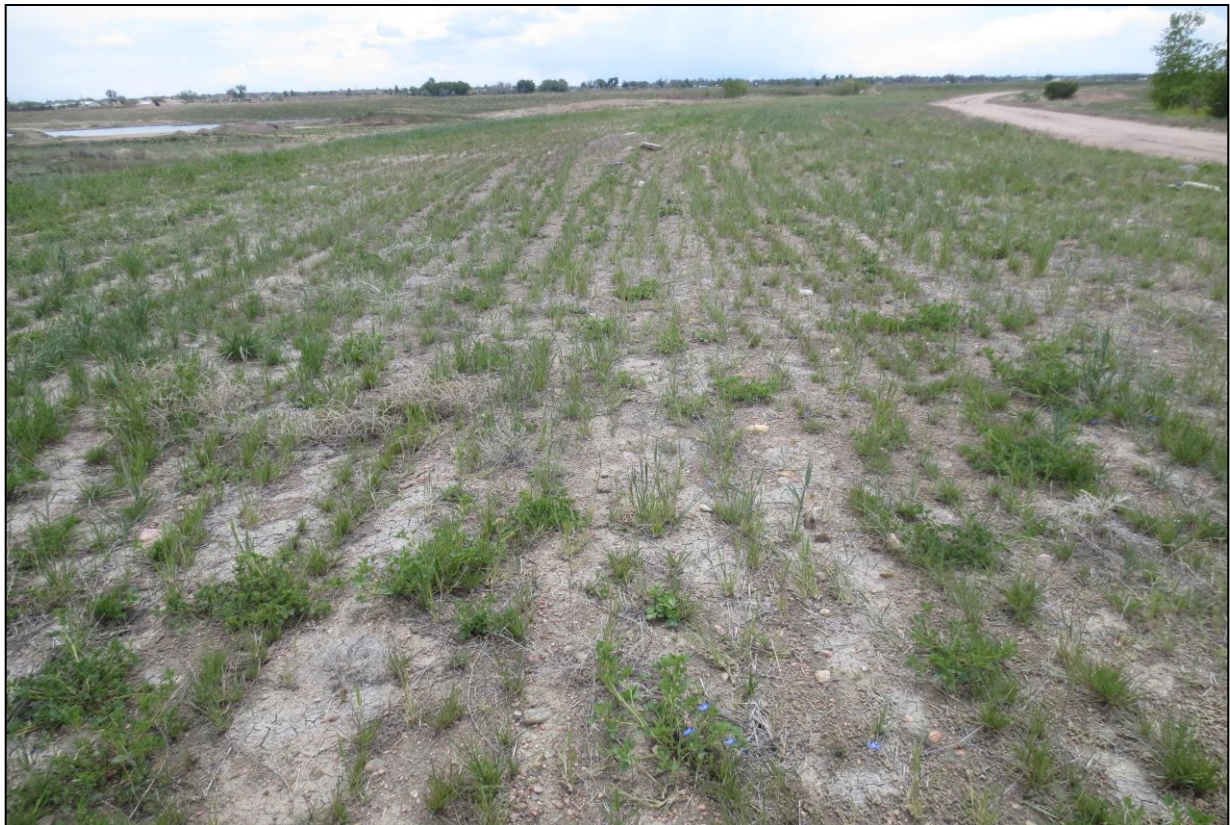
The entire site appears to have been seeded approximately 1-3 years ago. Vegetation is beginning to become established through the majority of the permitted mine site. There were a few annual weeds, various thistle and patches of cheatgrass. There were large patches of cheatgrass along the northern edge of the pit paralleling the 120th parkway. The Operator will need to continue to monitor and treat annual and noxious weeds if they appear in the permitted mine site. The Operator may want to consider re-seeding portions of the permitted site where desired vegetation is sparse.

**Photo 4:** Well revegetated portion of the pit.
