COLORADO DIVISION OF RECLAMATION, MINING AND SAFETY
MINERALS PROGRAM INSPECTION REPORT
PHONE: (303) 866-3567

MINE NAME: Walker Pit North	MINE/PROSPECTING ID#: M-1984-140	MINERAL: Sand and gravel	COUNTY: Prowers
INSPECTION TYPE: Monitoring	INSPECTOR(S): Amy Eschberger	INSP. DATE: May 29, 2014	INSP. TIME: 12:30
OPERATOR: Prowers County	OPERATOR REPRESENTATIVE: Mark Dorenkamp	TYPE OF OPERATION: 110c - Construction Limited Impact

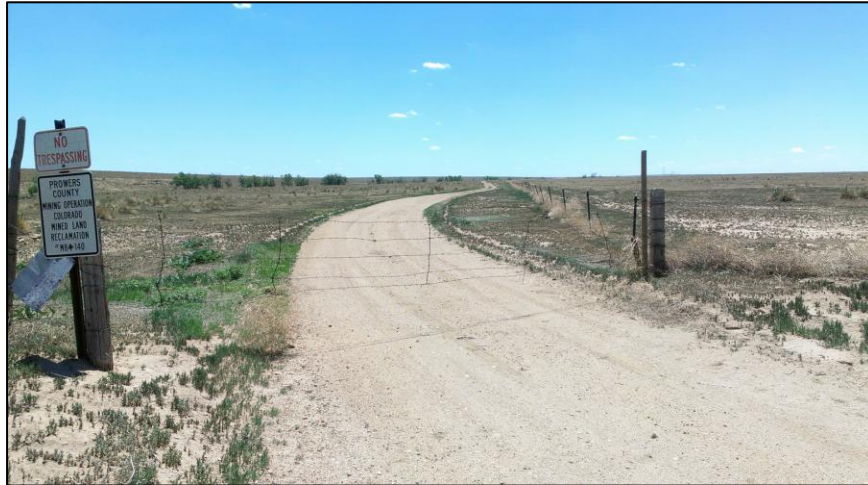
At the time of inspection, it was clear and warm, and the ground was dry. A permit sign was posted at the gated entrance to the site on Co Rd 10 (Photo 1). The permit boundary was marked with metal posts (Photo 2). No mining equipment was present during the inspection. Mr. Dorenkamp indicated that in the past several years, the County has only been intermittently hauling out material from stockpiles. The Operator submitted a Technical Revision that was approved on February 25, 2014 that allows for intermittent operation of the site.

Photo 1. View of gated entrance to site showing permit sign posted (at left).

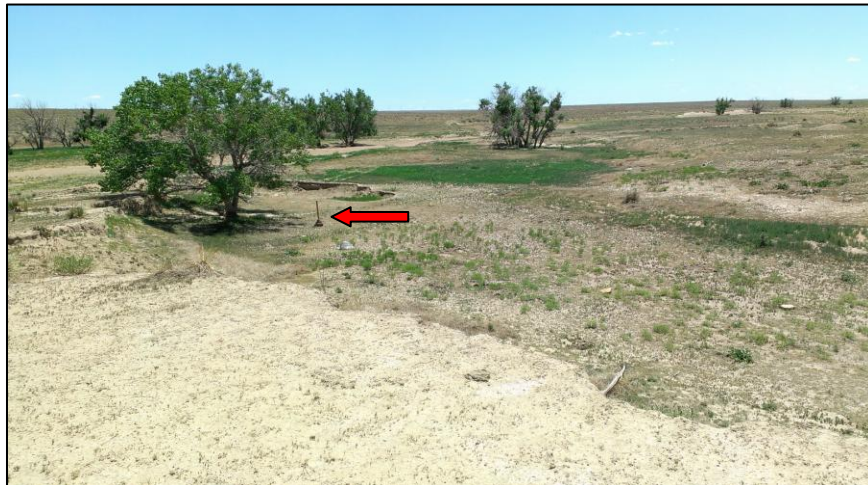
Photo 2. View looking east from just north of permit area, showing northeastern boundary marker (indicated with arrow).

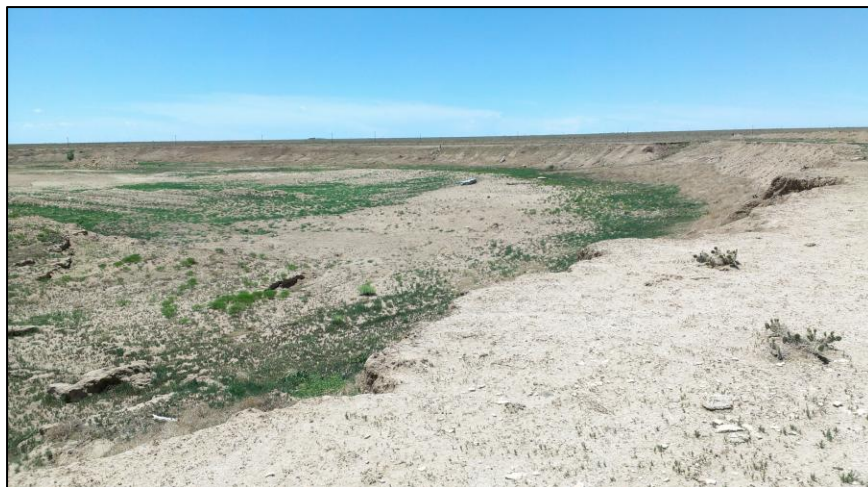
Photo 3. View looking west from just north of permit area, showing western bank wall of old Clay Creek meander.

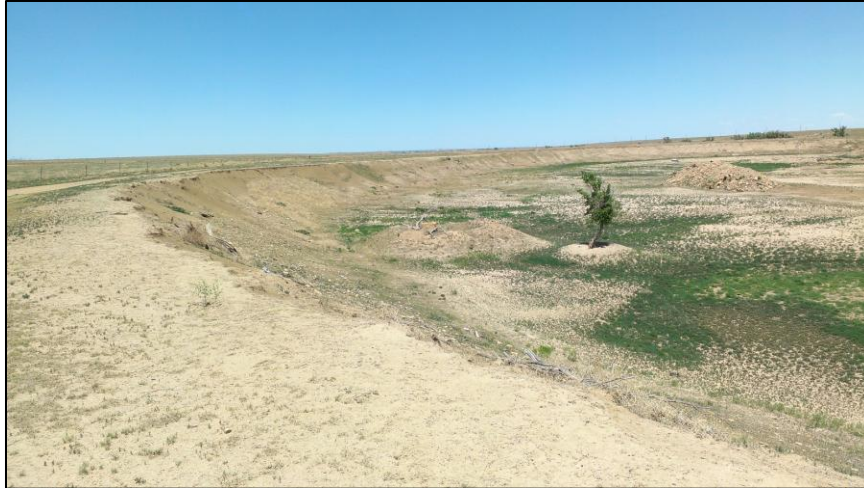
Photo 4. View looking north from southwestern portion of site, showing western and northern bank wall of old Clay Creek meander.

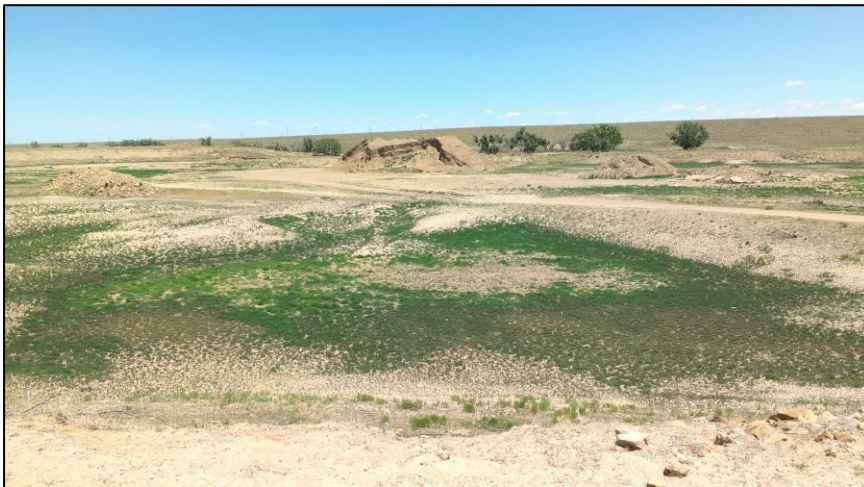
This is a 110c operation permitted for 9.9 acres to mine sand and gravel from an old meander in Clay Creek. This intermittent creek appears to flow primarily east of the mining operation, flowing from south to north toward the Arkansas River which is located approximately 7 miles north of the site. At the time of inspection, Clay Creek was dry. The old meander bank wall present along the northern and western boundaries of the permit area is approximately 10 feet in height (Photos 3 and 4). The topography of the permit area is somewhat undulating, with several small mounds and shallow depressions where previous excavations occurred. Several small material stockpiles are scattered throughout primarily the southern half of the site. One larger material stockpile is stored at the center of the permit area (Photo 5). No highwalls remain on site.

Photo 5. View looking northeast from southern portion of site, showing several small material stockpiles and one larger material stockpile at center.

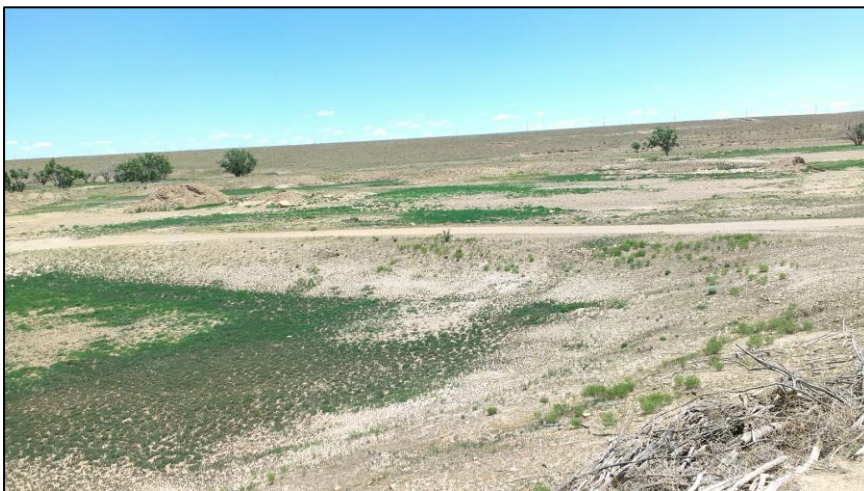
Approximately one acre located in the southwestern portion of the site near the haul road (Photo 6) was disturbed by previous mining operations. This previous disturbance is part of the permit area and will be reclaimed to rangeland with the rest of the affected area. Mining from the current operation progressed northward and eastward from this portion of the site.

Photo 6. View looking east/southeast from southwestern portion of site, showing previously disturbed area near haul road.
