**COLORADO DIVISION OF RECLAMATION, MINING AND SAFETY**  
**MINERALS PROGRAM INSPECTION REPORT**  
**PHONE: (303) 866-3567**

<b>MINE NAME:</b> Brann Pit	<b>MINE/PROSPECTING ID#:</b> M-1984-136	<b>MINERAL:</b> Sand and gravel	<b>COUNTY:</b> Prowers
<b>INSPECTION TYPE:</b> Monitoring	<b>INSPECTOR(S):</b> Amy Eschberger	<b>INSP. DATE:</b> May 29, 2014	<b>INSP. TIME:</b> 13:25
<b>OPERATOR:</b> Prowers County	<b>OPERATOR REPRESENTATIVE:</b> Mark Dorenkamp	<b>TYPE OF OPERATION:</b> 110c - Construction Limited Impact

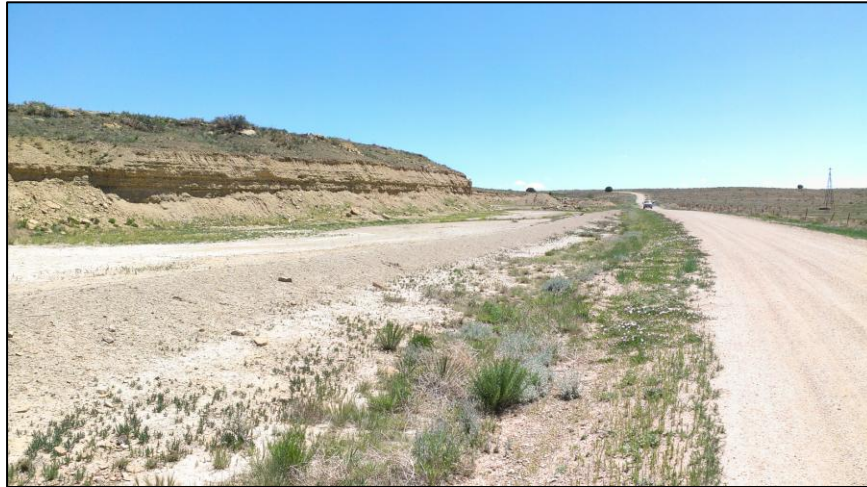
This was a normal monitoring inspection of the Brann Pit (File No. M-1984-136) conducted by Amy Eschberger of the Division of Reclamation, Mining and Safety (Division). Mr. Mark Dorenkamp of Prowers County was present for the inspection. The site is located approximately 24 miles south and 7 miles west of Lamar, Colorado in Prowers County, on land owned by George W. Brann. The site is adjacent to Co Rd 16 (Photo 1), located approximately 0.8 miles north of Co Rd F.

**Photo 1.** View looking south from central portion of site, showing Co Rd 16 located just west of the site.

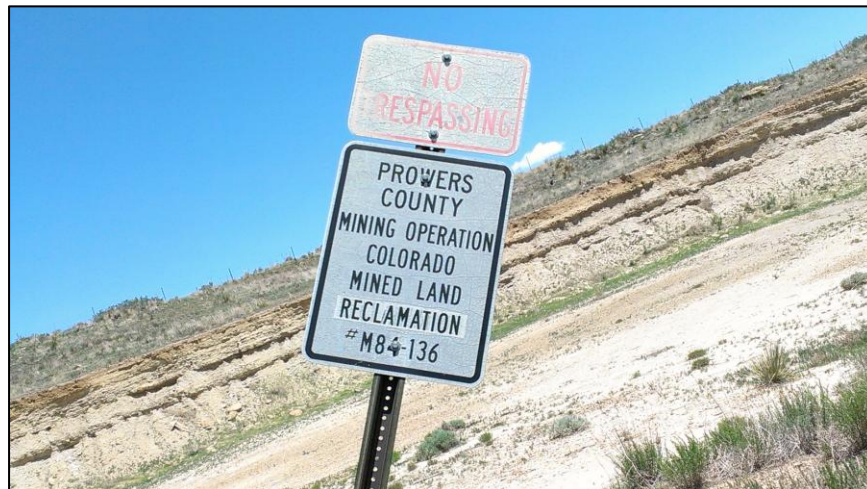
At the time of inspection, it was clear and warm, and the ground was dry. A permit sign was posted along Co Rd 16 (Photo 2). The permit area was well defined by Co Rd 16 to the west and an agricultural fence to the east. The eastern portion of the site consists of a long west-facing highwall approximately 20-25 feet in height with near vertical slopes (Photos 3 and 4). One material stockpile is present at the south end of the permit area and appears to be stable (Photo 5). A pile of large rocks is present near the center of the permit area (Photo 6).

**Photo 2.** View of permit sign posted along Co Rd 16.

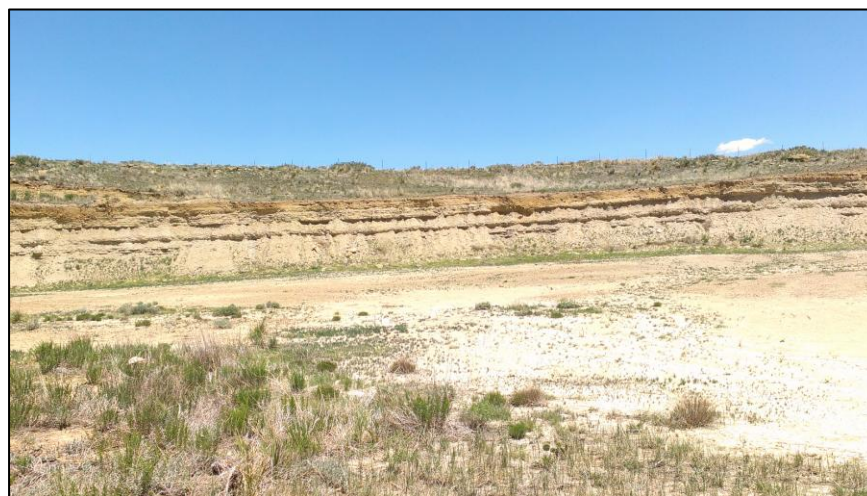
**Photo 3.** View of west-facing highwall located along eastern side of permit area.

According to the approved reclamation plan, the highwall will be sloped at a minimum of 2H:1V. To achieve this, the Operator may need to consult with the landowner about moving the eastern fence to allow for more room to maneuver equipment. Because the fence is not part of the permit area, this does not need to be included in the updated reclamation plan. However, the Operator shall be careful to not disturb area outside of the permit boundary.

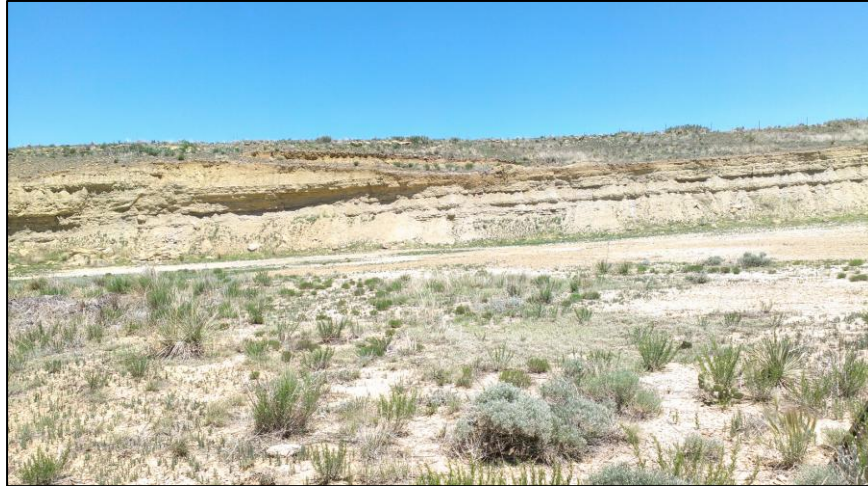
**Photo 4.** View of west-facing highwall located along eastern side of permit area (taken from further north than Photo 3).

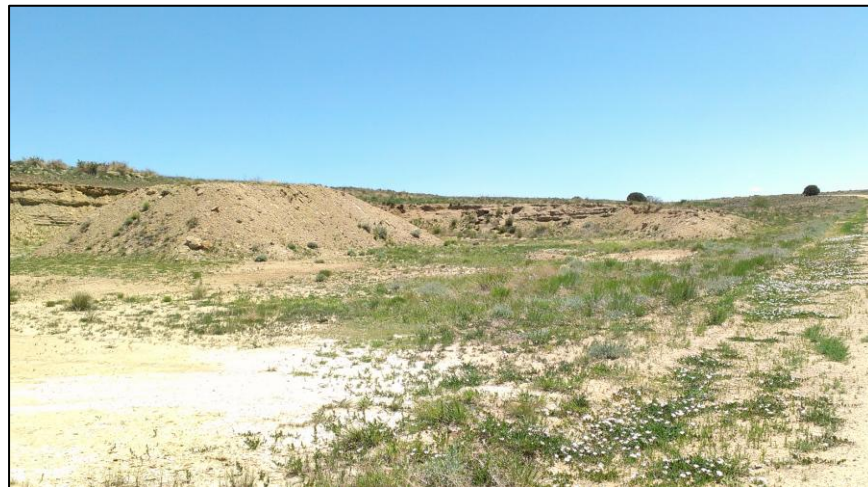
**Photo 5.** View of material stockpile located at far southern end of site.

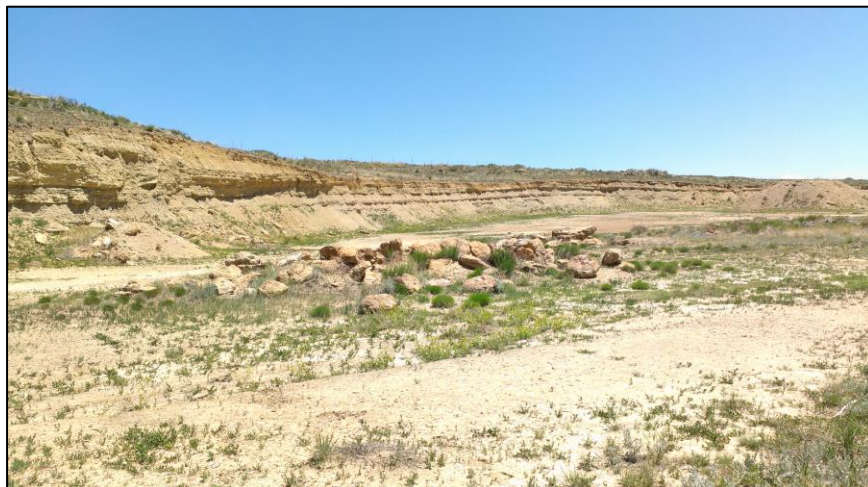
**Photo 6.** View of pile of large rocks located in central portion of site.

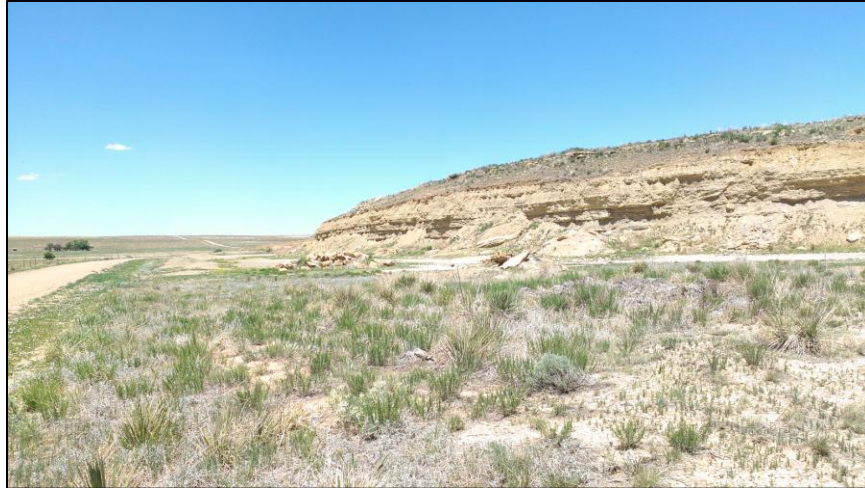
Native grasses and forbs have volunteered throughout the site (Photo 7). Less vegetative cover is present in the northern half of the site (Photo 8) where some minor erosion damage was observed. A gully appears to be forming in this portion of the permit area near the road (Photo 9). This gully seems to have been filled in naturally with tumbleweeds, but action by the Operator may be required to help stabilize this area from further erosion damage. Rule 3.1.6(3) states that the Operator shall effectively control erosion of all surface areas of the affected land. The Division strongly encourages the Operator to monitor erosion in the permit area and to work to prevent and repair erosion damage in a diligent manner so that it does not become a problem at this site.

**Photo 7.** View looking north from central portion of site, showing native grasses and forbs that have volunteered in the permit area.

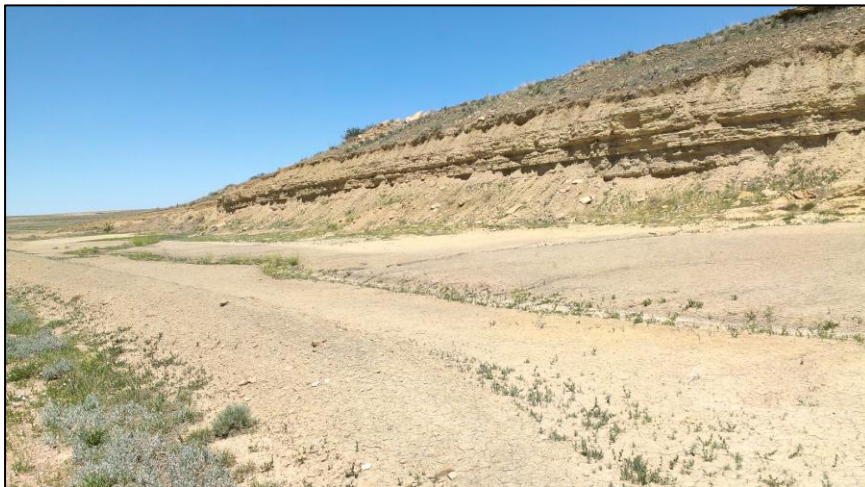
**Photo 8.** View looking north from northern portion of site, showing less vegetative cover in this area.

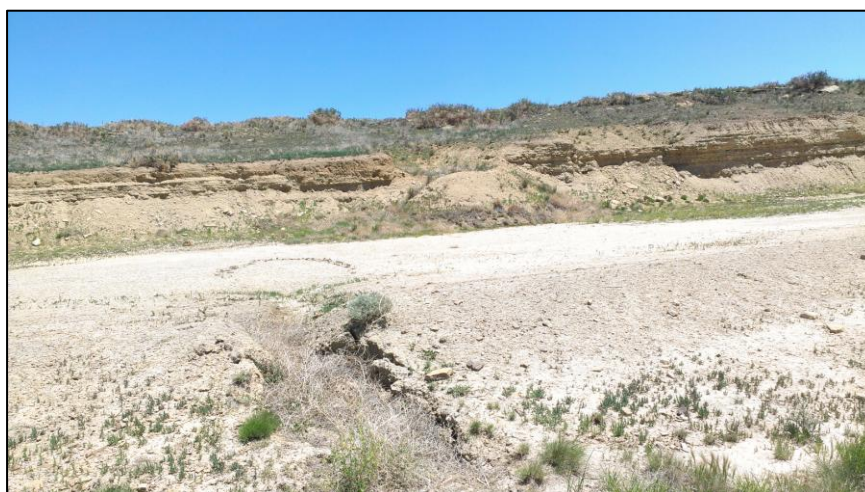
**Photo 9.** View of gully located in northern portion of site, near the road.
