**COLORADO DIVISION OF RECLAMATION, MINING AND SAFETY**  
**MINERALS PROGRAM INSPECTION REPORT**  
**PHONE: (303) 866-3567**

<b>MINE NAME:</b> Randy Shaw Pit	<b>MINE/PROSPECTING ID#:</b> M-1984-134	<b>MINERAL:</b> Sand and gravel	<b>COUNTY:</b> Prowers
<b>INSPECTION TYPE:</b> Monitoring	<b>INSPECTOR(S):</b> Amy Eschberger	<b>INSP. DATE:</b> May 29, 2014	<b>INSP. TIME:</b> 14:00
<b>OPERATOR:</b> Prowers County	<b>OPERATOR REPRESENTATIVE:</b> Mark Dorenkamp	<b>TYPE OF OPERATION:</b> 112c - Construction Regular Operation

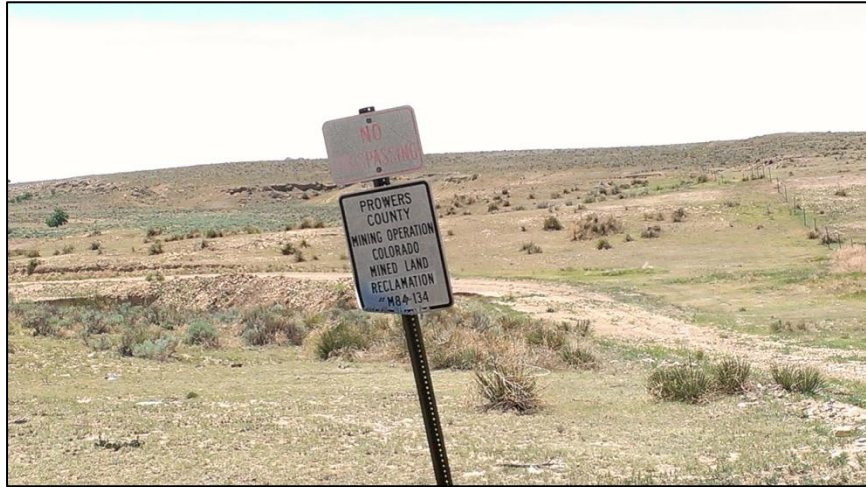
At the time of inspection, it was clear and hot, and the ground was dry. A permit sign was posted at the entrance off Co Rd 19 (Photo 1). The affected area is enclosed by an agricultural fence. This is a 112c operation permitted for 1,920 acres which encompasses portions of four sections (13, 23, 24, and 27 in T27S, R45W of the 6th P.M.) along Two Butte Creek. This dry operation consists of mining old alluvial sand and gravel deposits left from flooding of the creek.

**Photo 1.** View of permit sign posted at gated entrance to site off of Co Rd 19.

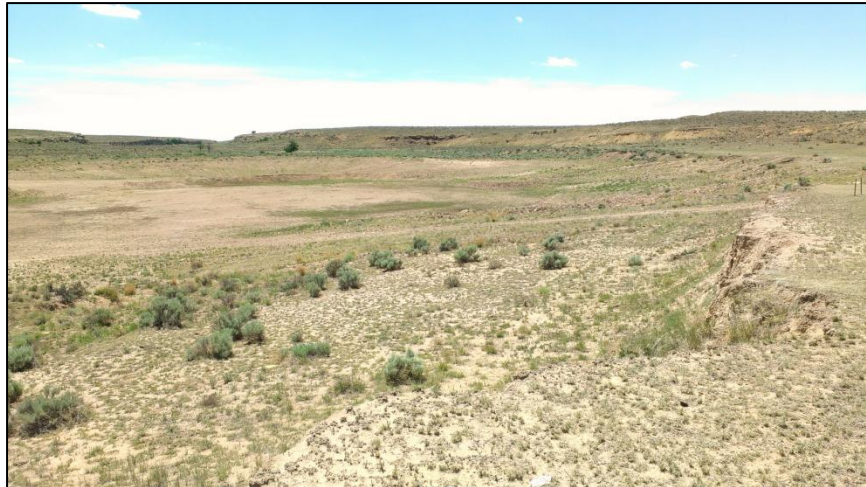
The current disturbed area consists of a large, circular excavation where mining progressed westward (Photos 2-4). No highwalls remain. All slopes in the affected area have been graded to 3H:1V or flatter. Only a few small mounds of processed material remain along the northern and eastern boundaries of the affected area (Photo 5). No mining equipment was present during the inspection. Mr. Dorenkamp stated that the County has only been hauling off material from stockpiles intermittently for the past several years. A Technical Revision (TR-01) that allowed for intermittent operation of the site was approved on 02/25/2014.

**Photo 2.** View looking west across northwestern portion of site. Note entrance of haul road at center.

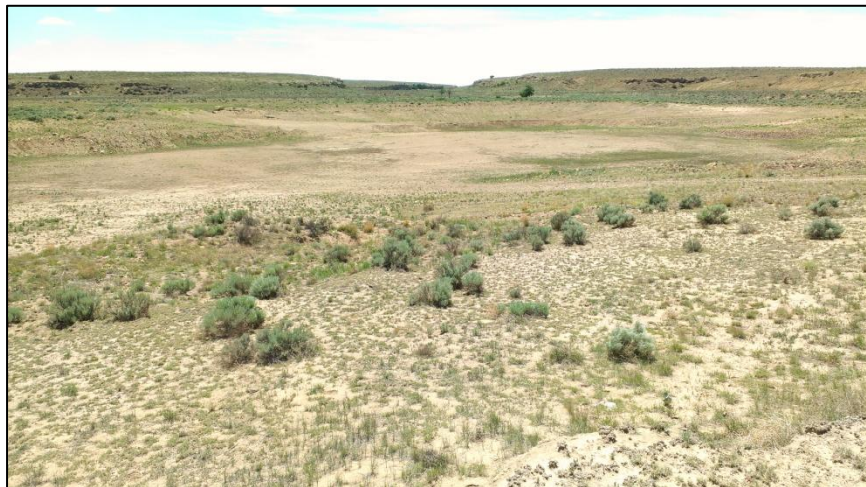
**Photo 3.** View looking west into main pit area on western portion of site.

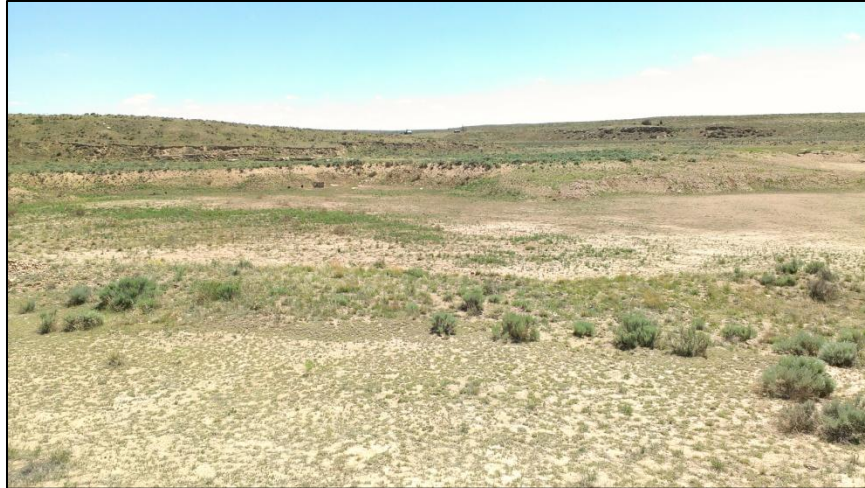
**Photo 4.** View looking south across central/eastern portion of site.

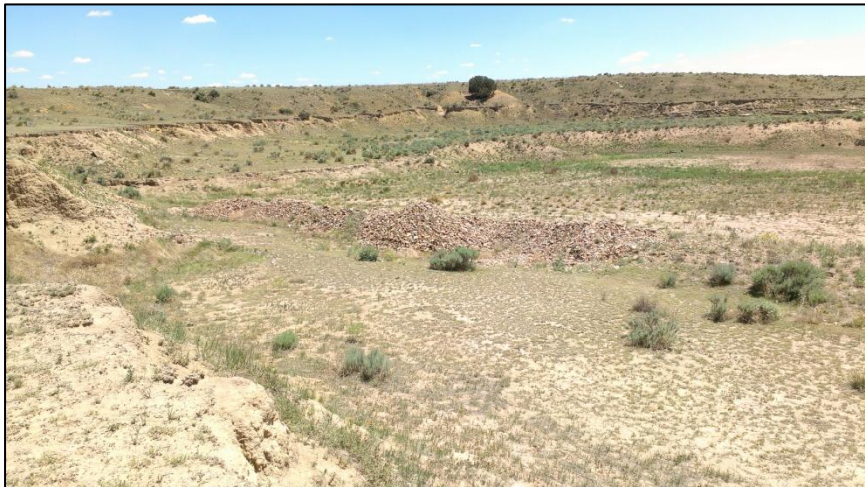
**Photo 5.** View looking southeast across eastern portion of site, showing small pile of processed material.
