COLORADO DIVISION OF RECLAMATION, MINING AND SAFETY
MINERALS PROGRAM INSPECTION REPORT
PHONE: (303) 866-3567

MINE NAME: Baculite Mesa Pit	MINE/PROSPECTING ID#: M-1997-011	MINERAL: Sand and gravel	COUNTY: Pueblo
INSPECTION TYPE: Monitoring	INSPECTOR(S): Timothy A. Cazier	INSP. DATE: November 15, 2013	INSP. TIME: 13:50
OPERATOR: Baculite Mesa, LLC	OPERATOR REPRESENTATIVE: Joe Gagliano	TYPE OF OPERATION: 112c - Construction Regular Operation

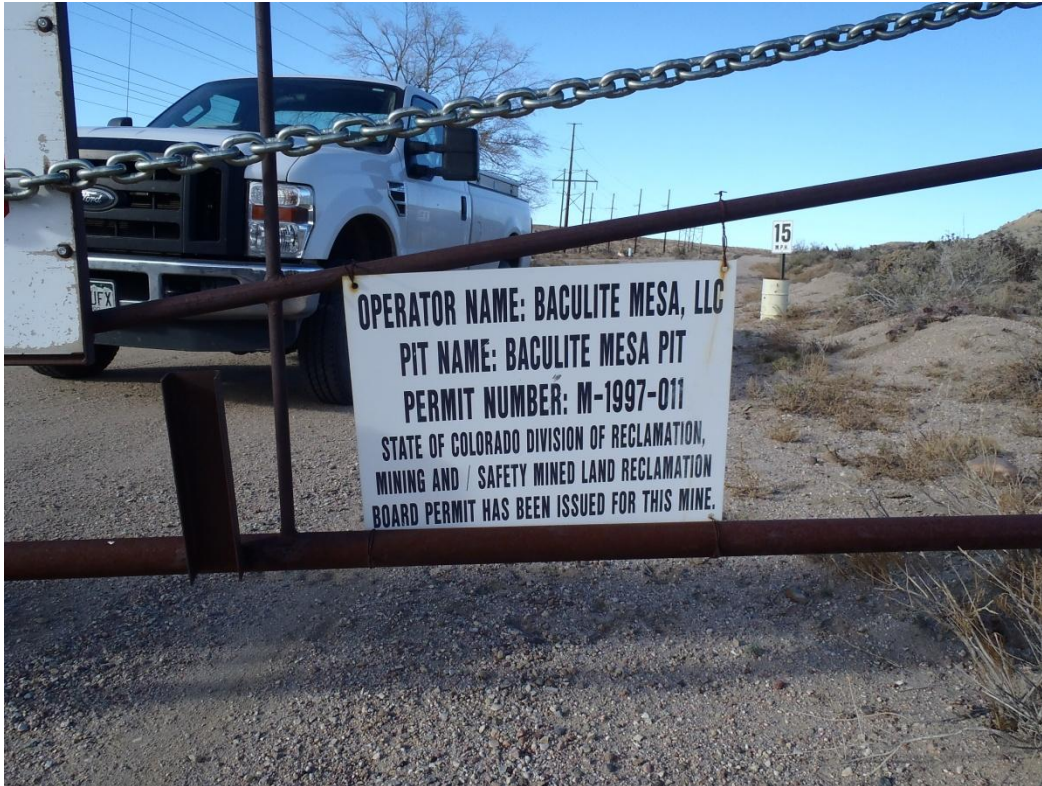
The site was not operating at the time of the inspection. A permit sign was displayed at the site entrance (see **Photo 1**). The active portion boundary was marked with T-posts (see **Photos 2 and 3**).

Photo 1. Permit Sign (at entrance).

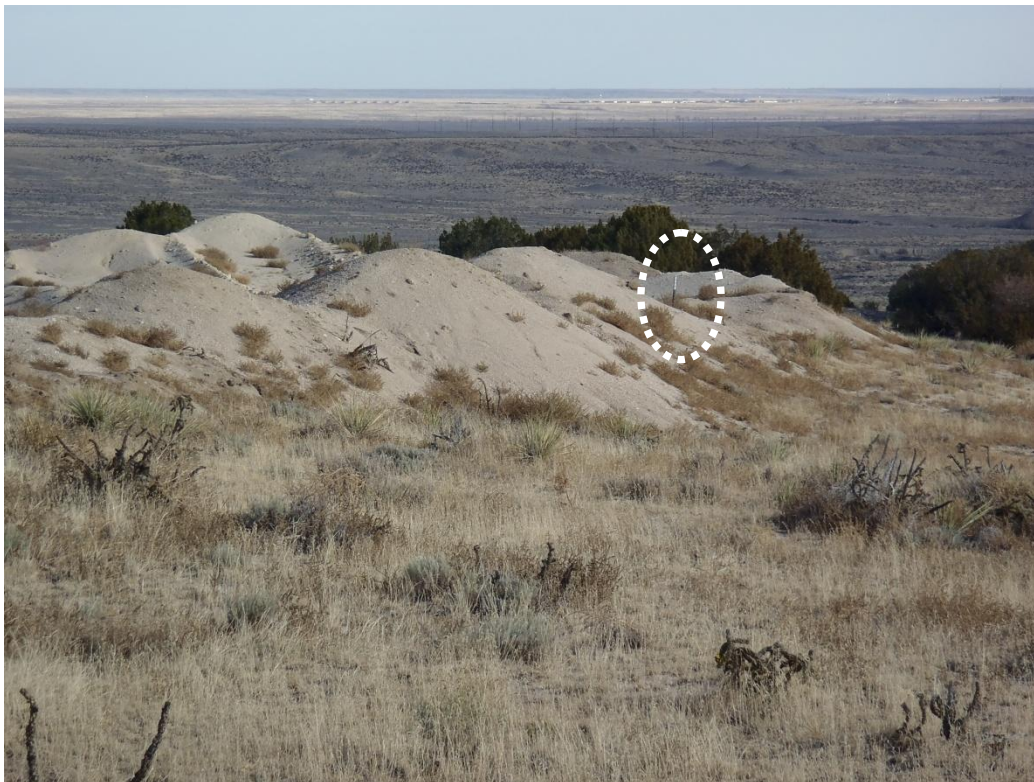
No distinction has been made between vegetative media for reclamation and backfill material. Material for both was observed stockpiled at the top of the highwall (see **Photos 2 and 6**). The only mine related equipment observed were a truck scales and scale house (see **Photo 7**). A small area on the north end of the pit has been seeded and shows some vegetation (see **Photo 8**).

Photo 2. T-post marking phased boundary & backfill material (above highwall, looking SE).

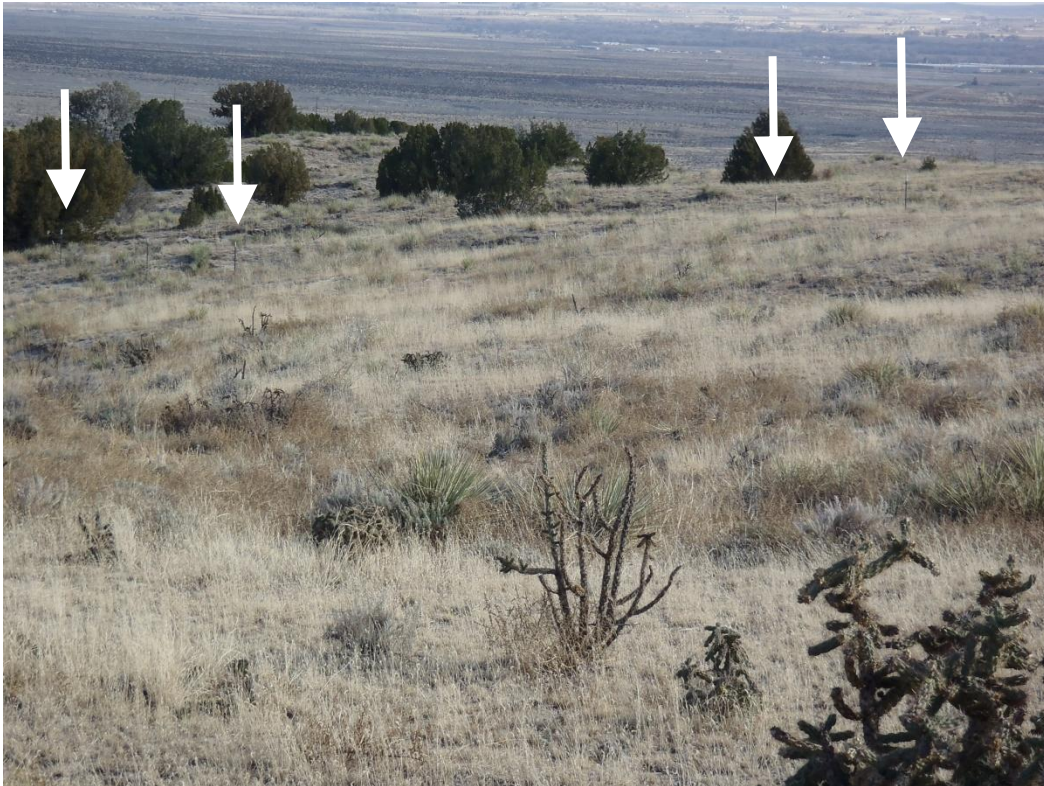
Photo 3. Additional boundary-marking T-posts (south side).

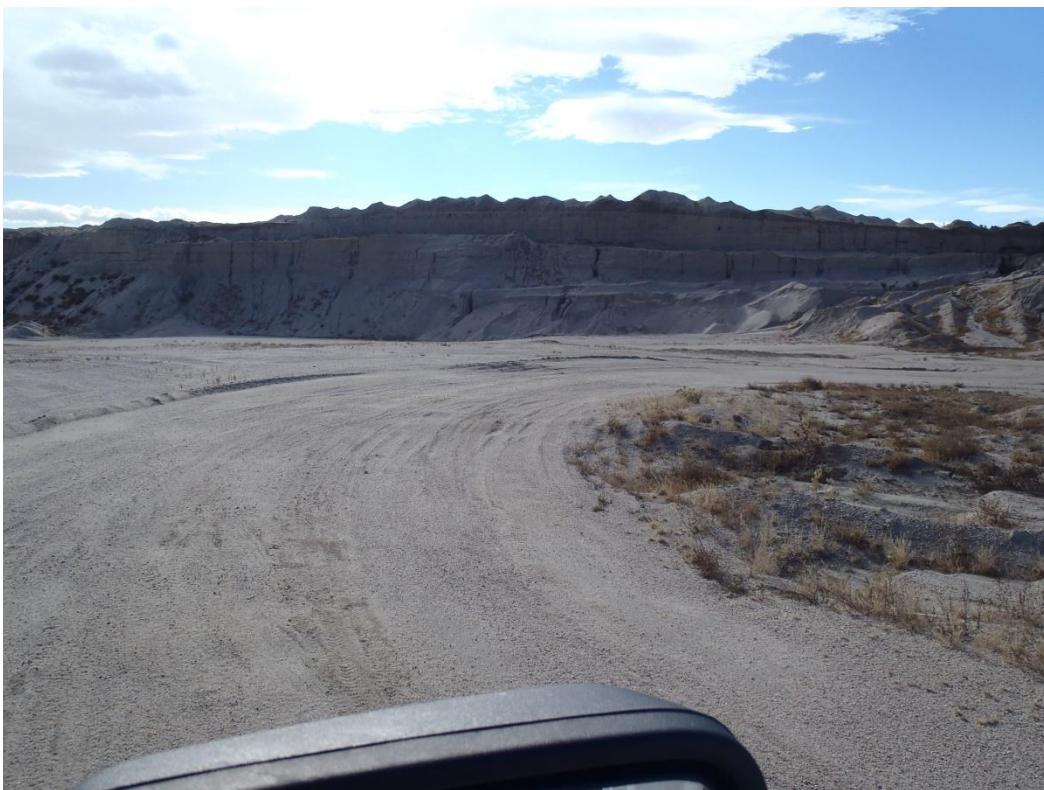
The highwall varied in height from about 8 feet (in the southeast) to over 30 feet in the southwest (see **Photo 4**). The excavation appeared to be proceeding in the south and west direction. Portions of the highwall exhibited considerable erosion (see **Photo 5**). However, eroded material settles out on the pit floor and did not appear to leave the site. For this reason, the eroded highwall was not cited as a problem.

Photo 4. Highwall – tallest portion (looking SW).

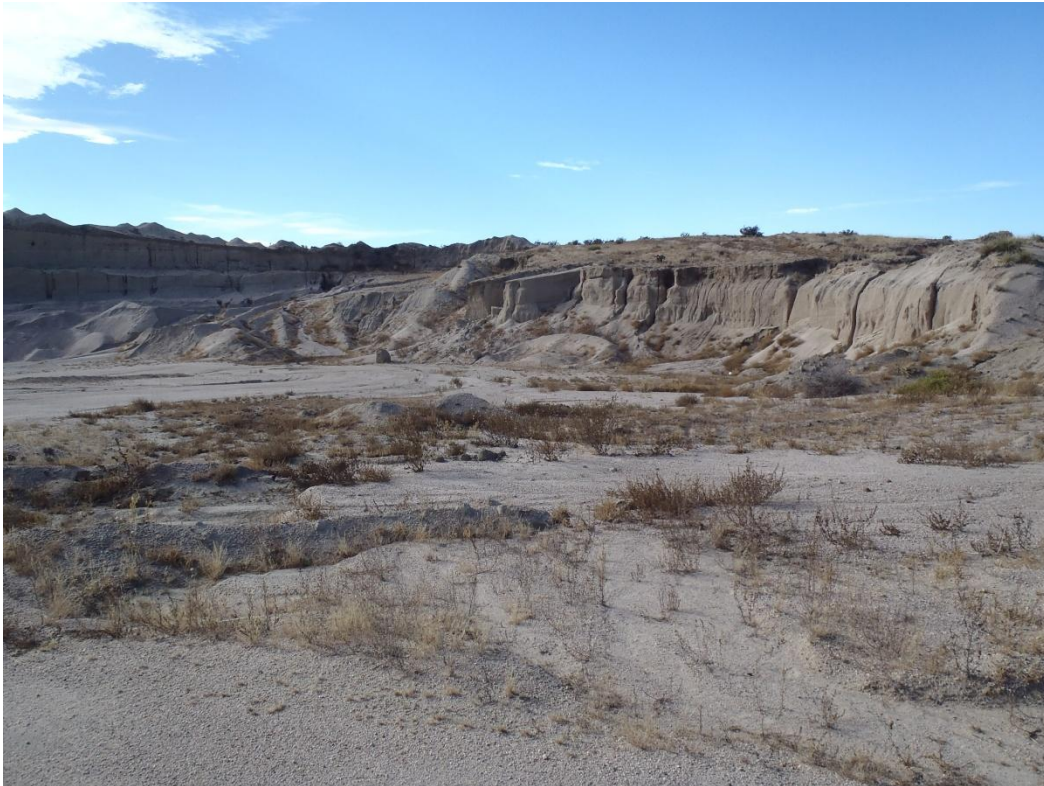
Photo 5. Eroding highwall (looking WSW)

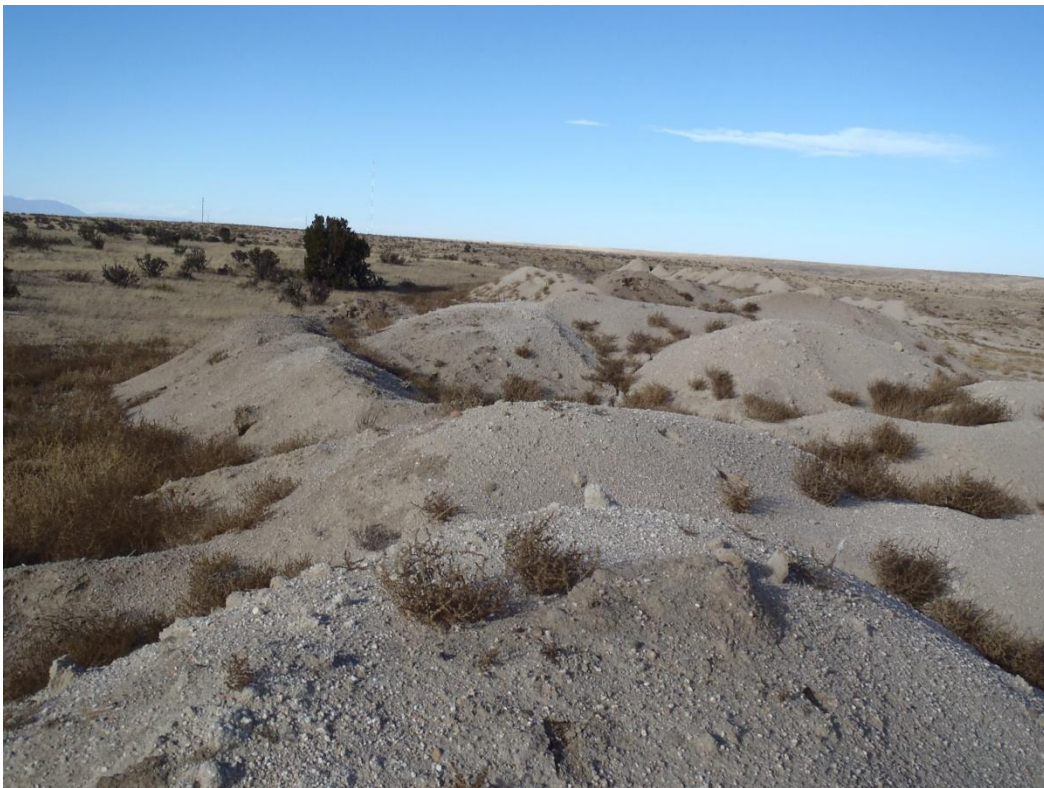
Photo 6. Vegetative media for reclamation and backfill material (west side, looking north).

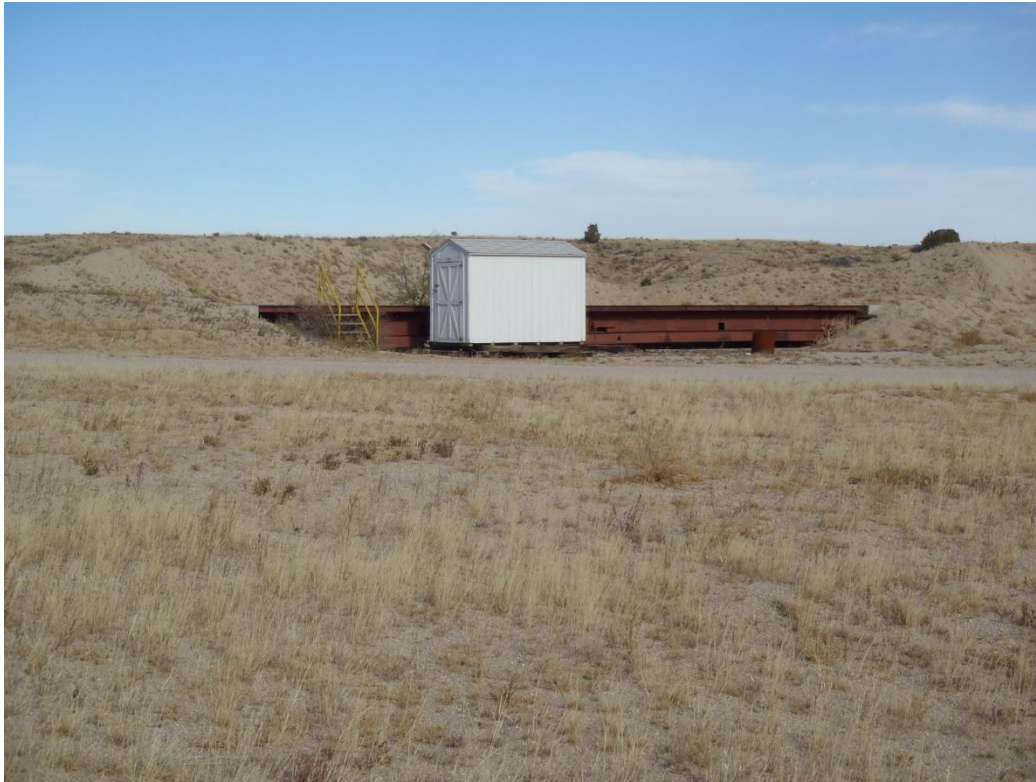
Photo 7. Truck scales and scale house (looking NNE).

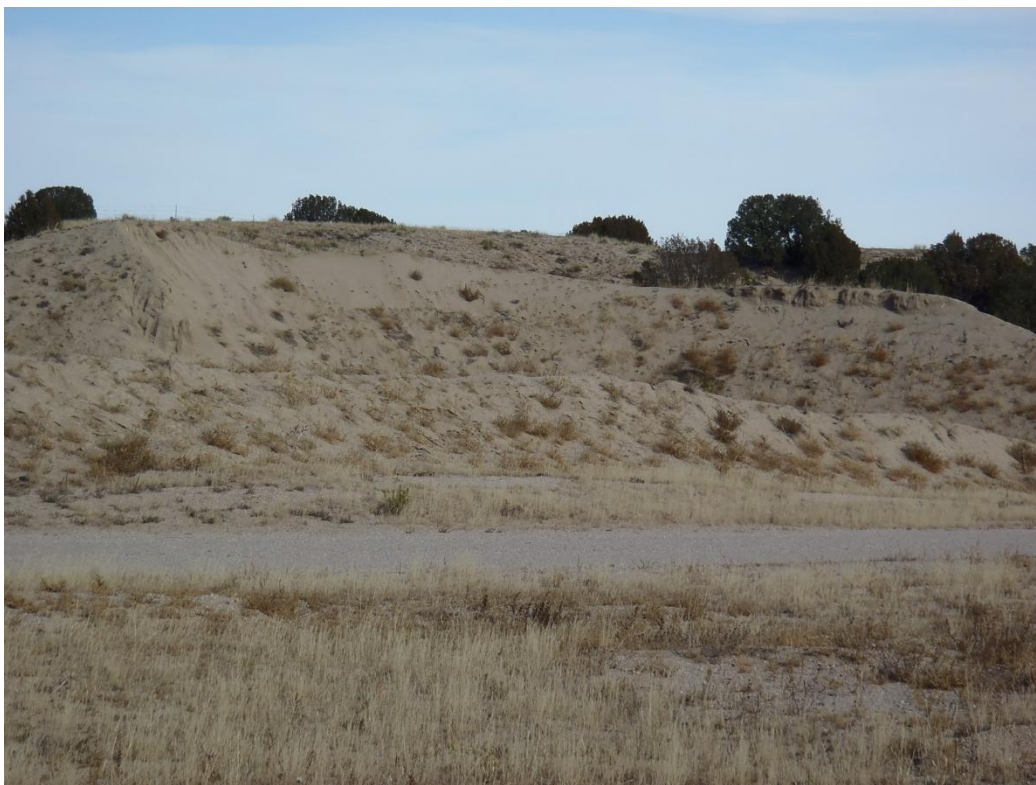
Photo 8. Small area in process of reclamation (north side, looking north).
