COLORADO DIVISION OF RECLAMATION, MINING AND SAFETY
MINERALS PROGRAM INSPECTION REPORT
PHONE: (303) 866-3567

MINE NAME: Topaz Mine	MINE/PROSPECTING ID#: M-1980-055-HR	MINERAL: Uranium and vanadium	COUNTY: San Miguel
INSPECTION TYPE: Monitoring	INSPECTOR(S): Bob Oswald	INSP. DATE: July 16, 2014	INSP. TIME: 15:00
OPERATOR: Energy Fuels Resources (USA) Inc.	OPERATOR REPRESENTATIVE: David Turk	TYPE OF OPERATION: 112d-3 - Designated Mining Operation

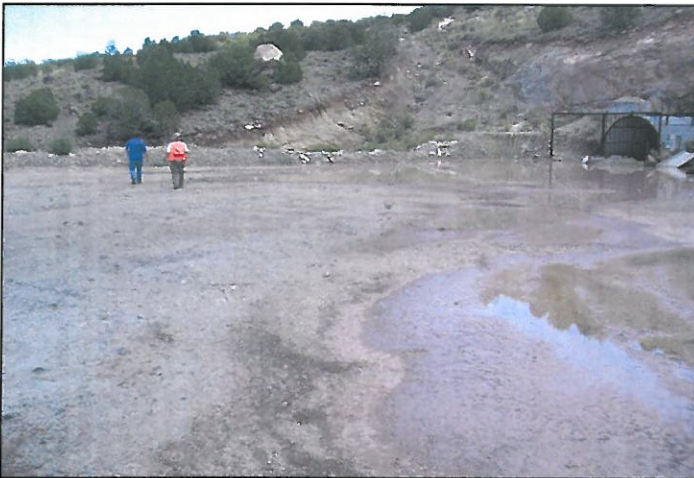
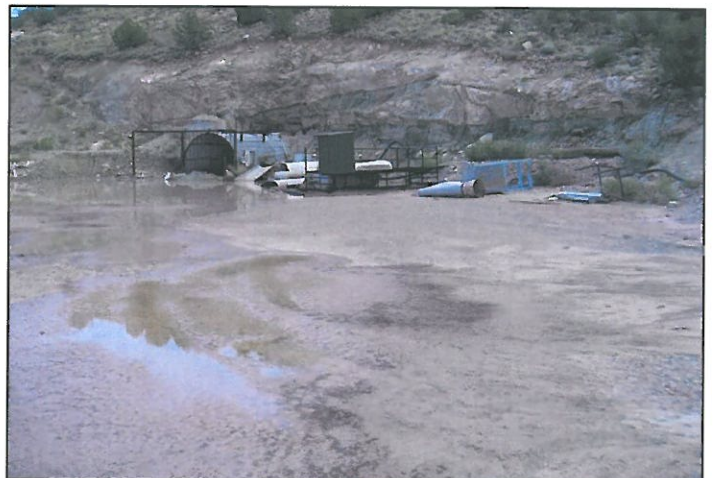
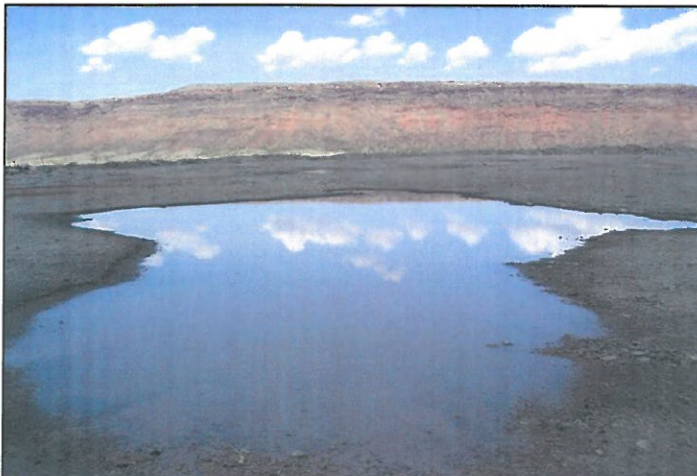
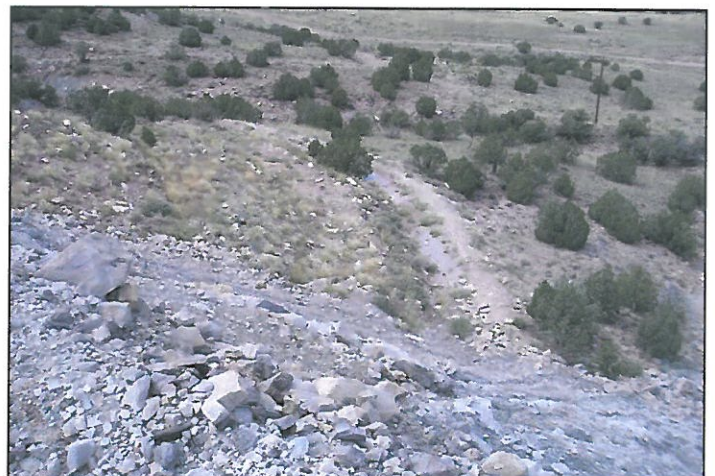
A precipitation event occurred the night before the inspection, which resulted in some minimal damage to some of the stormwater control structures on the site, although most of the structures were still intact and functional. The brunt of the storm event adversely affected the three mines in this group that are located at the eastern end of the complex. This site's stormwater control structures were designed by the operator's engineers during the formulation of the Environmental Protection Plan (EPP) several years ago, to provide sufficient capacity for the design storm. They were installed and maintained regularly as required.

The range of stormwater controls observed during this inspection includes upland diversion ditch, safety berm along the crest of the waste rock dump, sediment pond below the toe of the dump, culverts, waterbars and ditches along the roads. All the structures appeared to have functioned properly and most were observed to still be impounding water. There was a large amount of water ponded on the top of the dump surface, up to and possibly inside, the mine portal. The waste pad's safety berm was intact. All runoff from the coarse outslope of the dump face was captured in the sediment pond.

Though the stormwater control structures have been inspected previously and found to be installed and maintained properly, and still remain intact, it was apparent that storm intensity was important in determining whether the site's approved structures would remain intact. The same storm was far more intense at nearby permitted operations and easily overwhelmed the capacity of those structures. Even though this site is still in good condition, the operator is urged to perform the following measures as soon as possible:

1. evaluate all stormwater control structures, and ensure they still meet the specifications in the approved EPP;
2. upgrade the strength (cross-sectional thickness) of the dikes wherever possible, but do not raise only the height of the dikes;
3. consider designing and installing armored outlets (spillways) for any critical impoundments;
4. remove the sediment and debris from the impoundments, to re-establish the design capacity;
5. consider using the salvaged sediments as growth media, and either stockpile them for later use or spread them on graded surfaces and seed them;
6. reseed disturbed areas so that they become better protected against erosion; and
7. monitor for new areas of weeds since seeds may have been deposited with the sediments.
