**COLORADO DIVISION OF RECLAMATION, MINING AND SAFETY**  
**MINERALS PROGRAM INSPECTION REPORT**  
**PHONE: (303) 866-3567**

<b>MINE NAME:</b> Carnation Mine	<b>MINE/PROSPECTING ID#:</b> M-1977-416	<b>MINERAL:</b> Uranium & vanadium	<b>COUNTY:</b> San Miguel
<b>INSPECTION TYPE:</b> Monitoring	<b>INSPECTOR(S):</b> Bob Oswald	<b>INSP. DATE:</b> July 16, 2014	<b>INSP. TIME:</b> 14:30
<b>OPERATOR:</b> Energy Fuels Resources (USA) Inc.	<b>OPERATOR REPRESENTATIVE:</b> David Turk	<b>TYPE OF OPERATION:</b> 110d - Designated Limited Impact

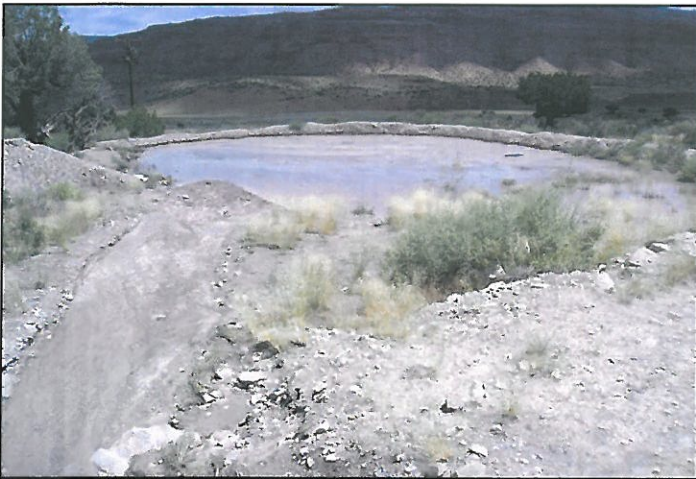
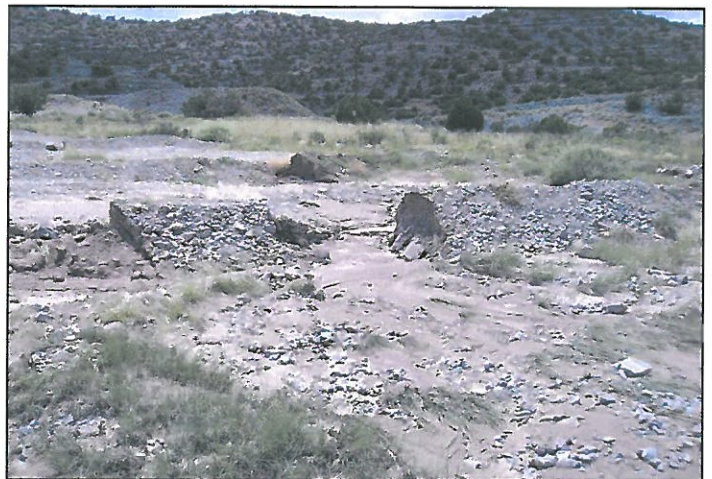
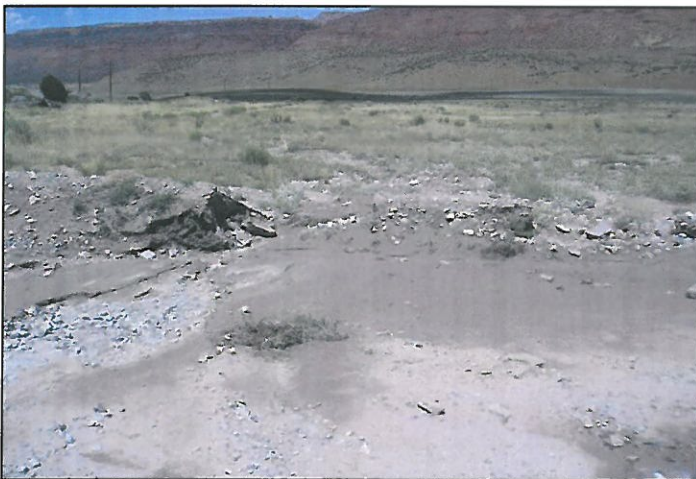
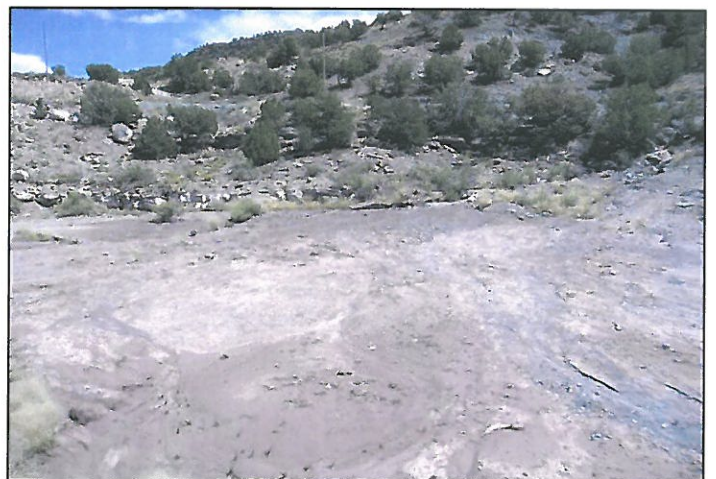
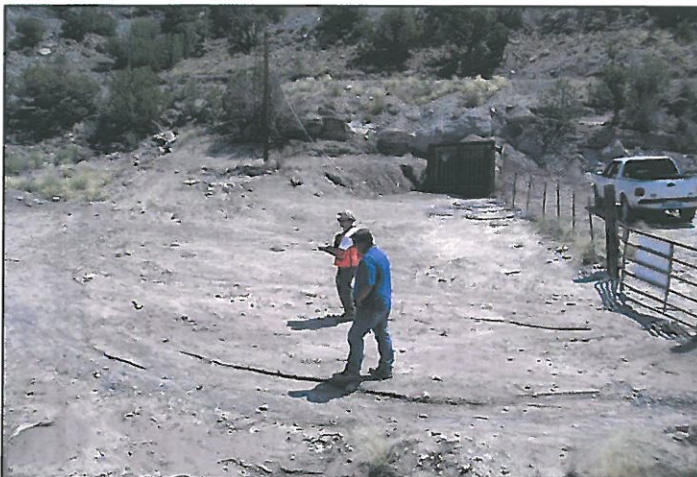
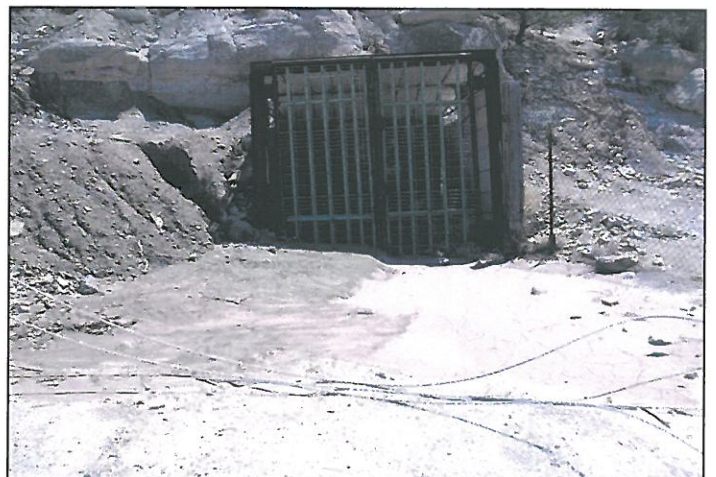
An intense precipitation event occurred the night before the inspection, which resulted in the partial or complete failure of most of the stormwater control structures on the site. The structures were designed by the operator's engineers during the formulation of the Environmental Protection Plan (EPP) several years ago, to provide sufficient capacity for the design storm. They were installed and maintained regularly as required. However, the intensity and/or total amount of precipitation in this event was beyond the design capacity of most of the structures. Only a few of the structures were intact (and full) at the time of the inspection.

The range of stormwater controls observed during this inspection includes upland diversion ditch, dikes and sediment cells below the toe of the dump, sediment pond and ditches along the road. This report will describe only the particularly notable individual items observed. What was apparent about the storm-related damage was that all the structures appeared to have functioned properly up to a point of maximum capacity and strength, usually evident by visible high-water marks of organic debris (indicating impoundment) and one or several locations of vertical down-cutting through each impoundment. In some cases, failure of one impoundment caused a slug of water and sediment to overwhelm one or more lower structures, resulting in a series of breaches.

The county road crossing the site is steep and bisects the waste dumps. Road ditches were deeply eroded. The sediment catchment pond next to the road was full but had not breached. The operator should review the plan's structures and ensure there is still sufficient diversion or catchment capacity (such as waterbarring, armoring, riprapping, and berms). Likewise, the outslope of the upper dumps adjoining the road are steep and could perhaps be pulled back, armored, or otherwise made less erodible.

The upland diversion ditch did not ultimately catch and convey all runoff from the slope above the pad. Up to a foot (depth) of sediment was deposited at the portal. Concentrated runoff across the dump and down the dump face resulted in an overload to the sediment cells on the flatter area to the north. This is where the uppermost dike failed, which triggered a series of cascading failures to lower cells from the accumulating runoff volume. It should be noted that immediately below the lowest failed control berm, the runoff velocity decreased and the sediment was deposited onsite. The dikes for these cells should be resurveyed to ensure they are aligned properly and built-up sufficiently.

1. repair all damaged stormwater control structures, at least to the specifications in the approved EPP;

2. upgrade the strength (cross-sectional thickness) of the dikes wherever possible, but do not raise only the height of the dikes;
3. consider designing and installing armored outlets (spillways) for at least the critical impoundments;
4. remove the sediment and debris from the impoundments, to re-establish the design capacity;
5. consider using the salvaged sediments as growth media, and either stockpile them for later use or spread them on graded surfaces and seed them;
6. reseed disturbed areas so that they become better protected against erosion; and
7. monitor for new areas of weeds since seeds may have been deposited with the sediments.
