COLORADO DIVISION OF RECLAMATION, MINING AND SAFETY
MINERALS PROGRAM INSPECTION REPORT
PHONE: (303) 866-3567

MINE NAME: Howard Creek Pit #1 & #2	MINE/PROSPECTING ID#: M-1999-033	MINERAL: Gravel	COUNTY: Fremont
INSPECTION TYPE: Surety-Related Inspection	INSPECTOR(S): Timothy A. Cazier	INSP. DATE: August 6, 2014	INSP. TIME: 10:00
OPERATOR: Fremont County	OPERATOR REPRESENTATIVE: Sterling Rife	TYPE OF OPERATION: 110c - Construction Limited Impact

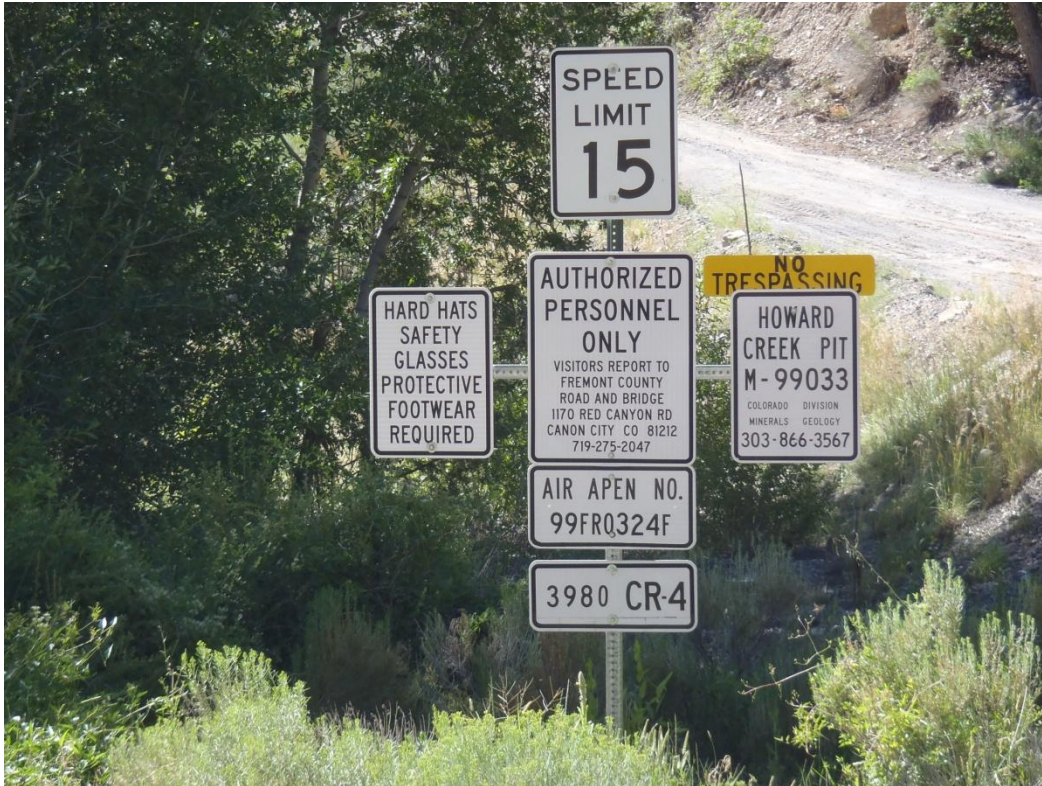
A Permit sign was displayed as required (see **Photo 1**). The primary focus of this inspection was to determine releasable acreage.

Photo 1. Permit sign (at entrance).

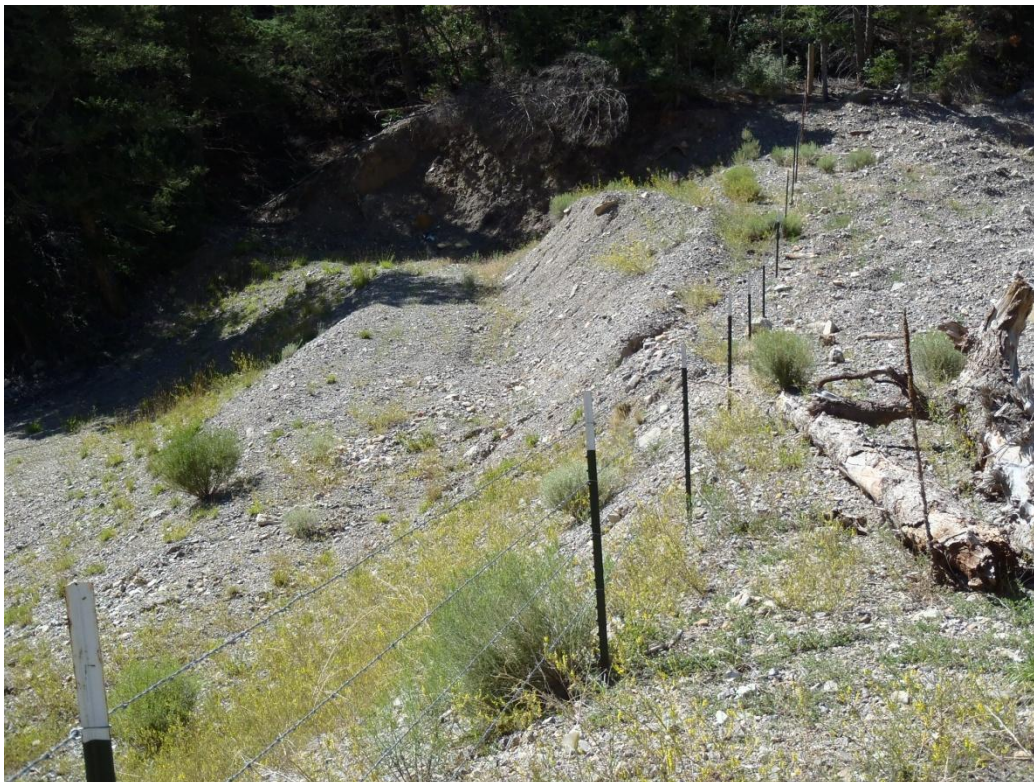
The area to be released is owned by Avenger Productions, Inc. This portion of the site has been fenced off (see **Photo 2**). The area is partially vegetated and some erosion rills (see **Photo 3**) from the recent heavy rains were observed. Mr. Rife was uncertain as to whether Fremont County ever disturbed this area as it had been fenced off for as long as he had been familiar with the site.

Photo 2. Fence separating area to be released, left of fence (looking east).

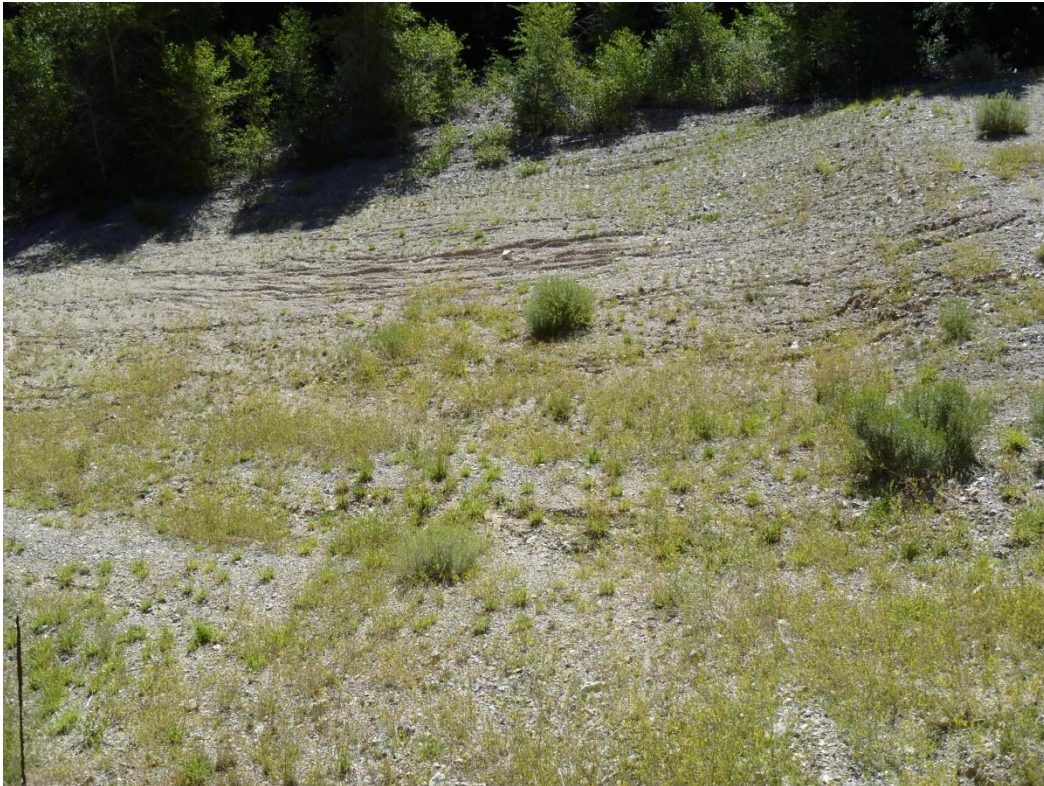
Photo 3. Area to be released (looking NE).

Based on previous inspection reports and the original permit application, the Division believes the area requested to be released was never disturbed as part of Fremont County's operations; but that this area was disturbed as a result of the limestone mining operations that occurred between 1900 through the 1950's. The Division will recommend approval of AR-01 given the evidence that the disturbance is pre-law. The Operator will be notified of the decision under separate cover.
