**COLORADO DIVISION OF RECLAMATION, MINING AND SAFETY**  
**MINERALS PROGRAM INSPECTION REPORT**  
**PHONE: (303) 866-3567**

<b>MINE NAME:</b> Bijou Clay Mine	<b>MINE/PROSPECTING ID#:</b> M-1997-007	<b>MINERAL:</b> Clay (general)	<b>COUNTY:</b> Elbert
<b>INSPECTION TYPE:</b> Monitoring	<b>INSPECTOR(S):</b> Amy Eschberger, TC Wait	<b>INSP. DATE:</b> June 3, 2014	<b>INSP. TIME:</b> 10:30
<b>OPERATOR:</b> The Denver Brick Company	<b>OPERATOR REPRESENTATIVE:</b> Rob Tibbetts	<b>TYPE OF OPERATION:</b> 112c - Construction Regular Operation

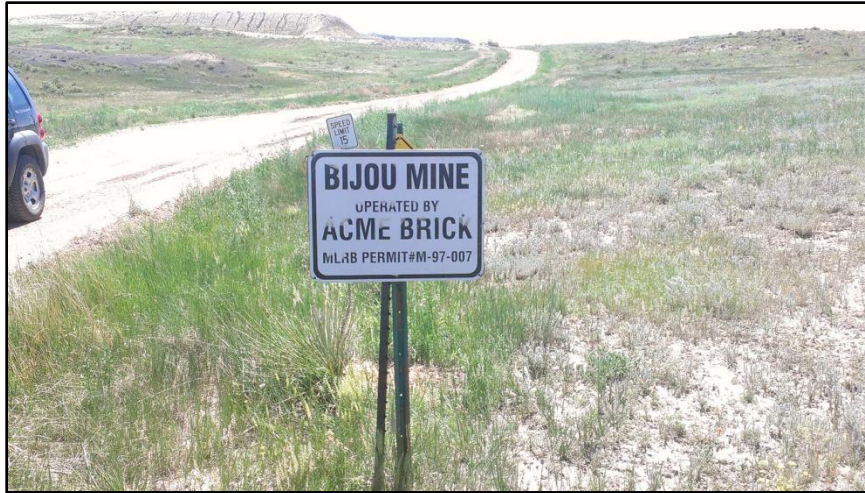
At the time of inspection, it was clear, hot and windy. The access road enters the site from the west and runs along its western and northern boundaries. A permit sign was posted off of Co Rd 73 just west of the site (Photo 1). The permit boundary was marked with metal posts and PVC pipes (Photo 2).

**Photo 1.** View of permit sign posted off of Co Rd 73.

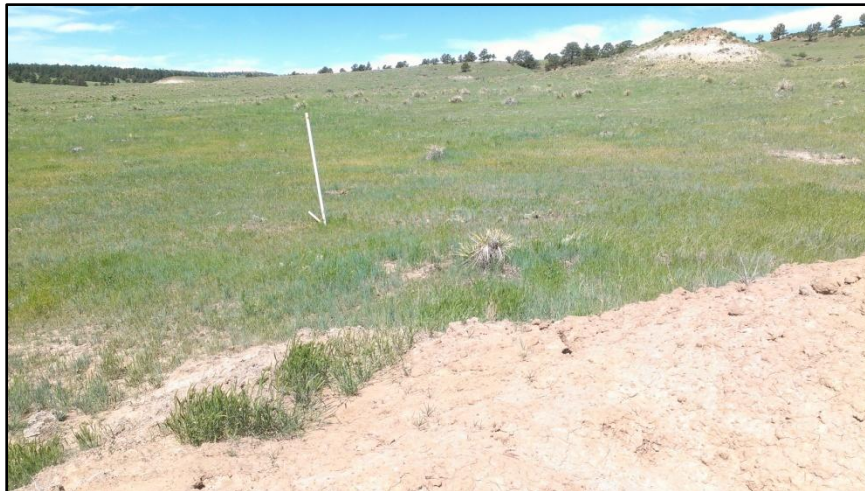
**Photo 2.** View of boundary marker at southwest corner of permit area.

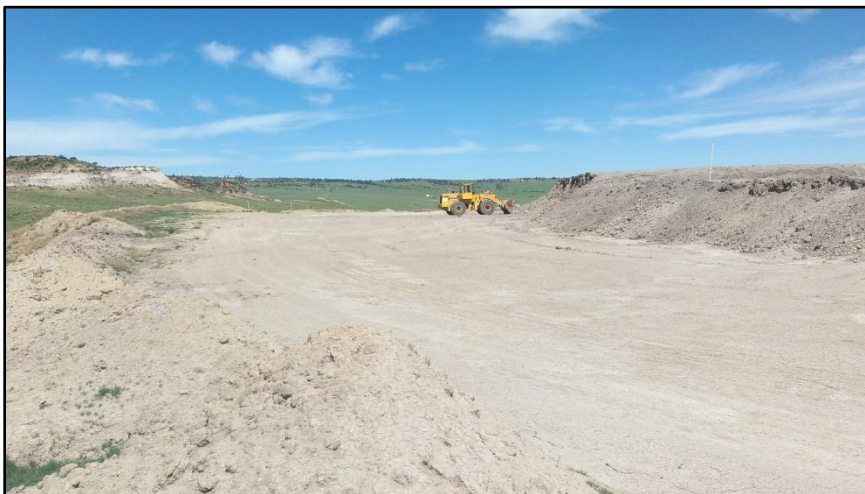
This is a 112c operation permitted for 33.75 acres to mine clay product for brick manufacturing. The product is stockpiled on site and transported to an off-site processing plant as needed. The only equipment present during the inspection was a front end loader which was cleaning up stockpiles (Photo 3). According to the recent annual report, mining activities last occurred at this site in November 2013. The site is permitted to operate intermittently.

**Photo 3.** View of front end loader in operation during inspection.

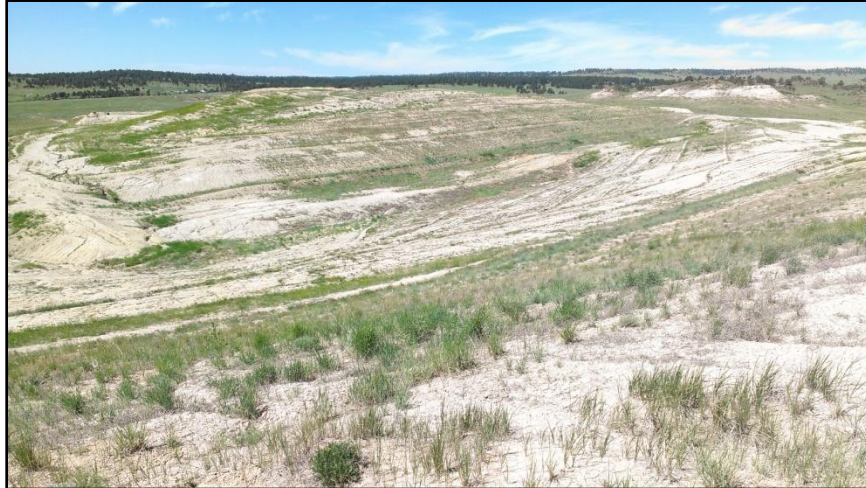
The site consists of a large graded area to the north where reclamation commenced in 2010, a relatively flat stockpile area south of the graded area, and a new pit located in the southwestern portion of the site where mining commenced in 2013. The graded area consists of a deep basin with slopes of 3H:1V or flatter (Photo 4). Some annual weeds and native grasses have volunteered throughout this area. No standing water was observed on the basin floor. Stormwater runoff appears to exit the basin to the east, flowing into a dry gulch located outside of the permit area (Photo 5). At this time, the drainage area appears to be stabilized by vegetative cover. However, the Operator should continue to monitor this drainage area and work to prevent any offsite damage from occurring in accordance with Rule 34-32.5-116(4)(j).

**Photo 4.** View looking southwest across graded basin in northern portion of permit area.

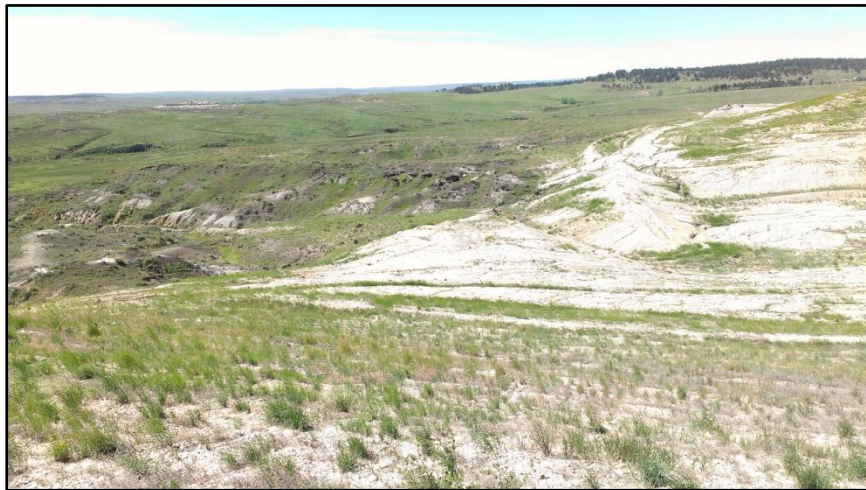
**Photo 5.** View looking southeast at primary drainage area for graded basin in northern portion of permit area.

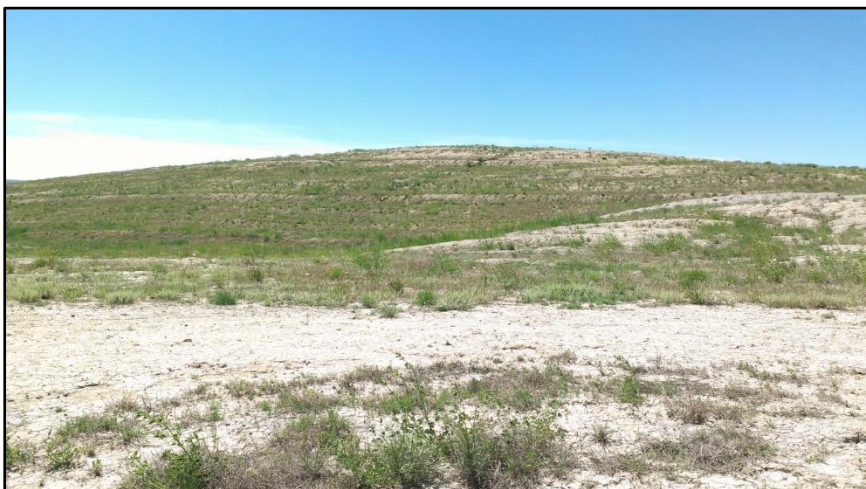
According to Mr. Tibbetts, no topsoil has been spread over the graded area, but it was broadcast seeded in the fall of 2010. The approved reclamation plan for this site states that 4 inches of topsoil will be replaced on affected land. A large topsoil stockpile is located northwest of the graded area and is stable with vegetative cover (Photo 6). The Operator will need to use this topsoil for reclamation.

**Photo 6.** View of large topsoil stockpile stabilized with vegetative cover located at northwestern corner of permit area.

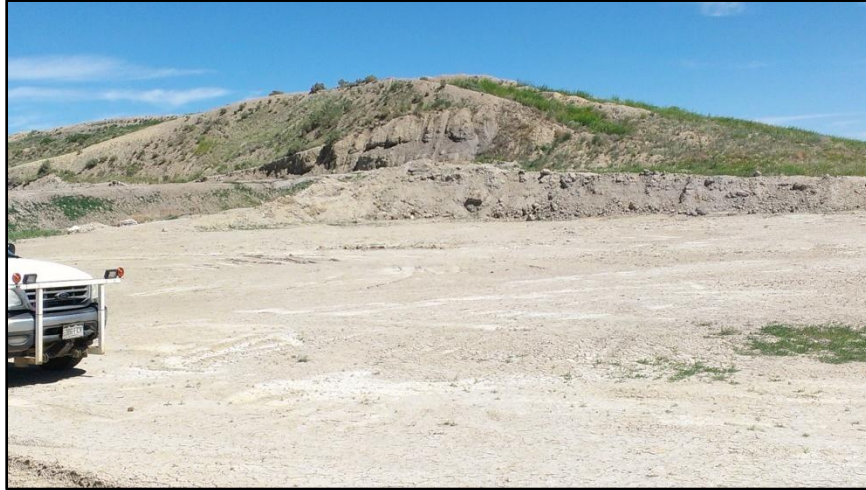
The graded area to the north is separated from the stockpile area to the south by an overburden highwall with a southern aspect and slopes near 1H:1V (Photo 7). According to the approved mining plan, a large quantity of overburden (up to 25 feet) was removed to access the clay material. This overburden was stockpiled south of the pit excavation, and it appears that the northern slope of this stockpile was graded into the basin during reclamation of the area in 2010. Currently, the overburden highwall is stabilized with vegetative cover.

**Photo 7.** View looking north at portion of overburden highwall. The remains of a product stockpile are shown at the base of the highwall.

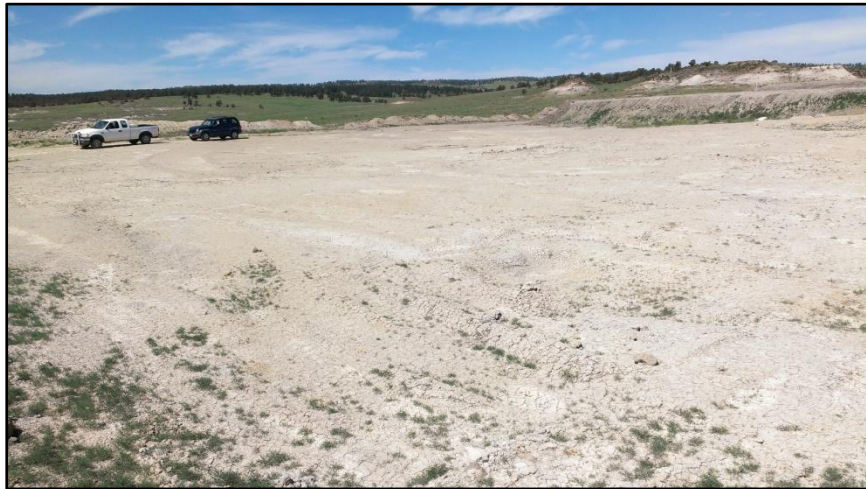
The relatively flat stockpile area is located just south of the overburden highwall (Photo 8). Only a few puddles of water left by a recent rain event were observed on the floor of this area. Berms surround the perimeter of the stockpile area. Stormwater runoff appears to be directed primarily to the south where the berms open up to a relatively flat, sparsely vegetated area where erosion does not currently appear to be a problem (Photo 9).

**Photo 8.** View looking southwest across eastern portion of stockpile area.

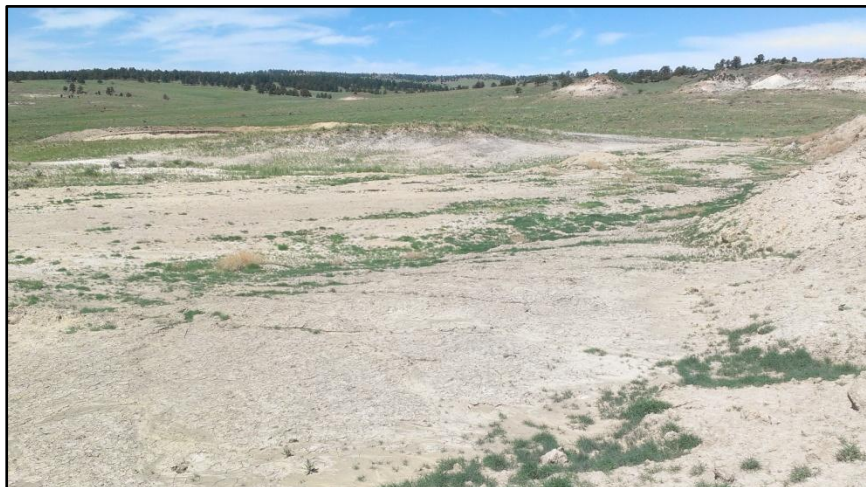
**Photo 9.** View looking southwest across sparsely vegetated area just south of stockpile area.

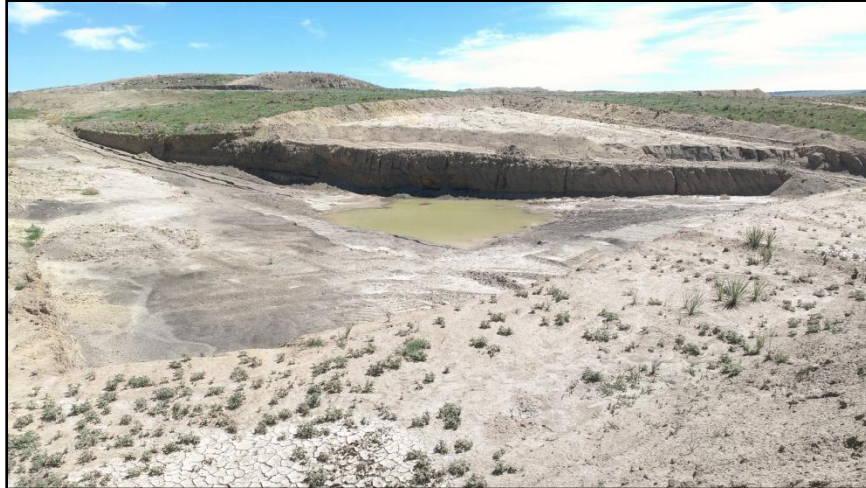
are approximately 4-5 feet in height with near vertical slopes (Photo 10). So far, three terraces have been cut into the southern pit wall (Photo 11). Berms surround the perimeter of the pit.

During the inspection, standing water was observed on the pit floor (See Photos 10 and 11). Mr. Tibbetts indicated that this water is from the rain event that occurred the previous day. The Division understands that because this is a clay mine, water may be retained longer than if the ground consisted of more permeable sediments. However, if water is retained on site for more than 72 hours, the Division of Water Resources requires the Operator to obtain a substitute water supply plan or augmentation plan approved by water court. Because the new pit is located down-gradient from the rest of the permit area in what appears to be a natural drainage path, it is likely that the pit receives a significant amount of surface runoff from up-gradient. Therefore, to help prevent and control water retention and sedimentation, it may be necessary for the Operator to install a diversion ditch around the northern side of the pit to divert stormwater and overland flow around the pit and back into the original drainage to the south.

**Photo 10.** View looking northeast across new pit located in southwestern portion of permit area.

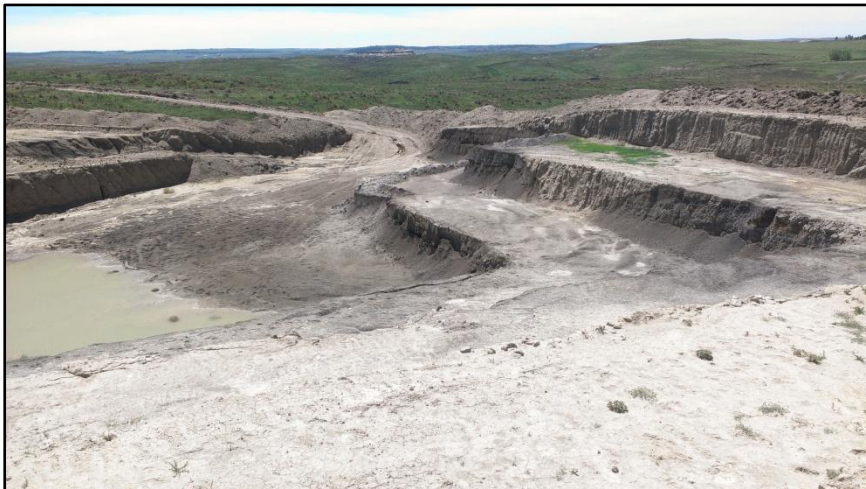
**Photo 11.** View looking east across new pit located in southwestern portion of permit area.

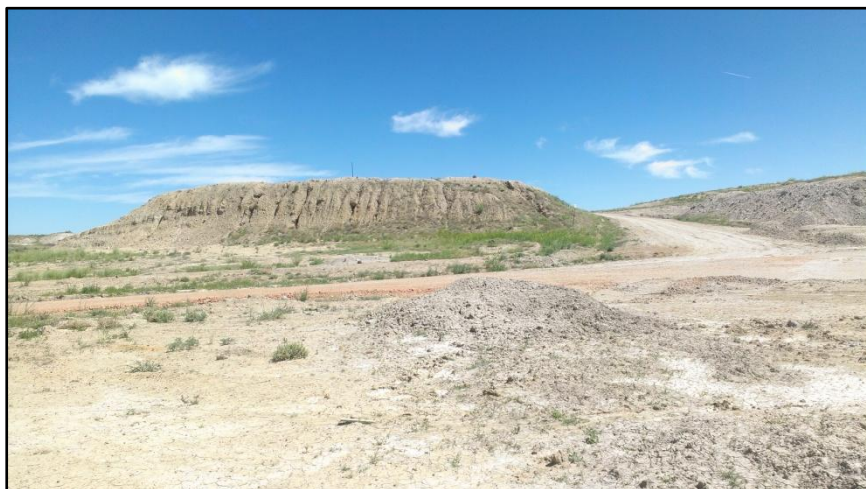
A large overburden stockpile is located just north of the main access road, near the western permit boundary (Photo 12). This stockpile has some erosion damage along its slopes; however, it appears to be stable with some vegetative cover. Because erosion has been a problem at this site in the past, the Division recommends that the Operator continue to monitor the stability of all surface areas of the affected land, including stockpiles, and work diligently to prevent and control erosion in accordance with Rule 3.1.6(3).

**Photo 12.** View looking north at overburden stockpile located north of access road near western permit boundary.
