**COLORADO DIVISION OF RECLAMATION, MINING AND SAFETY**  
**MINERALS PROGRAM INSPECTION REPORT**  
**PHONE: (303) 866-3567**

<b>MINE NAME:</b> Kiowa Clay Mine	<b>MINE/PROSPECTING ID#:</b> M-2007-009	<b>MINERAL:</b> Clay (general)	<b>COUNTY:</b> Elbert
<b>INSPECTION TYPE:</b> Monitoring	<b>INSPECTOR(S):</b> Amy Eschberger	<b>INSP. DATE:</b> June 3, 2014	<b>INSP. TIME:</b> 12:00
<b>OPERATOR:</b> The Denver Brick Company	<b>OPERATOR REPRESENTATIVE:</b> Rob Tibbetts	<b>TYPE OF OPERATION:</b> 112c - Construction Regular Operation

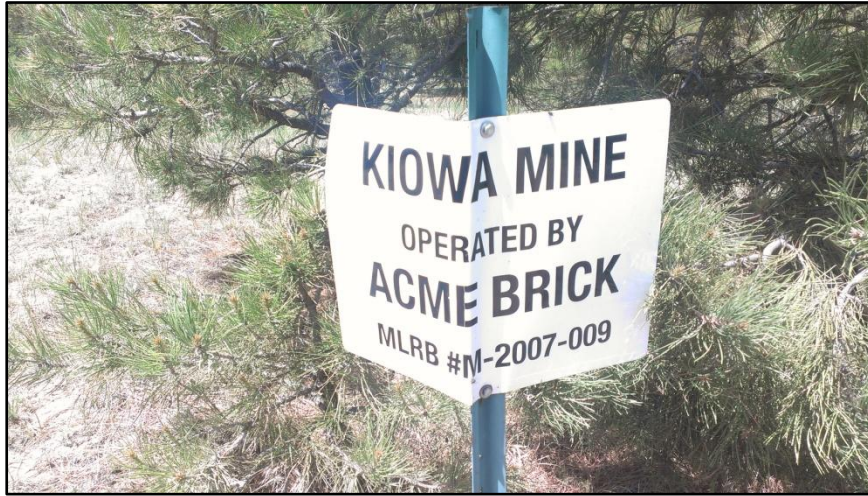
**Photo 1.** View of permit sign posted off dirt access road in permit area.

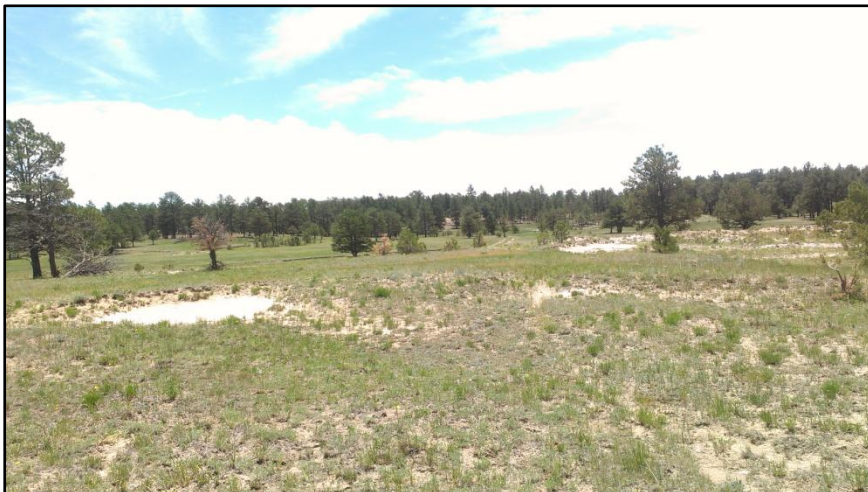
This is a 112c operation permitted for 400 acres to mine clay for brick manufacturing. However, according to the approved mining plan, only 72 acres will be mined, with an additional 20 acres disturbed by access roads, stockpile storage, and equipment staging. The maximum affected acreage to be disturbed at any time and for the life of the mine is 92 acres. At the time of inspection, mining activities had not yet commenced at this site, and no mining equipment was present (Photos 3-5). Mr. Tibbetts was uncertain of when mining activities might begin at this site.

**Photo 3.** View looking east from western boundary of proposed affected area.

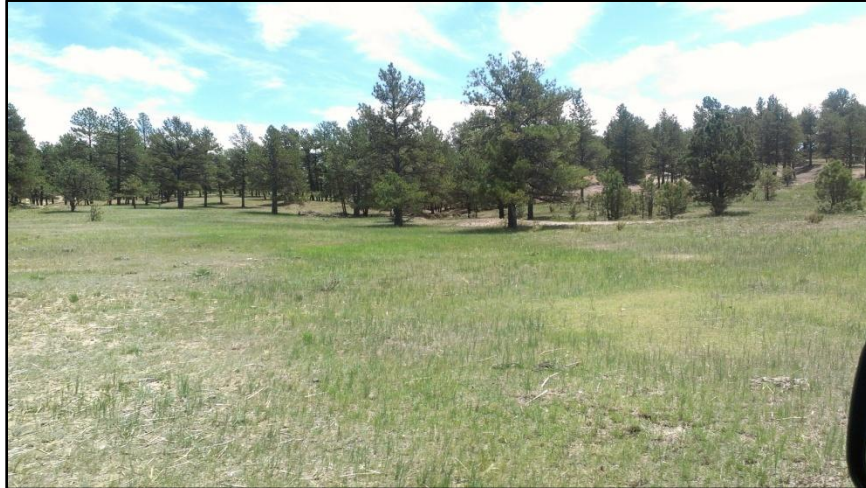
**Photo 4.** View looking east from access road, near center of proposed affected area.

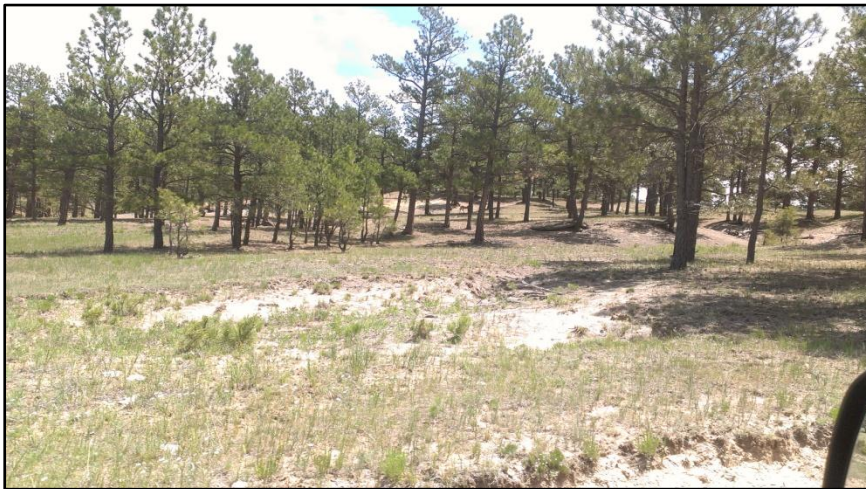
**Photo 5.** View looking east from access road in southern portion of permit area.

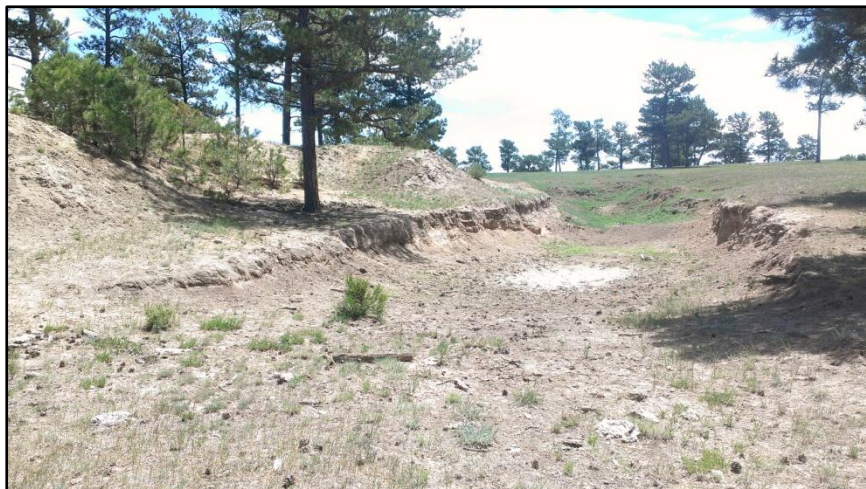
Some historical mining activity occurred in the southern portion of the permit area not far from the access road (Photo 6). This historical mining area is not within the boundary of the proposed affected area. This was noted in the pre-operation inspection report from 03/20/2007.

**Photo 6.** View of historical mining area located near access road within permit area, east of proposed affected area.
