**Re: Rocky Ford South Pit, Permit No. M-1977-222
Corrective Action Due Date for Problems Cited in May 08, 2014 Inspection Report
30-day Extension Request Approved**

COLORADO DIVISION OF RECLAMATION, MINING AND SAFETY
MINERALS PROGRAM INSPECTION REPORT
PHONE: (303) 866-3567

MINE NAME: Rocky Ford South Pit	MINE/PROSPECTING ID#: M-1977-222	MINERAL: Sand and gravel	COUNTY: Otero
INSPECTION TYPE: Monitoring	INSPECTOR(S): Amy Eschberger	INSP. DATE: May 8, 2014	INSP. TIME: 11:45
OPERATOR: ALL-RITE PAVING & REDI-MIX, INC.	OPERATOR REPRESENTATIVE: Herb Pearson	TYPE OF OPERATION: 112c - Construction Regular Operation

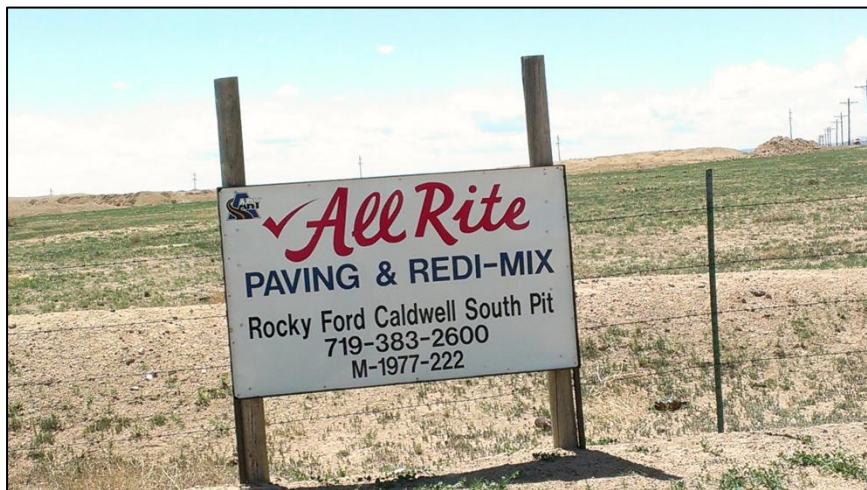
At the time of the inspection, it was clear, warm, and sunny, and no standing water was observed in the permit area. The permit sign was posted at the gated entrance to the site off of Co Rd 18 (Photo 2). However, the permit boundary was not marked. **This is cited as a Possible Problem for failure to mark the boundary of the affected area as required by Rule 3.1.12(2), and will require corrective action (see page 1).** During the inspection, a front-end loader and trailer were present on site. It appeared that the loader was being used to clean up stockpiles inside the pit.

Photo 2. Permit sign posted at gated entrance to site.

CORRECTIVE ACTIONS: The operator shall conduct a survey and replace the boundary markers in the correct location(s). The operator shall provide proof to the Division that this has been done by the corrective action date.

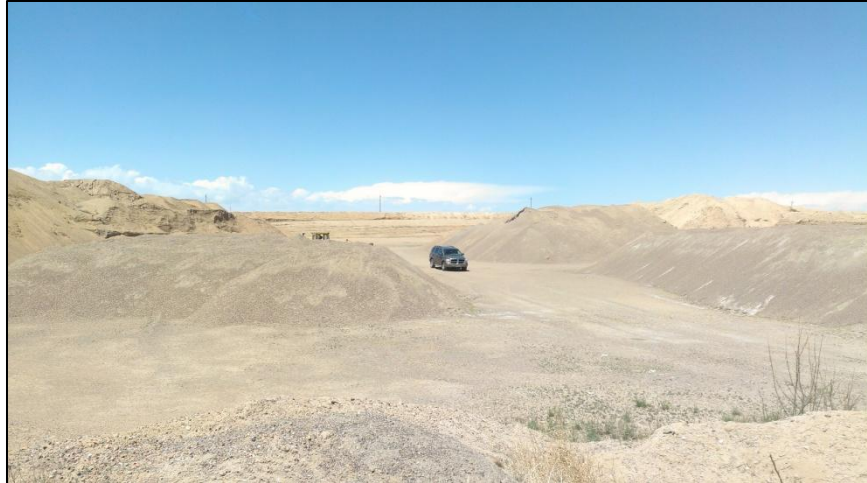
Photo 4. View looking into pit area from southeastern edge of pit, showing numerous stockpiles of material.

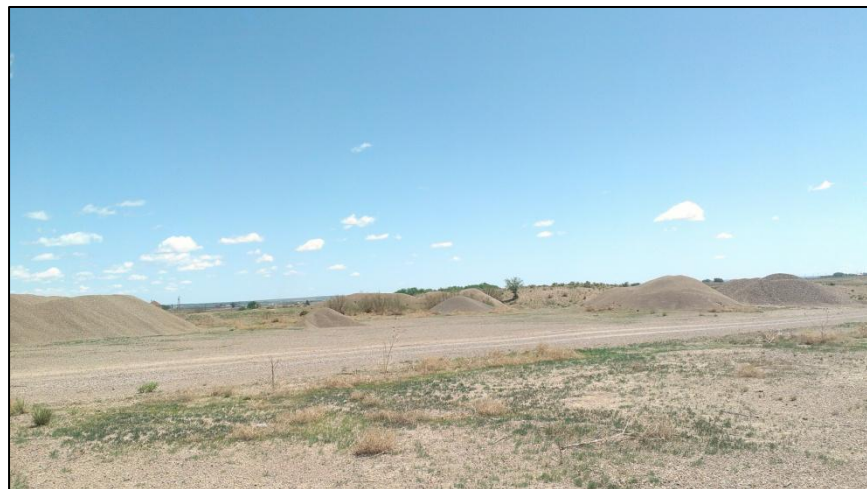
Photo 5. View looking east at several small stockpiles of material stored northeast of pit along haul road.

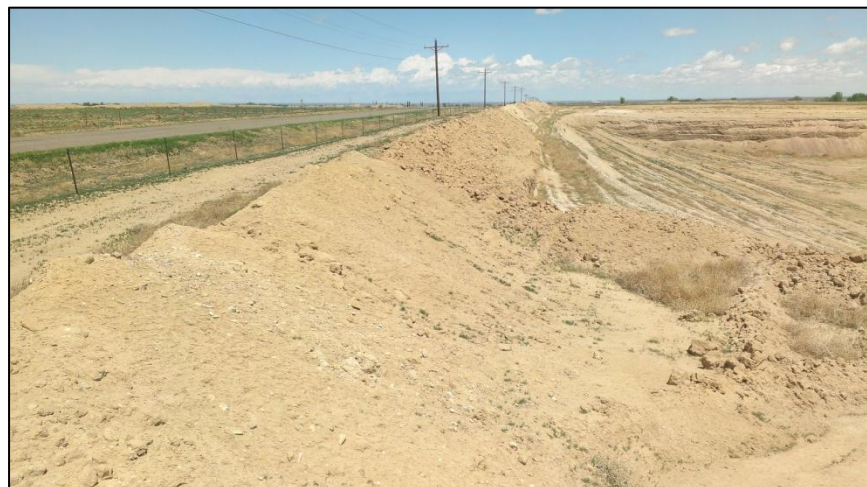
Photo 6. View looking north from southwestern corner of pit, showing overburden berm along western edge of pit.
