COLORADO DIVISION OF RECLAMATION, MINING AND SAFETY
MINERALS PROGRAM INSPECTION REPORT
PHONE: (303) 866-3567

MINE NAME: Elbert County Pit	MINE/PROSPECTING ID#: M-1985-129	MINERAL: Sand and gravel and stone	COUNTY: Elbert
INSPECTION TYPE: Monitoring	INSPECTOR(S): Amy Eschberger	INSP. DATE: June 24, 2014	INSP. TIME: 13:00
OPERATOR: Hudick Excavating, Inc.	OPERATOR REPRESENTATIVE: Bill Hudick	TYPE OF OPERATION: 112c - Construction Regular Operation

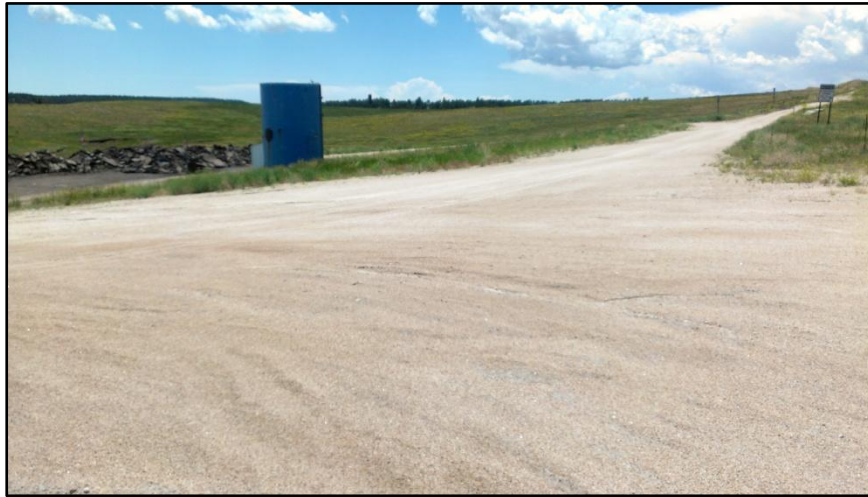
Photo 1. View looking south, showing part of released area (at left) with water tank and asphalt waste. Access road continues uphill (at right) to active pit.

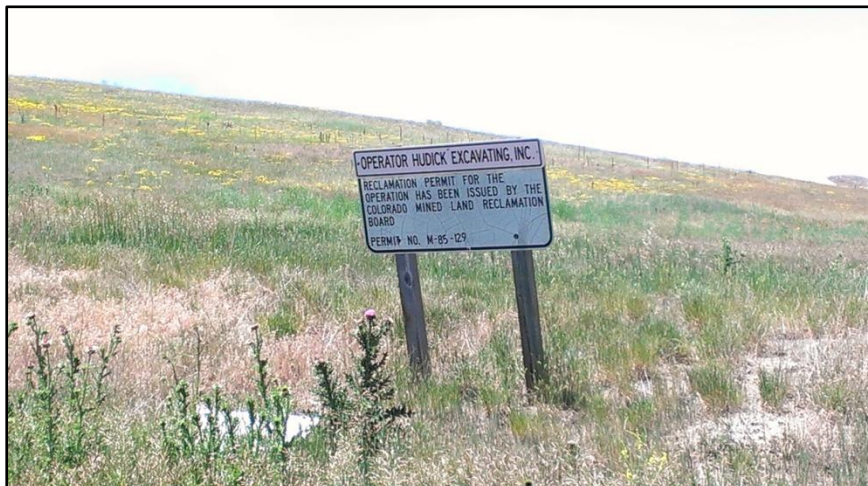
At the time of inspection, it was warm and sunny, and the ground was mostly dry. A few small puddles remained from a recent rain event. A permit sign was posted at the gated entrance off of Elbert Road (Photo 3). The permit boundary was marked by metal posts (Photo 4) and by a fenceline along the south side. The mining area inside the permit boundary was marked by blue flags. The active pit area is situated on a hill, where mining is progressing southwestward. No active mining was taking place during the inspection. According to Mr. Hudick, mining activities have consisted mainly of hauling off material for the past few years. As of this inspection, material was last hauled off in March or April of this year.

Photo 3. View of permit sign posted at gated entrance off of Elbert Road.

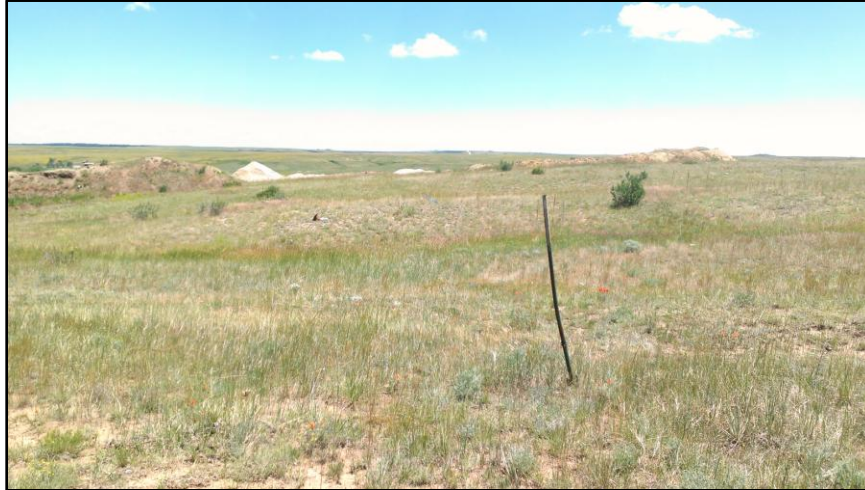
Photo 4. View looking east, showing metal stake marking western permit boundary.

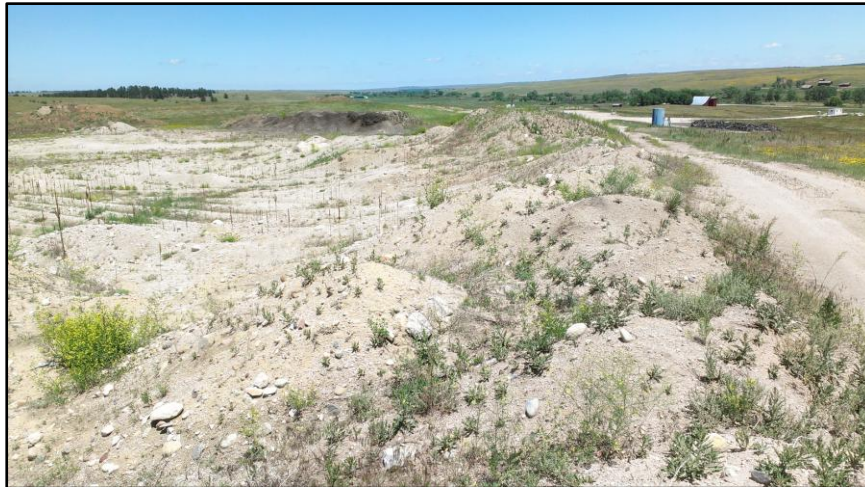
The active pit is located in the southwestern portion of the permit area. The dirt access road travels around the southern edge of the pit to the top of the mined slope. All pit slopes are approximately 3H:1V or flatter (Photos 5 and 6) and appear to be stable with some vegetative growth (consisting mostly of annual weeds and some biennial forbs). Native grasses and forbs have volunteered onto the pit floor (Photo 7). Many stockpiles of material of various sizes and shapes surround the western and southern edges of the pit (Photos 8 and 9). Topsoil is stockpiled just outside of the material stockpiles (Photo 10). According to the approved reclamation plan, additional topsoil may be imported for reclamation. All stockpiles appear to be stable with volunteer vegetation. A small stockpile of mulch (Photo 11) is present on the northeast side of the pit area, near the access road. Mr. Hudick stated that this mulch was left by the previous Operator, Elbert County, and it will be used for reclamation. A portable screener was sitting in the pit (see Photo 7), but was not being used during the inspection. An old conveyor and a small trailer (Photo 12) were present northeast of the pit, just west of the mulch stockpile. The central portion of the permit area consists of a grassy, gently sloping area that, according

Photo 5. View looking northeast at southern edge of pit, showing 3H:1V or flatter slope gradients.

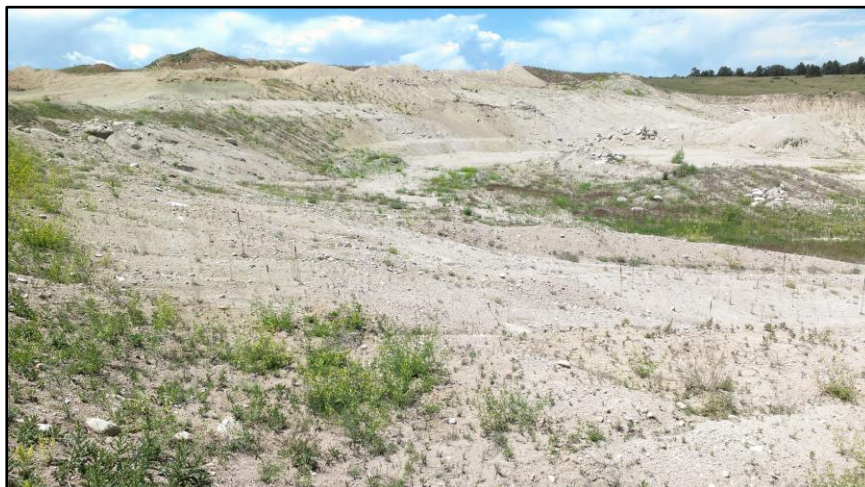
Photo 6. View looking northwest at western edge of pit, showing 3H:1V or flatter slope gradients.

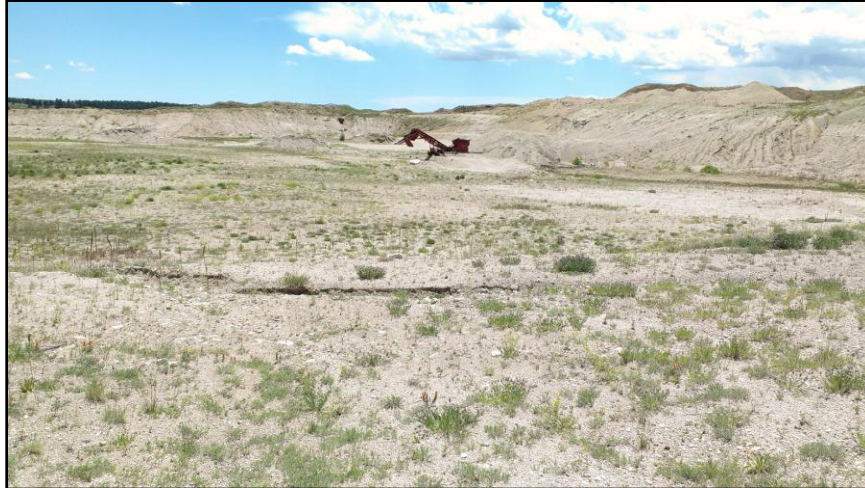
Photo 7. View looking south from western edge of pit, showing volunteer vegetation on pit floor. Note portable screener in pit.

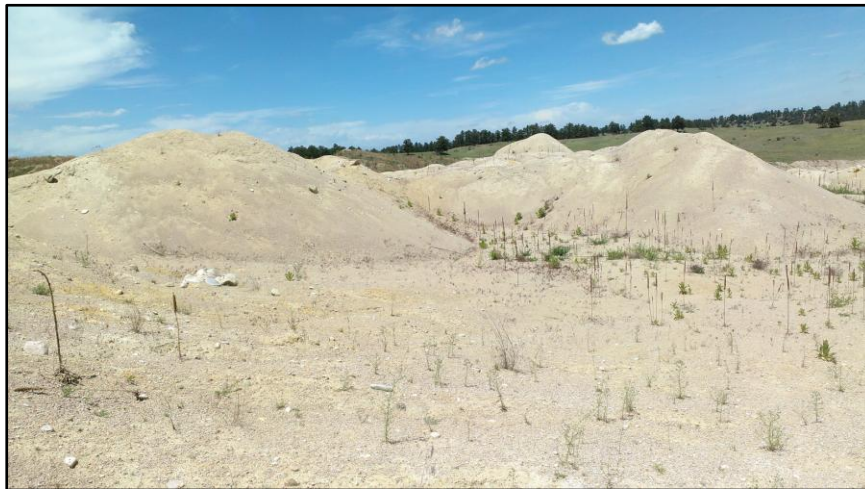
Photo 8. View of material stockpiles located just outside southwestern edge of pit.

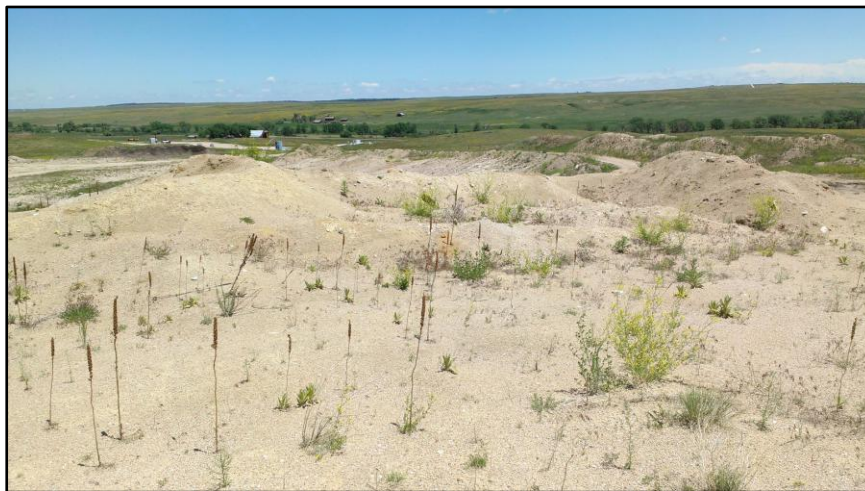
Photo 9. Another view of material stockpiles located just outside southwestern edge of pit.

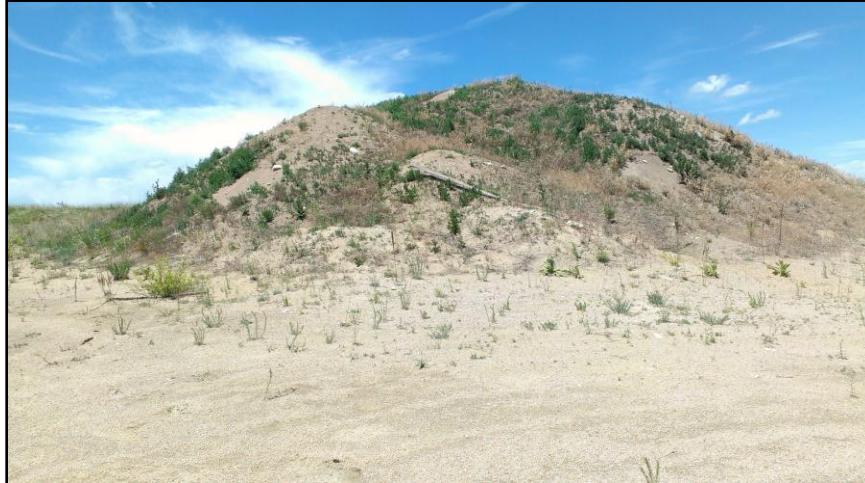
Photo 10. View of topsoil stockpile stabilized with volunteer vegetation, located outside western edge of pit

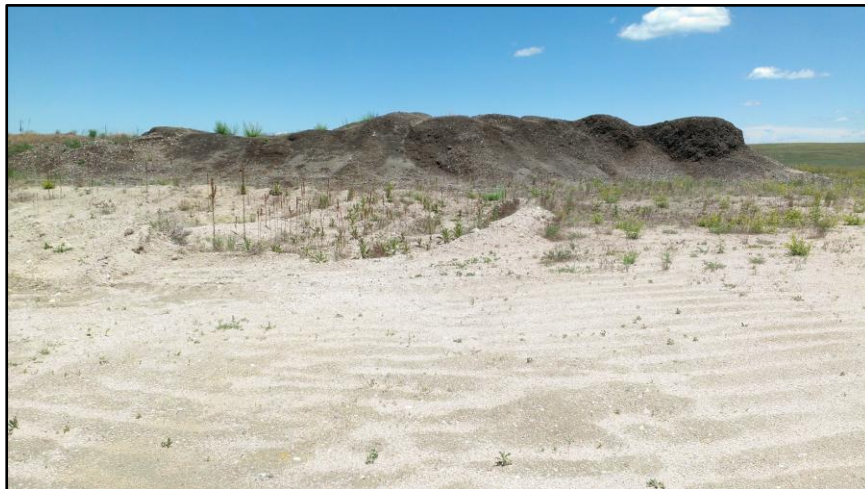
Photo 11. View of mulch stockpile located on eastern edge of pit.

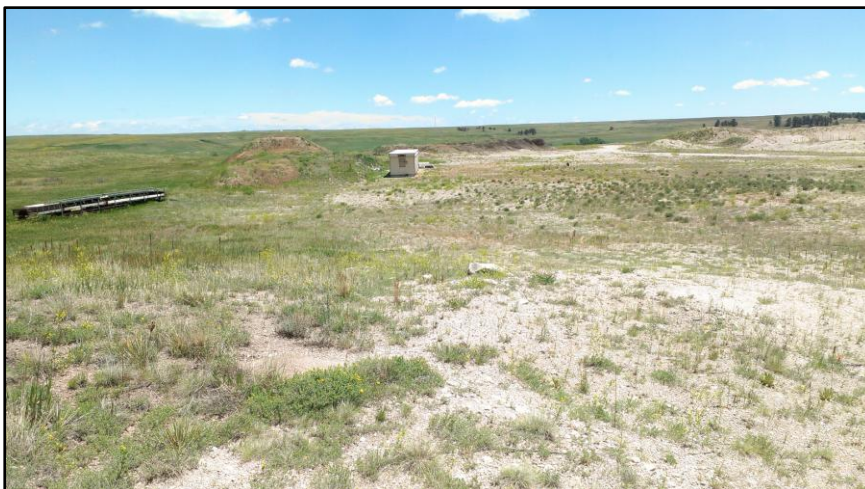
Photo 12. View looking east, showing old conveyor and small trailer stored at northeastern edge of pit.
