Re: Rocky Ford South Pit, Permit No. M-1977-222, Corrective Action Inadequate

COLORADO DIVISION OF RECLAMATION, MINING AND SAFETY
MINERALS PROGRAM INSPECTION REPORT
PHONE: (303) 866-3567

MINE NAME: Rocky Ford South Pit	MINE/PROSPECTING ID#: M-1977-222	MINERAL: Sand and gravel	COUNTY: Otero
INSPECTION TYPE: Monitoring	INSPECTOR(S): Amy Eschberger	INSP. DATE: May 8, 2014	INSP. TIME: 11:45
OPERATOR: ALL-RITE PAVING & REDI-MIX, INC.	OPERATOR REPRESENTATIVE: Herb Pearson	TYPE OF OPERATION: 112c - Construction Regular Operation

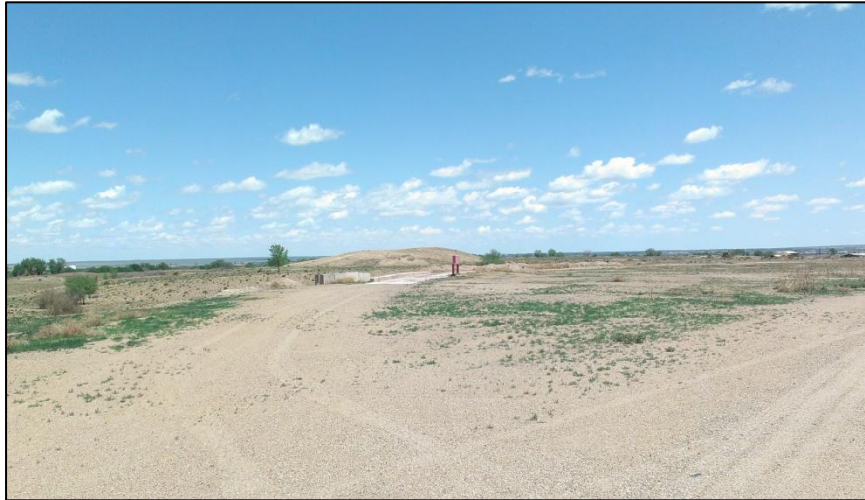
Photo 1. View looking northeast from near site entrance, showing road with scale (at left).

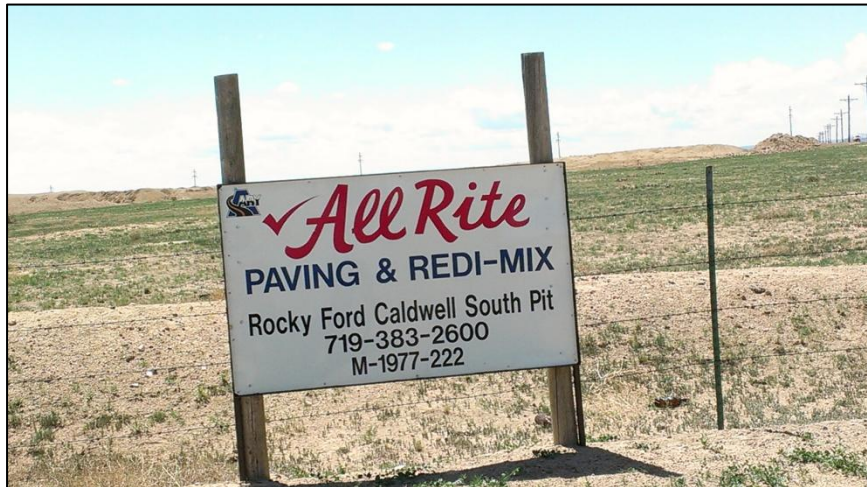
At the time of the inspection, it was clear, warm, and sunny, and no standing water was observed in the permit area. The permit sign was posted at the gated entrance to the site off of Co Rd 18 (Photo 2). However, the permit boundary was not marked. **This is cited as a Possible Problem for failure to mark the boundary of the affected area as required by Rule 3.1.12(2), and will require corrective action (see page 1).** During the inspection, a front-end loader and trailer were present on site. It appeared that the loader was being used to clean up stockpiles inside the pit.

Photo 2. Permit sign posted at gated entrance to site.

CORRECTIVE ACTIONS: The operator shall conduct a survey and replace the boundary markers in the correct location(s). The operator shall provide proof to the Division that this has been done by the corrective action date.

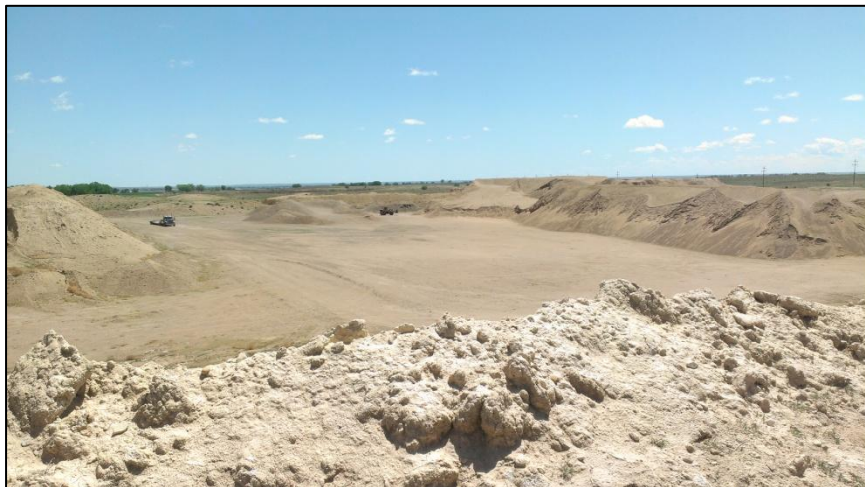
Photo 3. View looking east from western permit boundary into active pit.

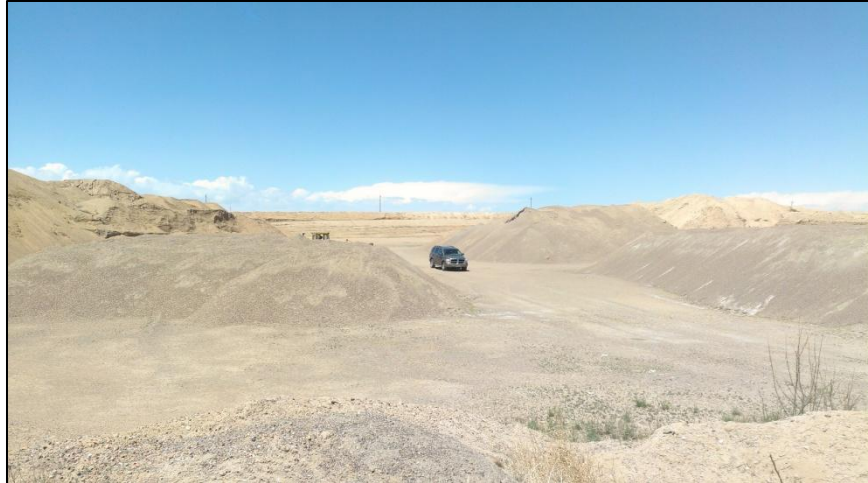
Photo 4. View looking into pit area from southeastern edge of pit, showing numerous stockpiles of material.

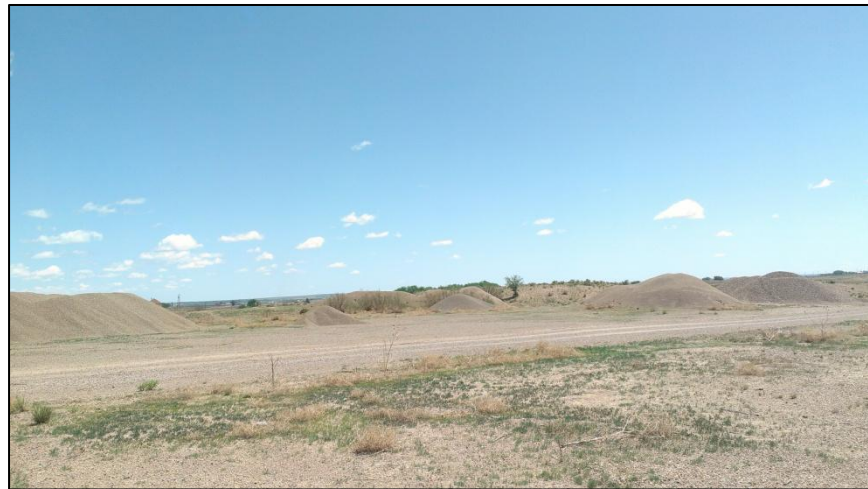
Photo 5. View looking east at several small stockpiles of material stored northeast of pit along haul road.

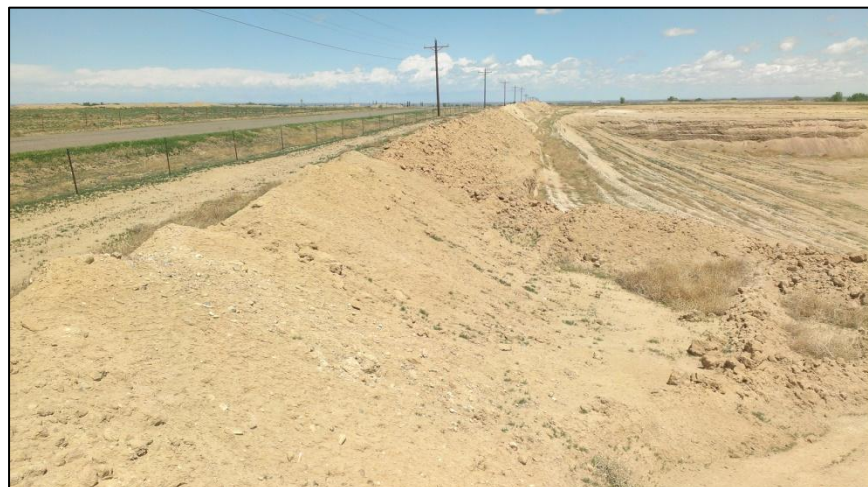
Photo 6. View looking north from southwestern corner of pit, showing overburden berm along western edge of pit.

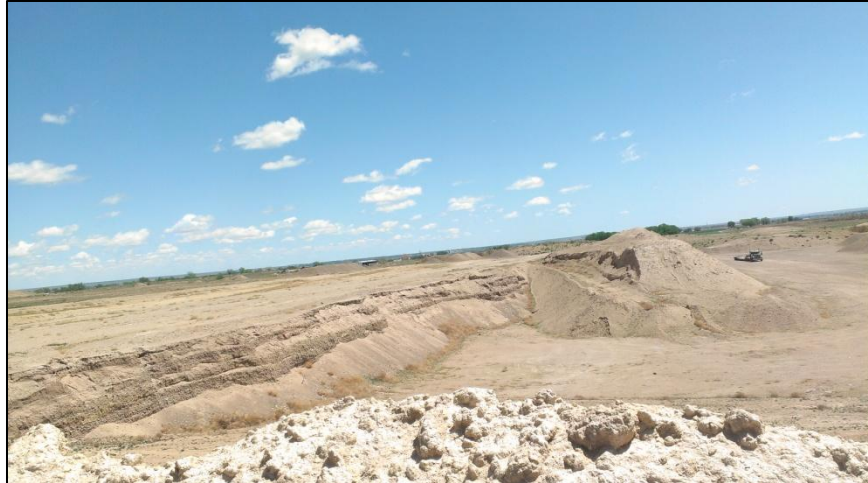
Photo 7. View looking northeast from western edge of pit at northern, south-facing pit wall approximately 250 ft long with a 2H:1V slope.

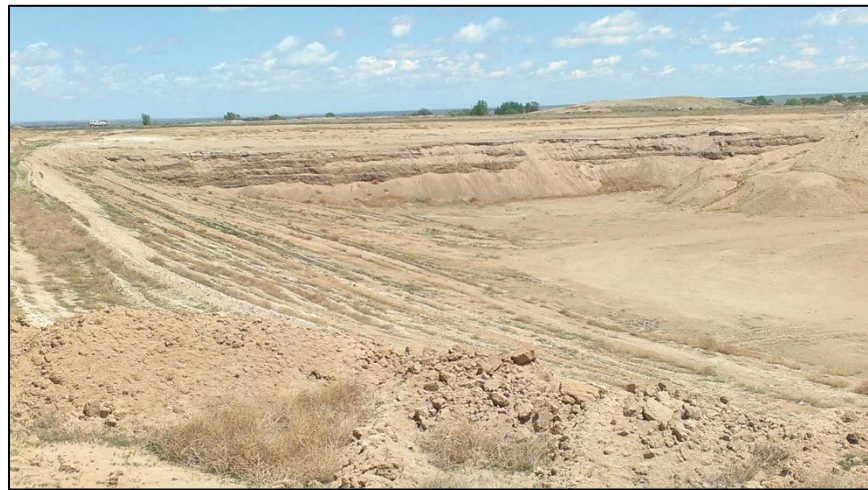
Photo 8. View looking northeast from southwestern corner of pit, showing western, east-facing pit wall approximately 430 ft long with a 3H:1V slope.

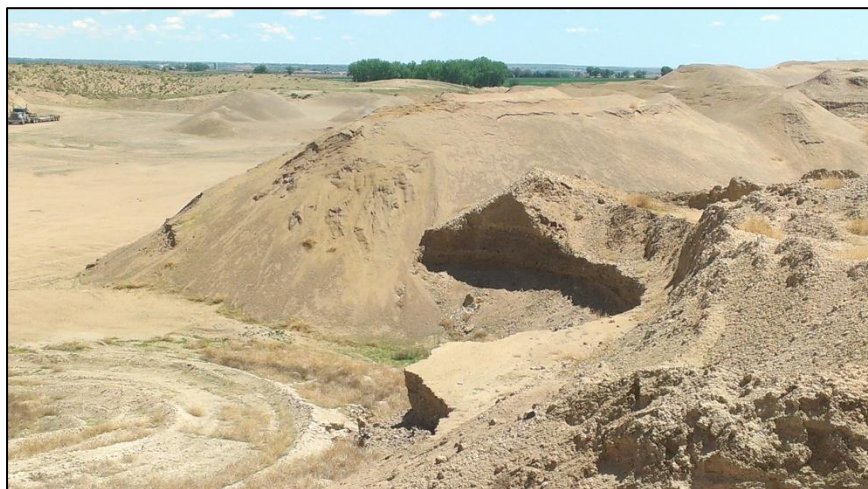
Photo 9. View looking east from southwestern corner of pit, showing north-facing cut approximately 150 ft long with a 1H:1V slope.

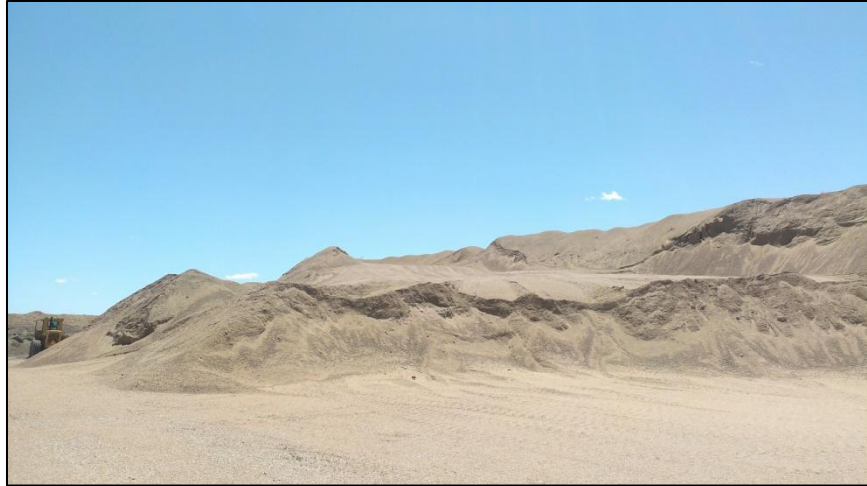
Photo 10. View looking southeast from center of pit, showing large material stockpile along southern pit wall. Note front-end loader at far left.

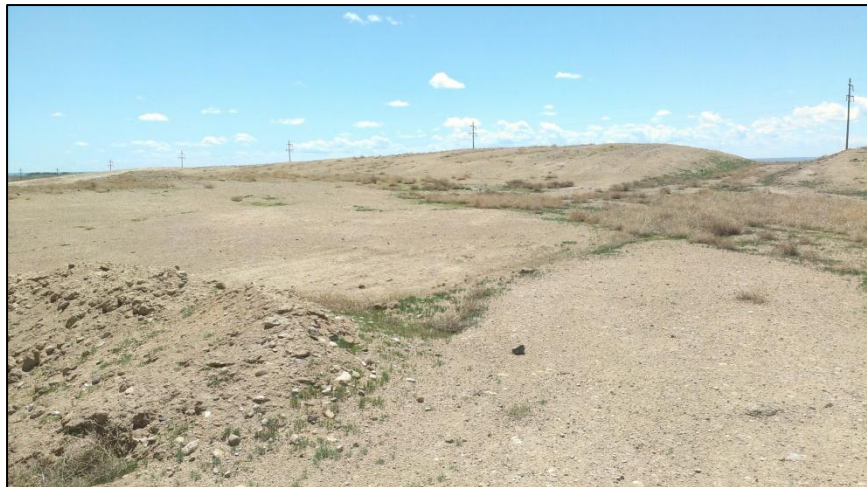
A small excavation approximately 200 feet long and 10-15 feet deep is present southeast of the pit. A disturbed area approximately 4.25 acres in size is located just southwest of the pit (Photo 11). A large topsoil stockpile is located along the far northern boundary of the permit area and is stable with grass cover. Another large topsoil stockpile is stored southeast of the pit and also appears to be stable.

Photo 11. View looking south/southeast at disturbed area just southwest of pit.

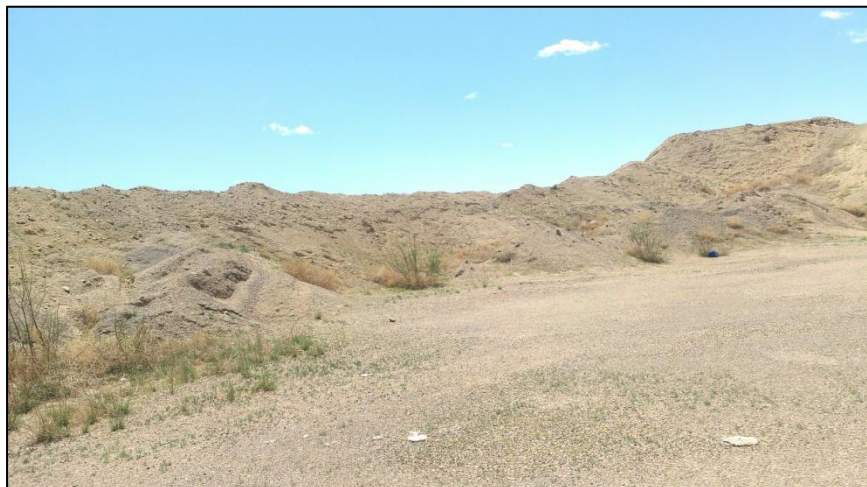
During the inspection, some noxious weeds were present in the permit area, including tamarisk (Photos 12 and 13), thistle, and kochia (Photo 14). A problem was cited in the 02/17/2010 inspection report for failure to employ weed control at this site. The Operator submitted a weed control plan (TR-01) that was approved on 09/13/2010. This approved plan should be implemented in order to monitor and control the growth and spread of noxious weeds in the permit area. However, implementation of this plan does not appear to be occurring at this site. **This is cited as a Possible Problem for failure to employ weed control methods for state listed noxious weed species within the permitted area, and to reduce the spread of weeds to nearby areas as required by Rule 3.1.10(6), and will require corrective action (see page 1).**

Photo 12. View looking south from southeastern portion of pit, showing some tamarisk present along the berm.

CORRECTIVE ACTIONS: Implement approved weed control plan and provide proof to the Division that this has been done by the corrective action date. Photographs taken before and after weed control implementation shall be sufficient as proof.

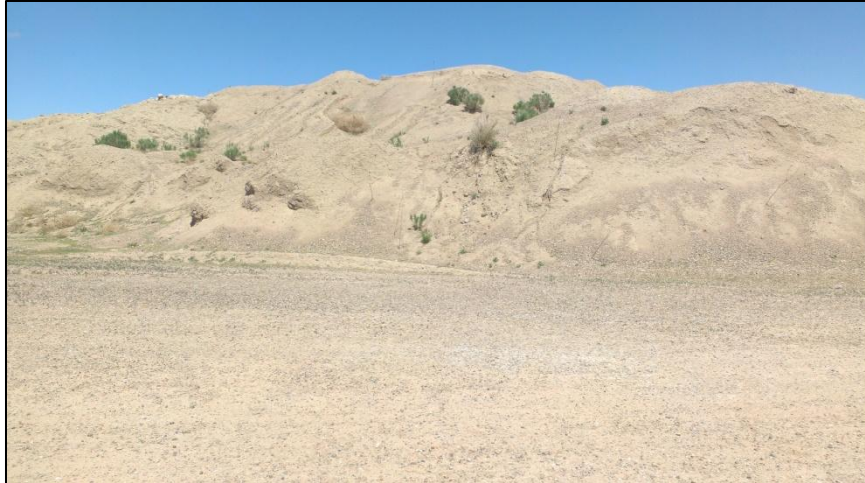
Photo 13. View looking north from center of pit at large material stockpile near northern edge of pit, showing some tamarisk present on stockpile.

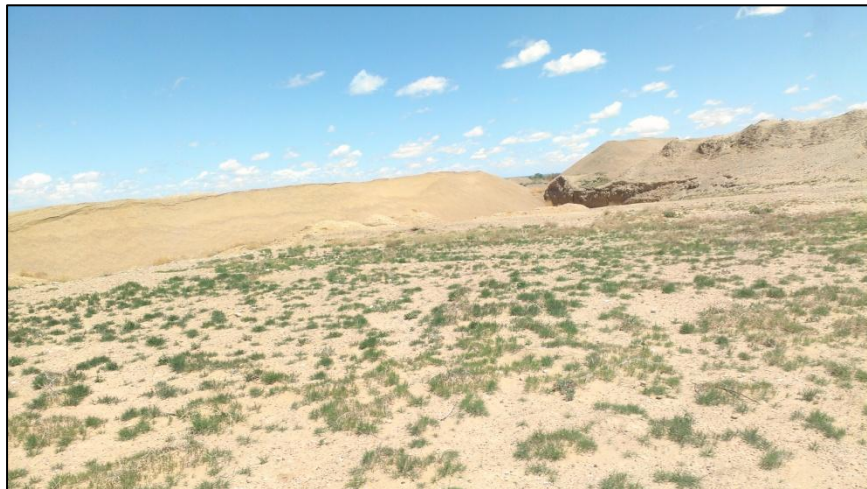
Photo 14. View looking north from southern portion of permit area, showing presence of kochia.

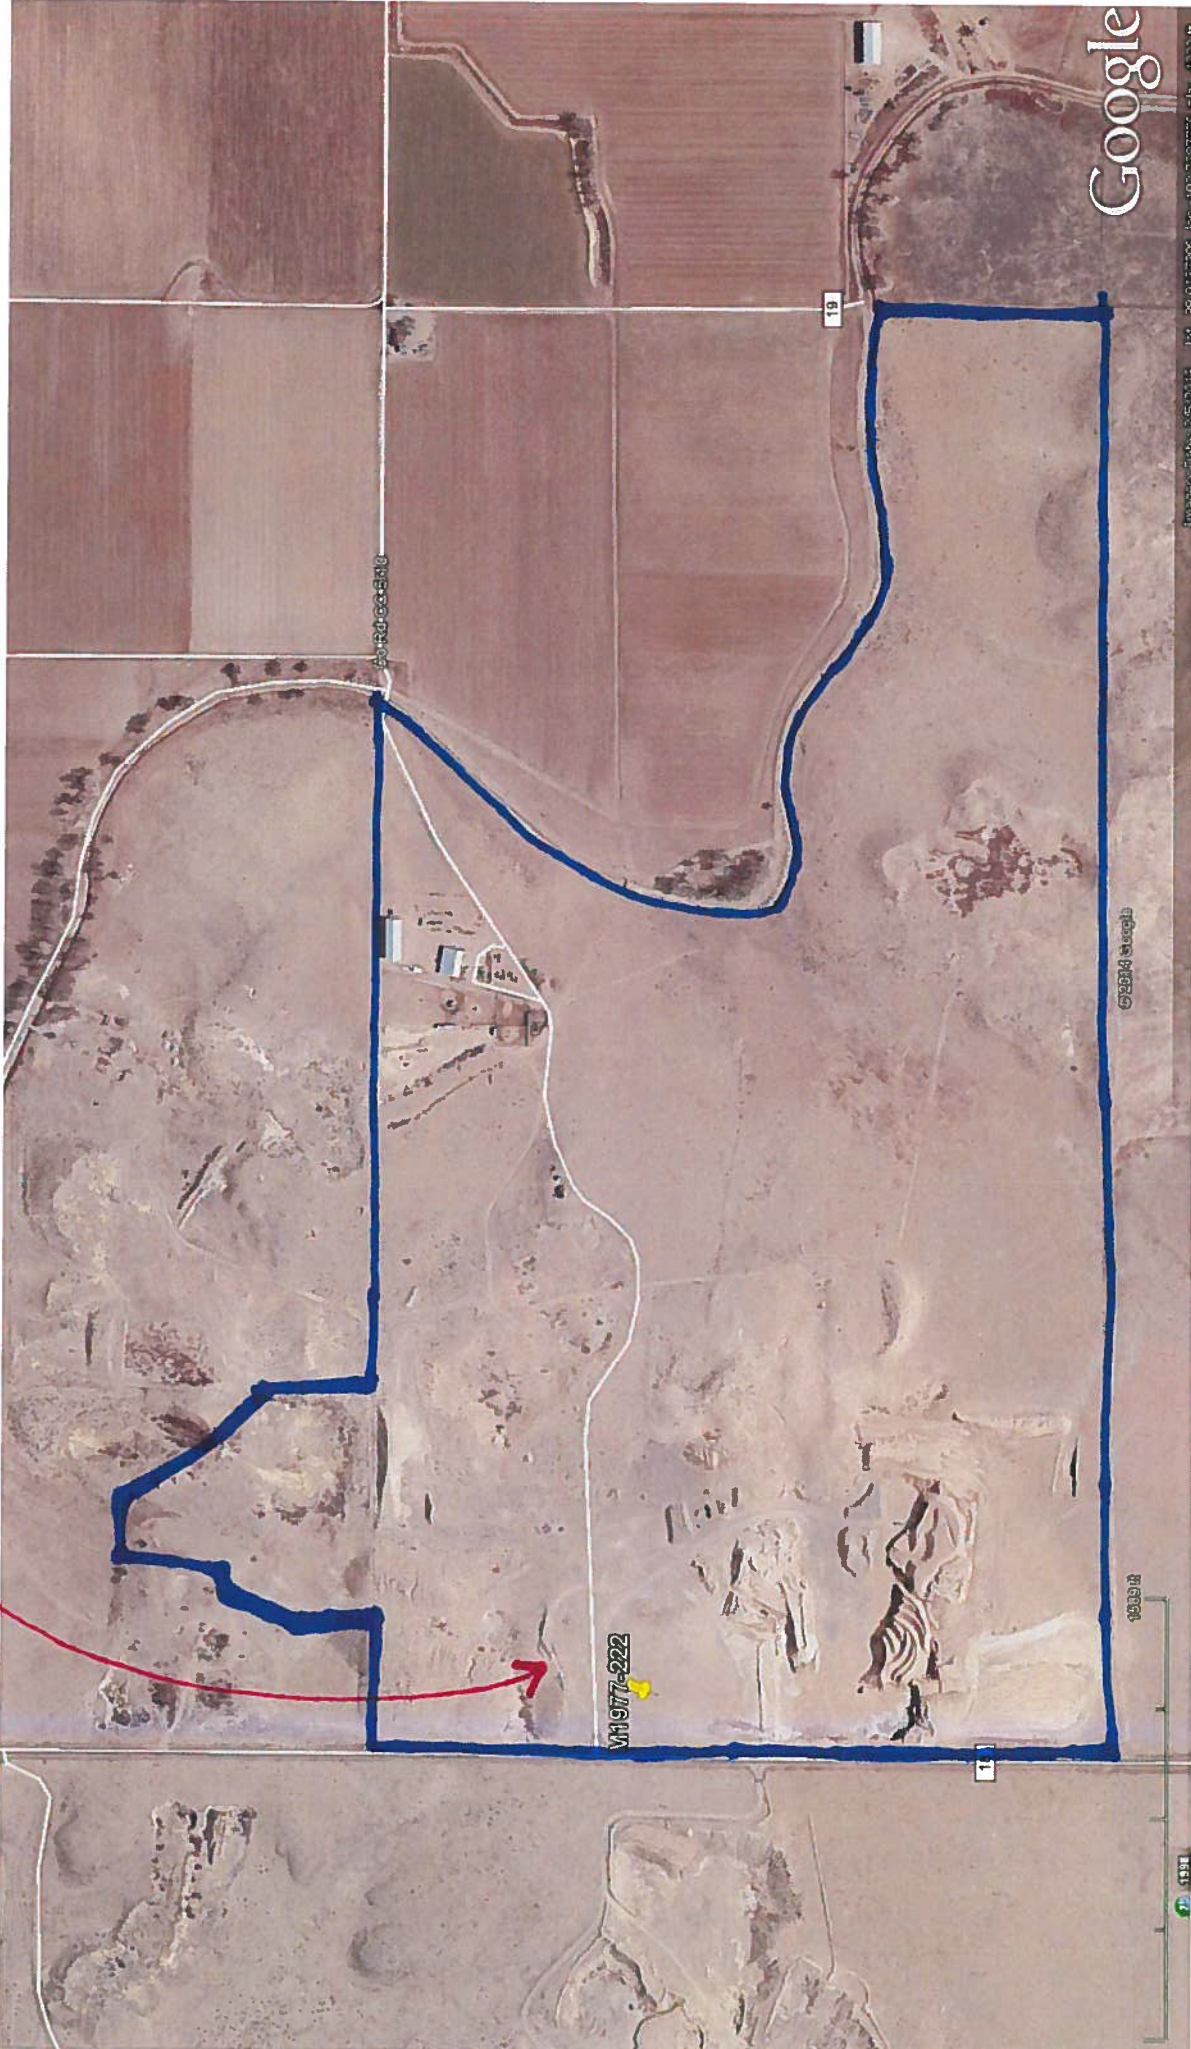
M-1977-222
Rocky Ford South Pit

- 1) The permit boundary shown on the map is not accurate according to Division records (see enclosed map for clarification). According to the permit boundary submitted by the Operator, the truck scale that was constructed for this operation at some time between 06/2012 and 02/2013 would be outside of the permit boundary. Please show the correct permit boundary on the map. Because the Operator is currently re-surveying the permit boundary (as mentioned above), the Division recommends the Operator re-submit the corrected map after the survey has been completed.

Scale Constructed between 6/2012 and 2/2013 is outside of permit dred according to map submitted.

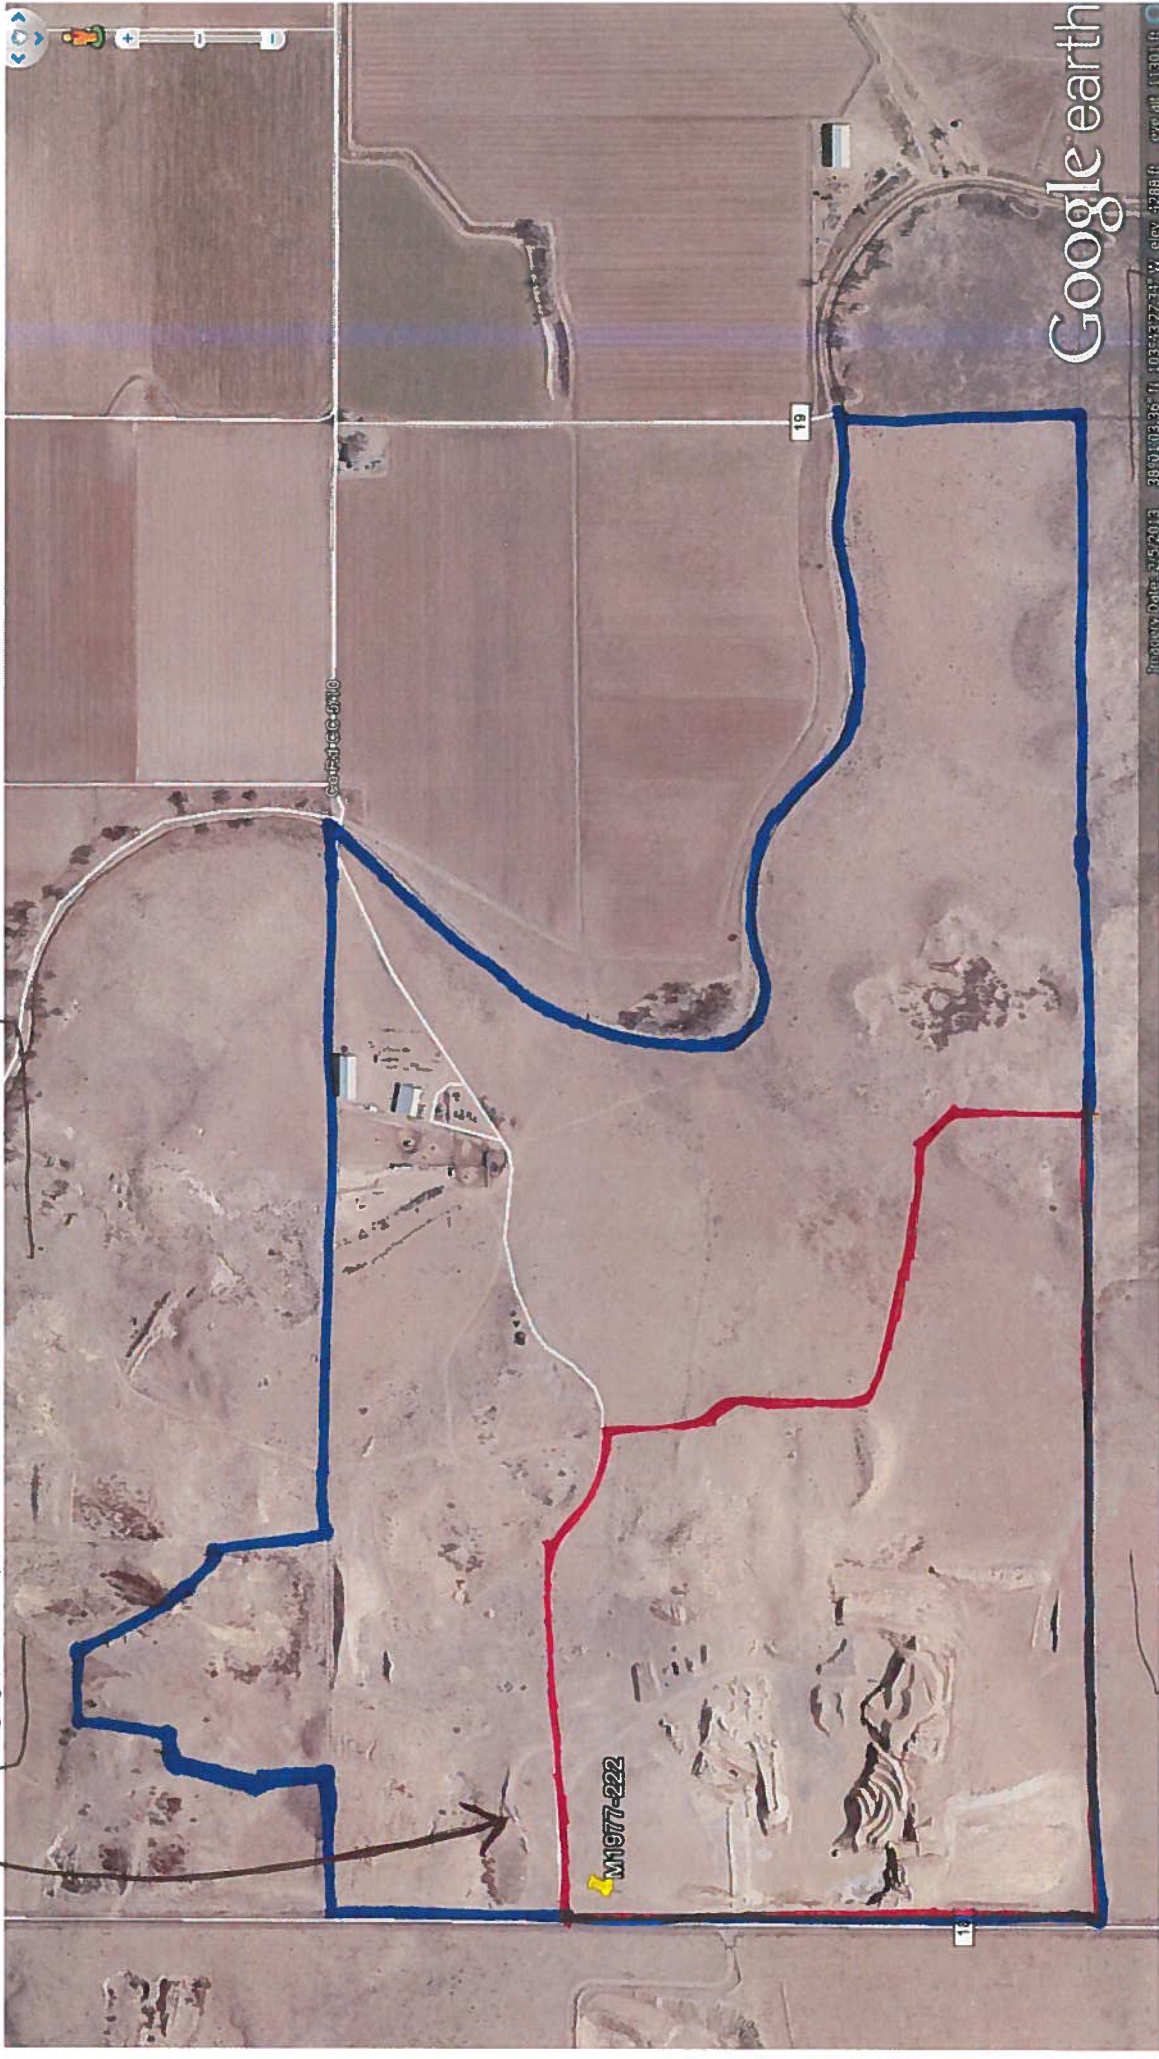
- Permit boundary according to map submitted on 9/8/2014.
- Permit boundary according to Division records.
