COLORADO DIVISION OF RECLAMATION, MINING AND SAFETY
MINERALS PROGRAM INSPECTION REPORT
PHONE: (303) 866-3567

MINE NAME: Penrose Ranch's	MINE/PROSPECTING ID#: M-1992-016	MINERAL: Sand and gravel	COUNTY: Fremont
INSPECTION TYPE: Surety-Related Inspection	INSPECTOR(S): Timothy A. Cazier	INSP. DATE: August 6, 2014	INSP. TIME: 15:50
OPERATOR: Rocky Mountain Materials & Asphalt, Inc.	OPERATOR REPRESENTATIVE: Mike Kessler	TYPE OF OPERATION: 112c - Construction Regular Operation

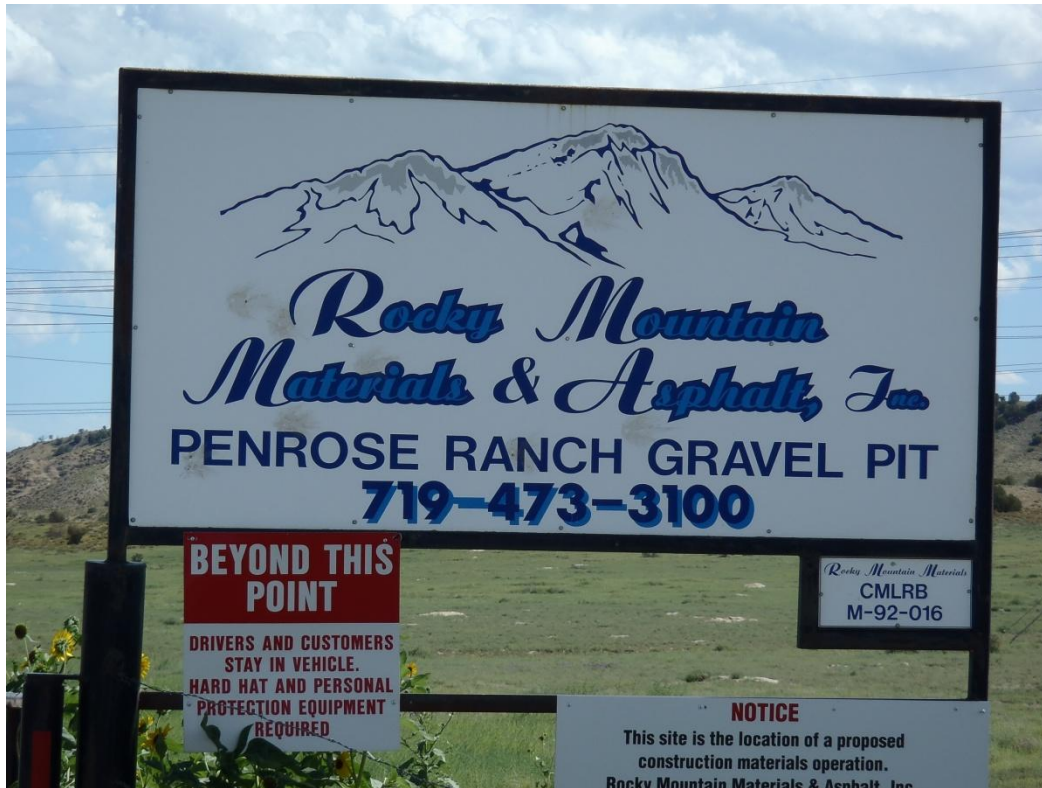
Permit signs were displayed as required (see **Photos 1** and **2**).

Photo 1. Permit sign (at south entrance).

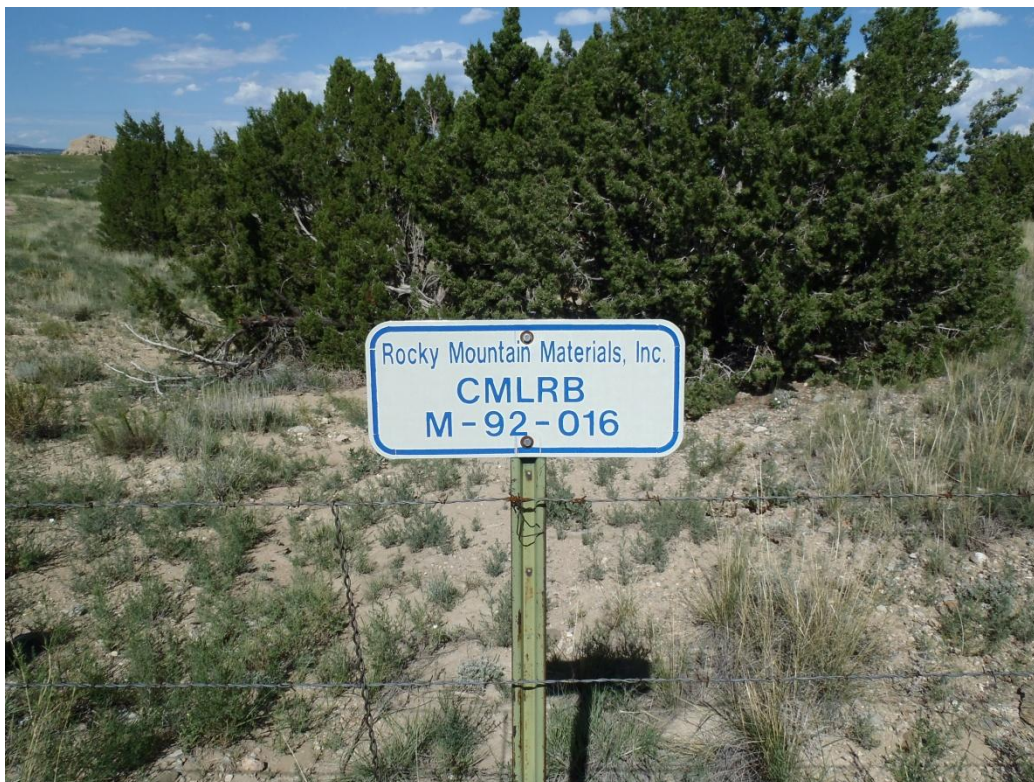
Photo 2. Permit sign (at south entrance).

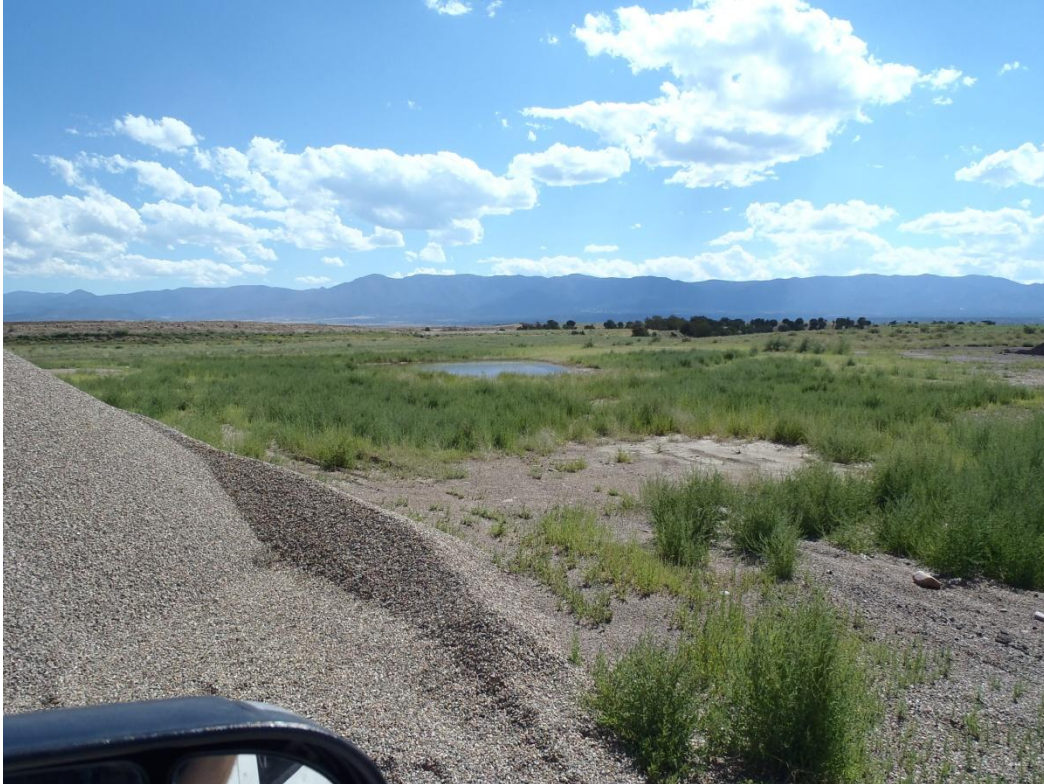
Area 2: Reclamation is complete with the exception of the sediment pond area in the middle of Area 2 (see **Photo 3**). The sediment pond receives runoff from the processing area. As such, the area surrounding the sediment pond is expected to require some grading to prevent ponding, and revegetation work at final reclamation. The Division estimates ~2.3 acres surrounding the pond will need additional reclamation. The other ~19.5 acres are considered to have completed reclamation.

Photo 3. Sediment pond in Area 2 (looking SW).
