COLORADO DIVISION OF RECLAMATION, MINING AND SAFETY
MINERALS PROGRAM INSPECTION REPORT
PHONE: (303) 866-3567

MINE NAME: Thomeczek Pit	MINE/PROSPECTING ID#: M-1995-007	MINERAL: Sand and gravel	COUNTY: Bent
INSPECTION TYPE: Monitoring	INSPECTOR(S): Amy Eschberger	INSP. DATE: July 3, 2014	INSP. TIME: 09:30
OPERATOR: Bent County Ready Mix	OPERATOR REPRESENTATIVE: None	TYPE OF OPERATION: 110c - Construction Limited Impact	
REASON FOR INSPECTION: Normal I&E Program	BOND CALCULATION TYPE: None	BOND AMOUNT: \$25,400.00	
DATE OF COMPLAINT: NA	POST INSP. CONTACTS: None	JOINT INSP. AGENCY: None	
WEATHER: Clear	INSPECTOR'S SIGNATURE: <i>Amy Eschberger</i>	SIGNATURE DATE: September 17, 2014

INSPECTION TOPIC: Reclamation Success

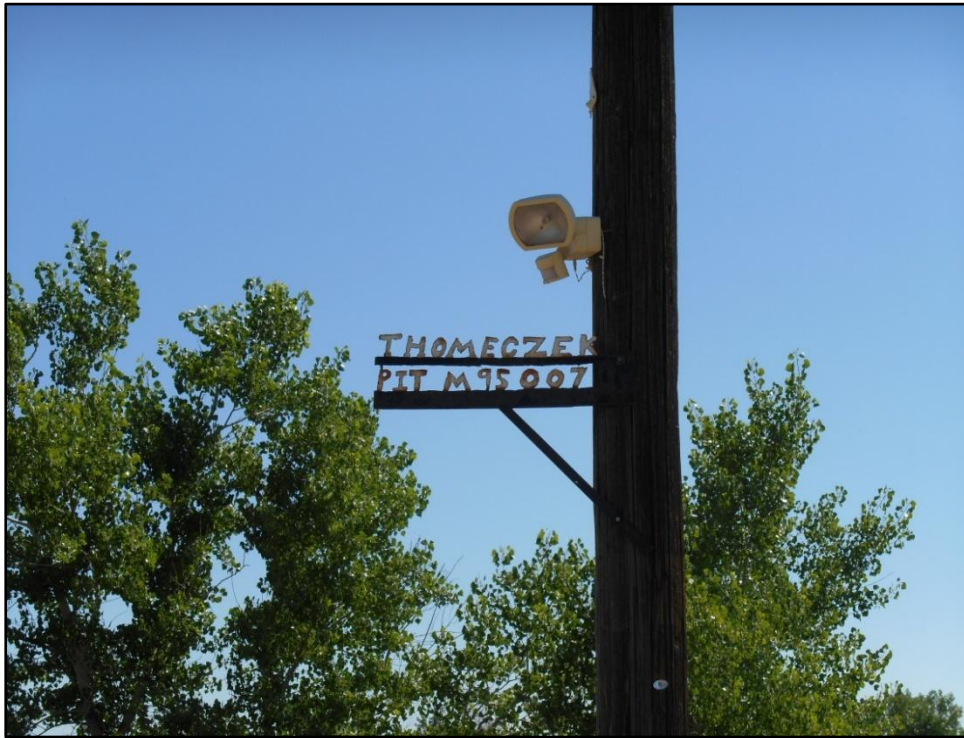
Photo 1. View of permit sign posted at entrance to site.

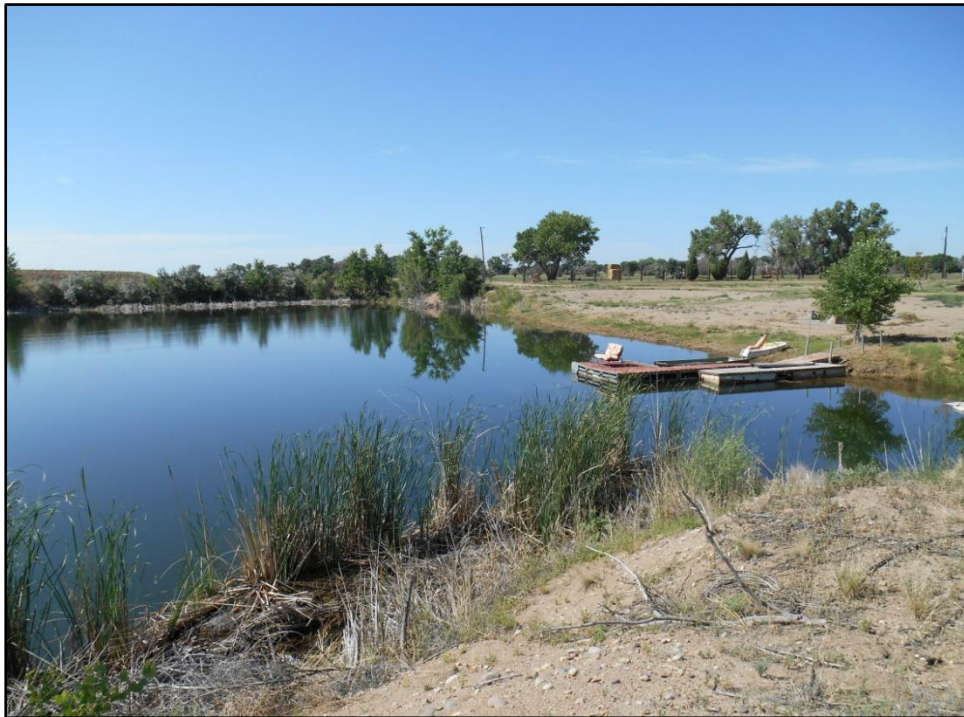
Photo 2. View of northwestern bank of pond (at right, with pier) that has been graded to a 4.5H:1V slope.

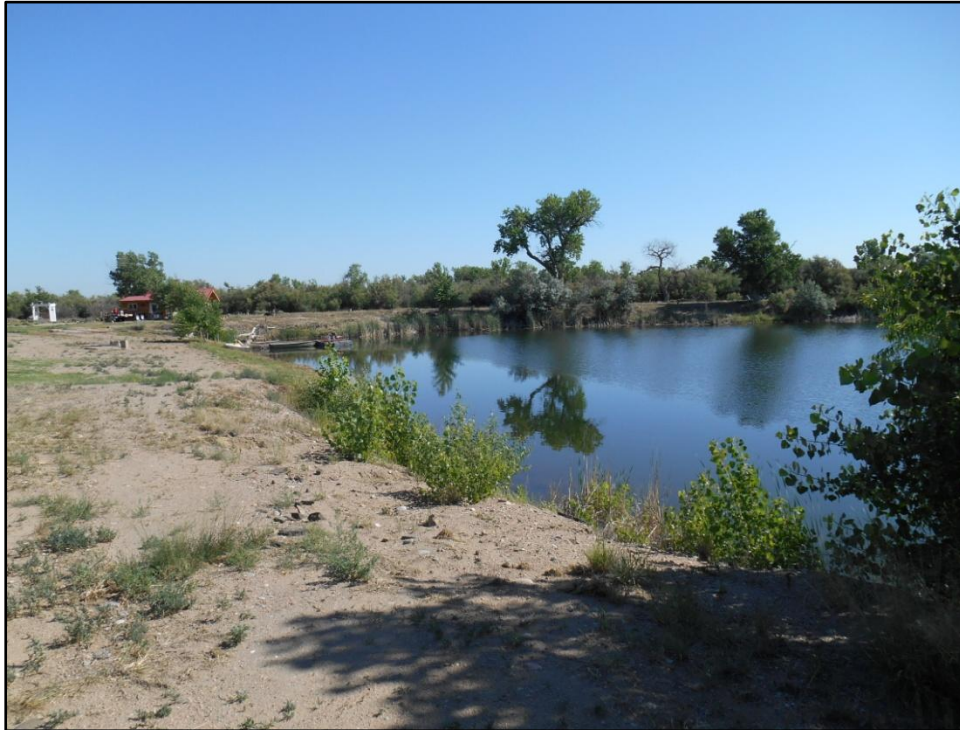
Photo 3. View of southwestern bank of pond, showing slopes steeper than 3H:1V.

- 1) Implement weed control at the site, including removal of Tamarisk and Russian-Olive trees from disturbed areas.
- 2) Grade all pond slopes to 3H:1V or flatter.
- 3) Remove the large stockpile located in the southern portion of the permit area (possibly use to grade pond banks, and push the remainder into the pond).
- 4) Revegetate the ground beneath the stockpile.

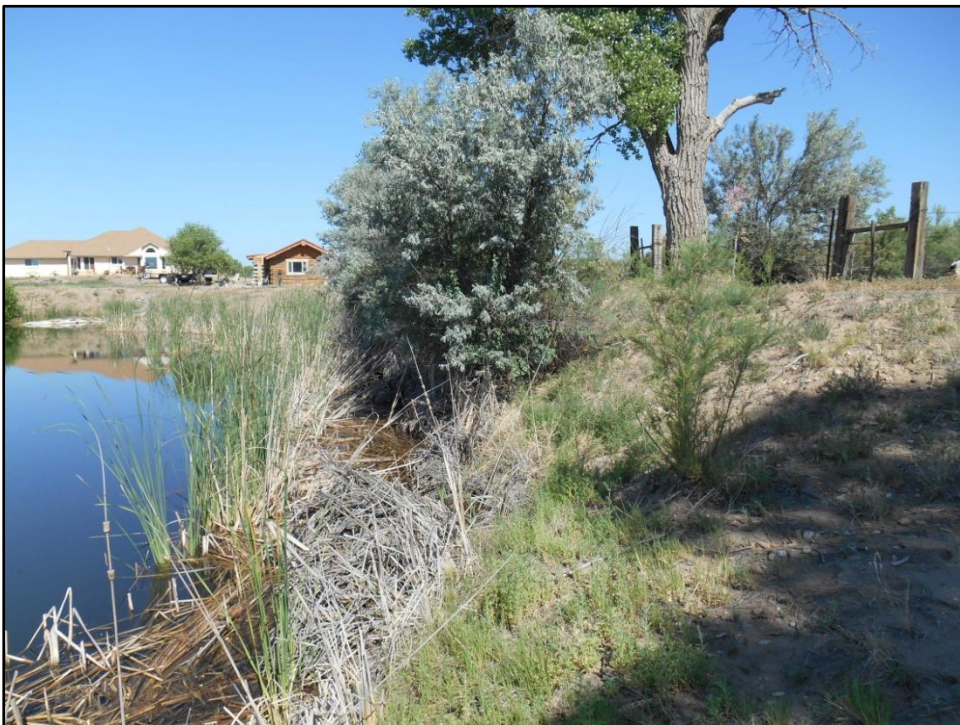
Photo 4. View of northern bank of pond, showing slopes steeper than 3H:1V.

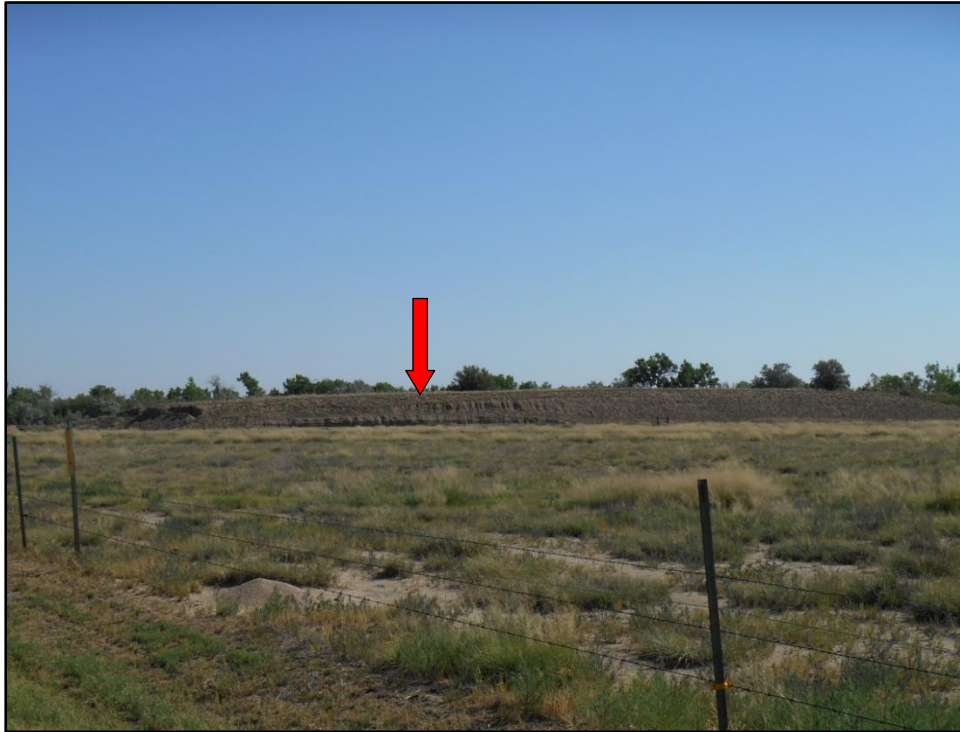
Photo 5. View looking north from outside of permit area, showing large overburden/topsoil stockpile extending along southern permit boundary (marked).

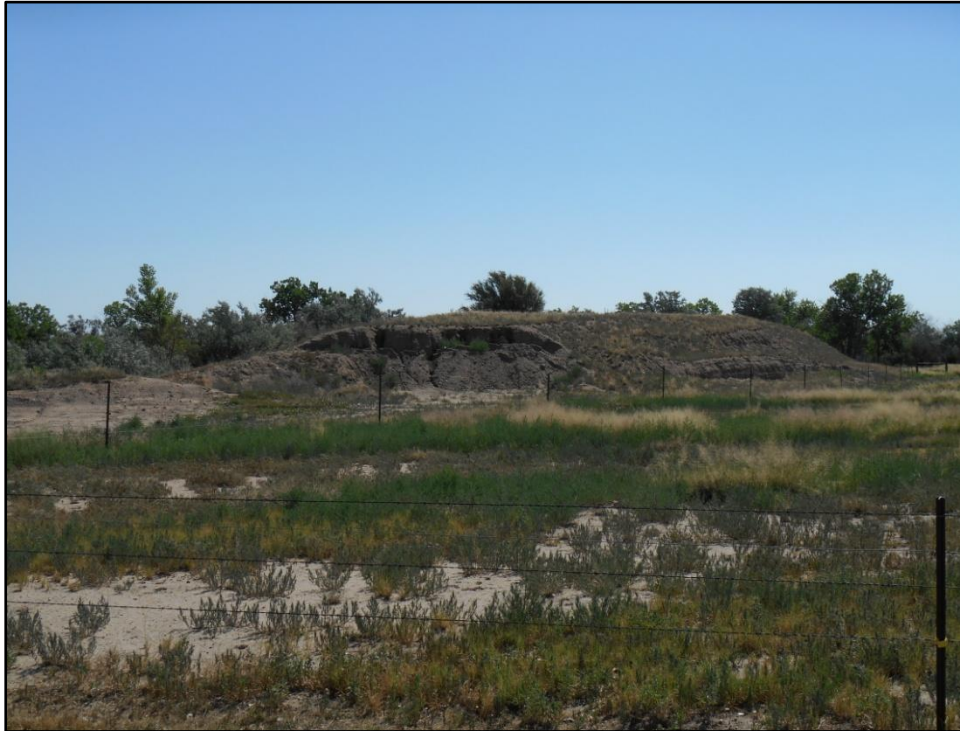
Photo 6. View looking east at side of large overburden/topsoil stockpile located near southern permit boundary.

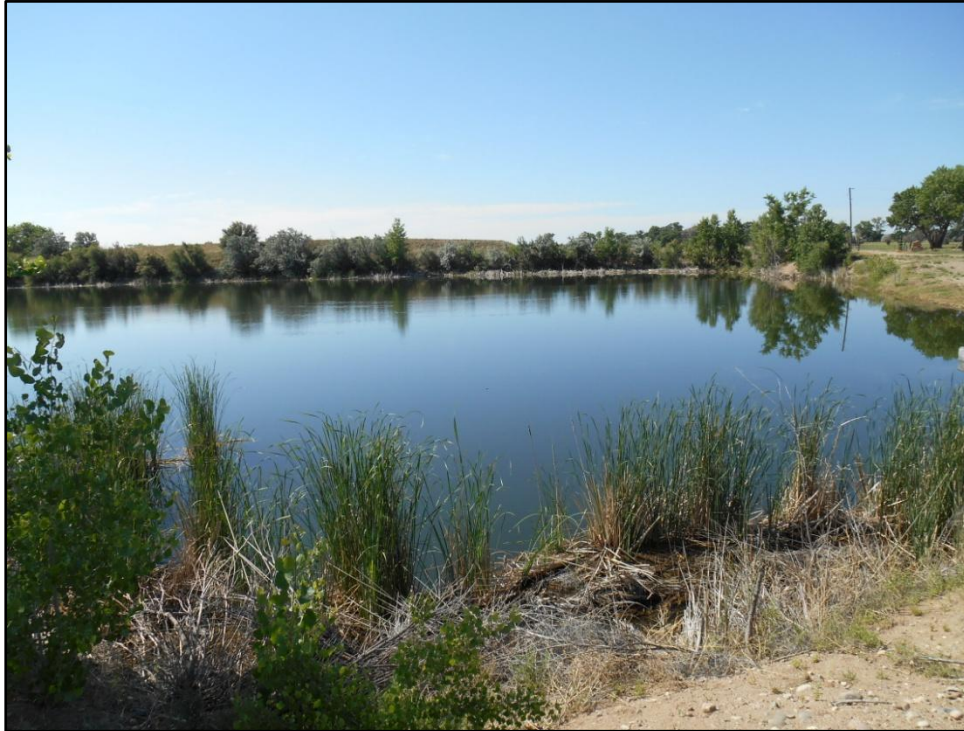
PROBLEM/POSSIBLE VIOLATION: Problem: Tamarisk (salt cedar) and Russian-Olive trees are present within or have volunteered into the permit area and have become established. This is a problem for failure to employ weed control methods for state listed noxious weed species within the permitted area, and to reduce the spread of weeds to nearby areas as required by Rule 3.1.10(6).

Photo 7. View looking southwest from northern edge of pond, showing numerous Tamarisk and Russian-Olive trees present along southern edge of pond.

CORRECTIVE ACTIONS: Implement approved weed control plan and provide proof to the Division that this has been done. If a weed control plan is not already in place, the Operator shall develop a weed control and management plan in accordance with Rule 3.1.10(6). This plan should be developed in consultation with the county extension agency, or weed control district office and should include specific control measures to be applied, a schedule for when control measures will be applied and a post-treatment monitoring plan. This weed control plan shall be submitted to the Division as a Technical Revision to the approved plan with the appropriate Technical Revision fee of \$216.00 by the corrective action date.

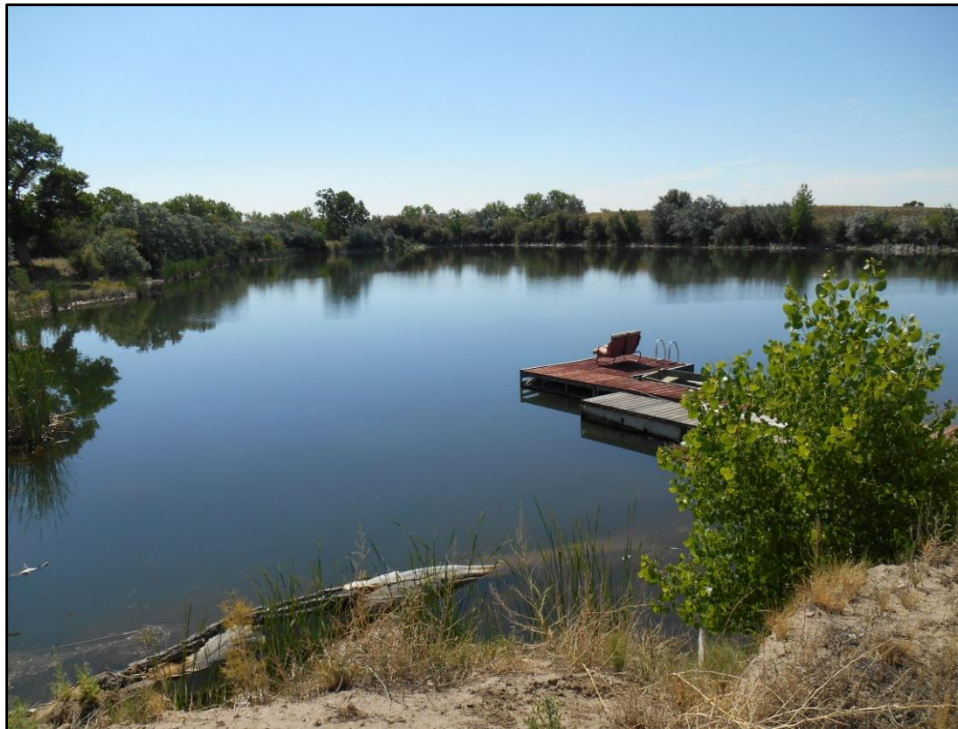
Photo 8. View looking southeast from northwestern edge of pond, showing numerous Tamarisk and Russian-Olive trees present along southern and eastern edges of pond.
