COLORADO DIVISION OF RECLAMATION, MINING AND SAFETY
MINERALS PROGRAM INSPECTION REPORT
PHONE: (303) 866-3567

MINE NAME: DeBeque Gravel Pit	MINE/PROSPECTING ID#: M-1981-058	MINERAL: Sand and gravel	COUNTY: Mesa
INSPECTION TYPE: Monitoring	INSPECTOR(S): Travis H. Marshall	INSP. DATE: September 2, 2014	INSP. TIME: 13:00
OPERATOR: Thomas F & Ginger L Latham	OPERATOR REPRESENTATIVE: Thomas Latham	TYPE OF OPERATION: 112c - Construction Regular Operation

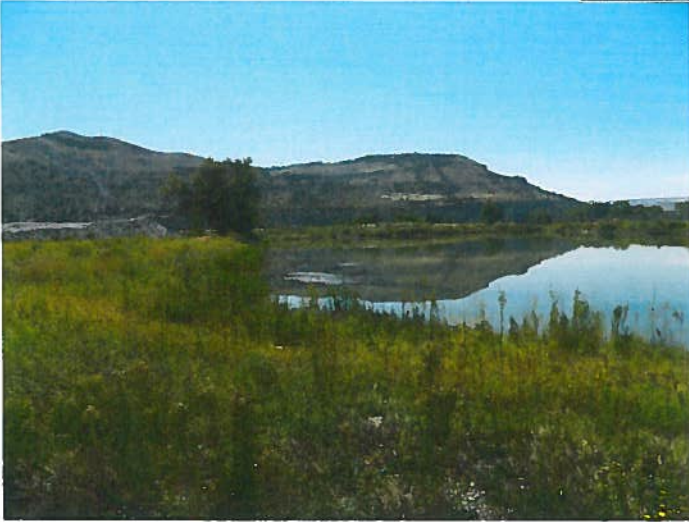
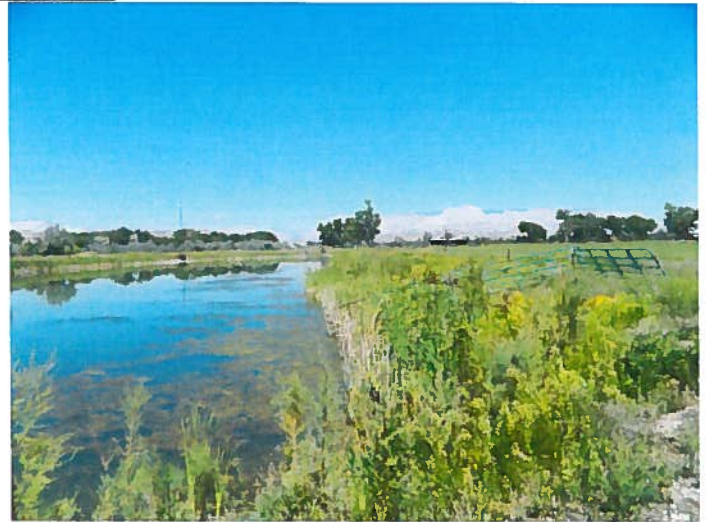
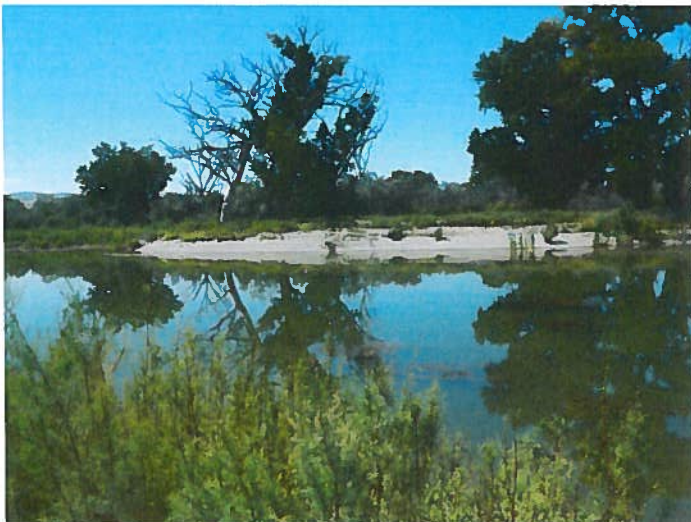
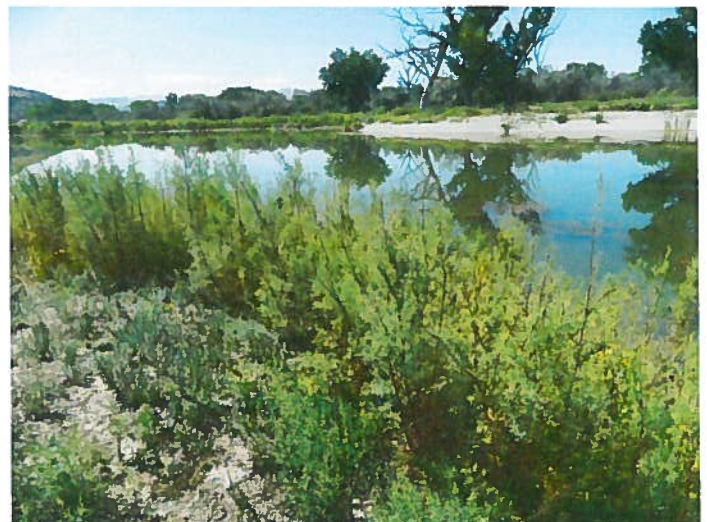
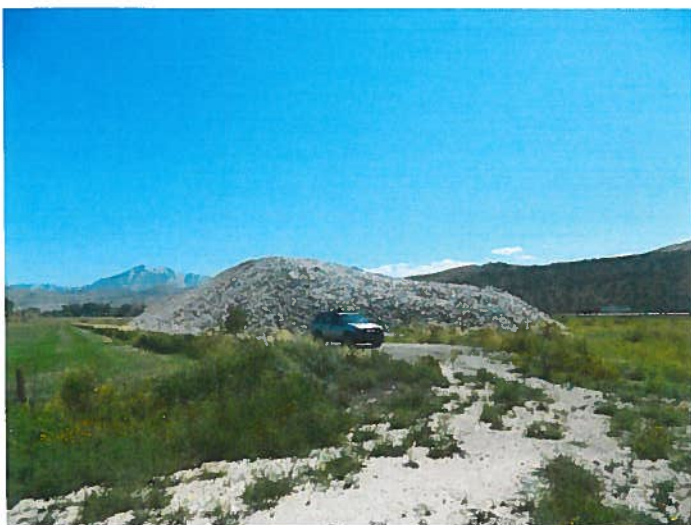
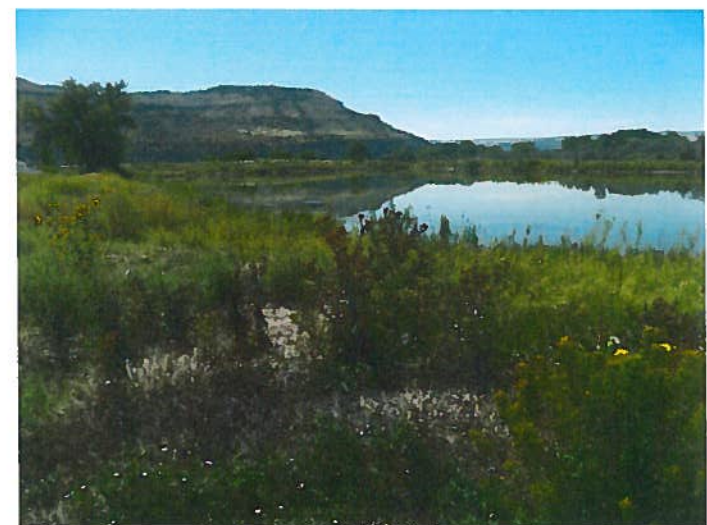
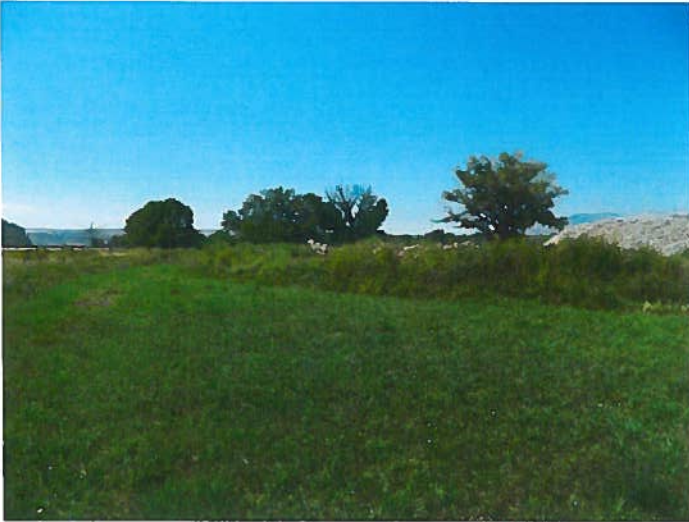
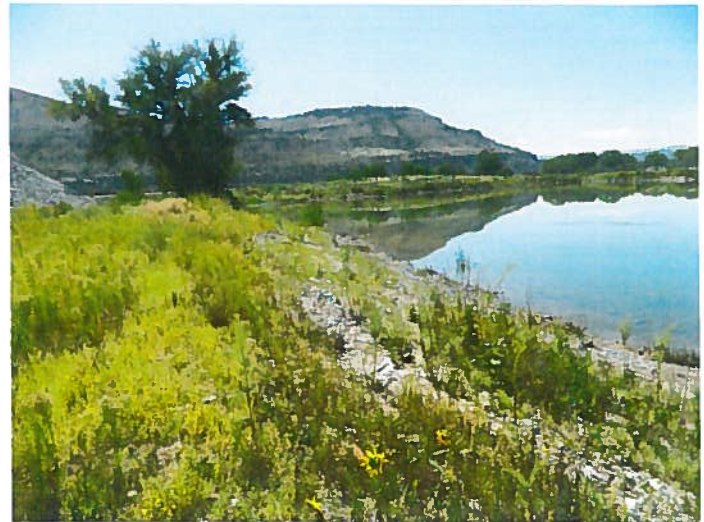
Topsoil stockpiles are located adjacent to the south and west perimeter of the permit area. The topsoil stockpiles do not have established vegetation on them and are therefore susceptible to erosion. Rule 3.1.9(1) states if topsoil is not replaced into the backfill area within a time short enough to avoid deterioration of the topsoil, vegetative cover or other means shall be employed so that the topsoil is protected from erosion. This is noted as a problem with the corrective action listed on the first page of this inspection report.

Various weeds were observed within the permit boundary. Tamarisk were observed within the permit area and must be treated. Tamarisk is considered noxious weed and must be treated to minimize spreading to adjacent non-infested lands. The presence of tamarisk is considered a problem and they must either be treated and/or removed from the permit area. Please supply this office with photo-documentation that demonstrates that treatment and/or removal of the noxious weed species has been completed no later than October 31, 2014 to avoid enforcement action.

CORRECTIVE ACTIONS: The operator shall seed the stockpiles with the seed mix that was submitted as part of the approved Reclamation Plan. If no seed mix has been provided, the operator shall submit a seed mix for approval as a technical revision to the permit along with the appropriate \$216 revision fee to the Division by the corrective action date. The Operator shall demonstrate compliance by submitting seed tags, a bill of sale or photographs of seeding activities. The Operator may also request a follow up inspection.
