COLORADO DIVISION OF RECLAMATION, MINING AND SAFETY
MINERALS PROGRAM INSPECTION REPORT
PHONE: (303) 866-3567

MINE NAME: Nahcolite Project	MINE/PROSPECTING ID#: M-1983-194	MINERAL: Carbonates	COUNTY: Rio Blanco
INSPECTION TYPE: Monitoring	INSPECTOR(S): Travis H. Marshall	INSP. DATE: September 4, 2014	INSP. TIME: 12:00
OPERATOR: Natural Soda, Inc.	OPERATOR REPRESENTATIVE: Michael Clark	TYPE OF OPERATION: 112d-3 - Designated Mining Operation

Report of Undesirable Event

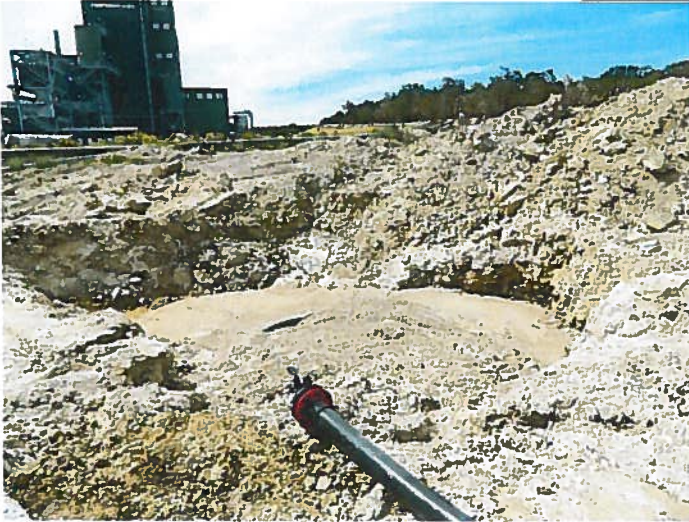
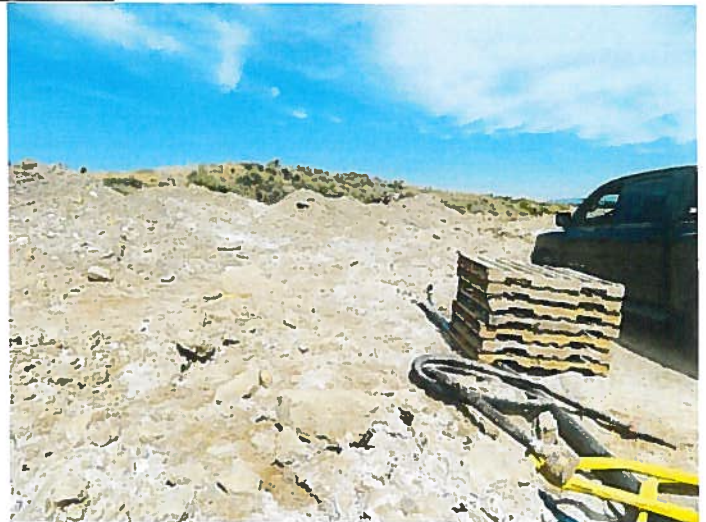
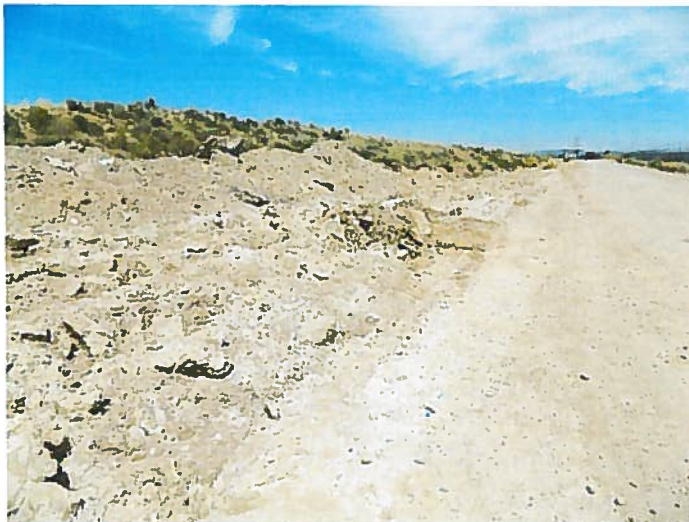
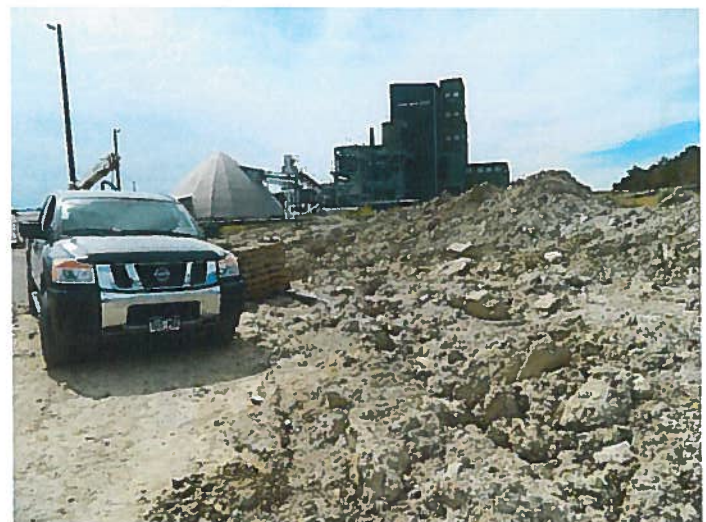
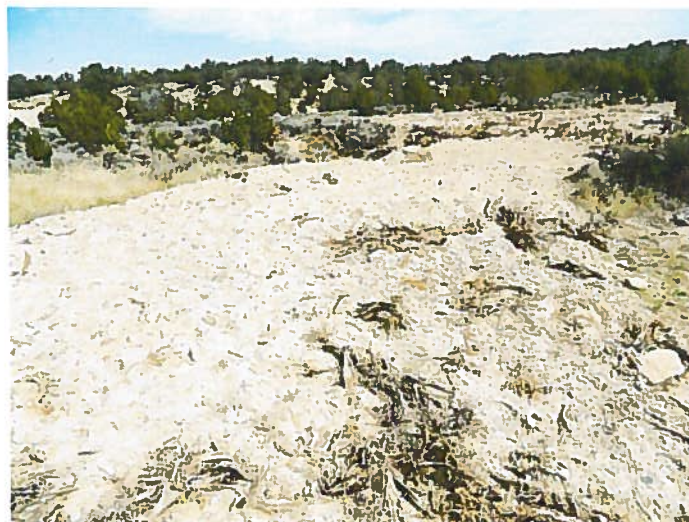
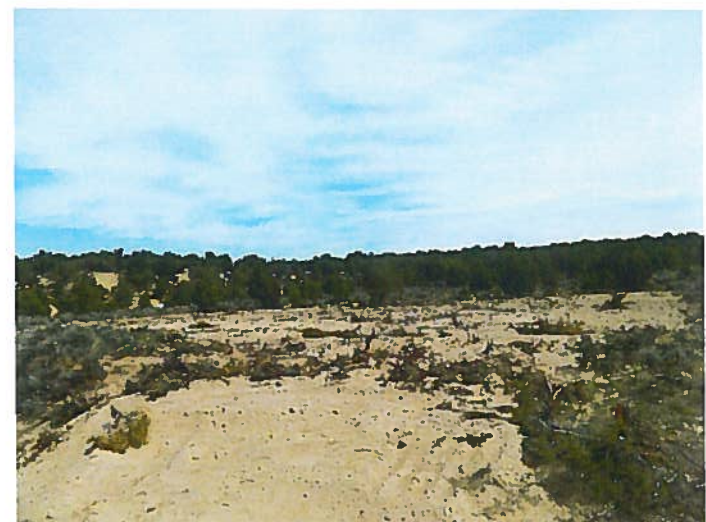
The spill occurred when a 4" plastic water pipe returning flow from the process pond to the plant was cut when a contractor was trenching for a new water line to the new water supply wells (WSW3 and WSW4). The release lasted for approximately 2 hours at an estimated rate of 40 gallons per minute, an estimated total of 4,800 gallons was released to the surface. According to the operators spill report approximately 40% of the spill was diverted back into the process pond. The remaining 60% was contained along the pond roadway ditch and new waterline trench where it soaked in.

The extent of the spill damage was minimal. The operator stated that the cause of the spill was attributed to the fact that the water return pipe was plastic and was therefore not locatable prior to excavation. To avoid future damage to the line the operator proposes to install surface markers locating the plastic pipes location.

While on location a recently reclaimed drill site approved under Technical Revision 35 was observed. The site was regraded and woody debris was placed over the replaced topsoil. The operator proposes to seed the site later this fall 2014.

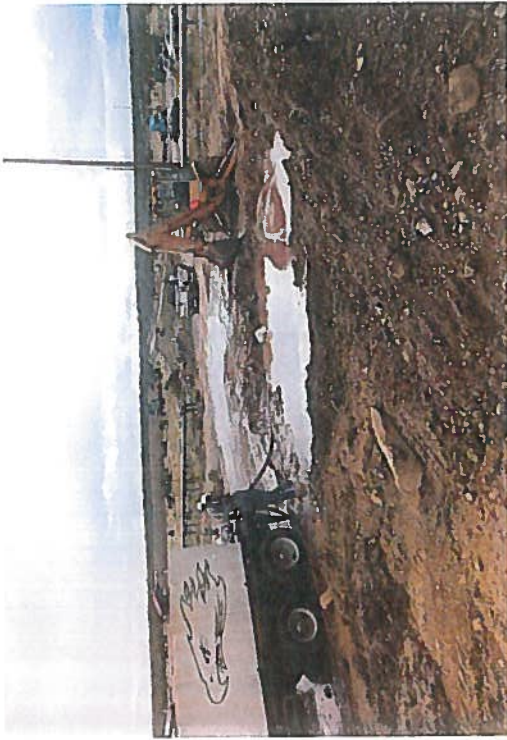
Water pooled from leak in process-pond return line
Water on road is from concurrent rainfall

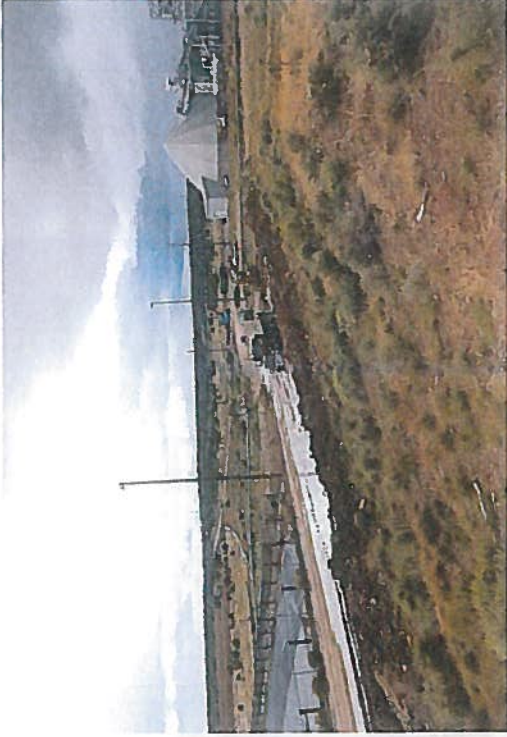
11. Cause of, and Extent of Event: 4" plastic water pipe returning flow from process pond to plant was cut when contractor was trenching for water line to new water wells WSW3 and WSW4. Release lasted 2 hours, typical flow is 40 gpm, quantity out of pipe approx. 4800 gallons. About 40% was divered back into process pond, about 60% was divered north along pond roadway catchment and new waterline trench where it soaked in. None discharged offsite.

Cut in process-pond return line occurred across from SW corner of ponds
Water from leak, mixed with rain water, flows north along west side of pond road

16. Clean up Procedures and Dates: Waterline was repaired by 17:00. Excavation was barracaded.			
17. Action Taken to Prevent Recurrence/Initiate or Update Contingency Planning Underground locator service was engaged prior to excavation, but missed this pipe. Pipe is plastic and had no locator wire. Other pipes were located because they are metal or plastic with wire. Location of this pipe is noted for future avoidance.

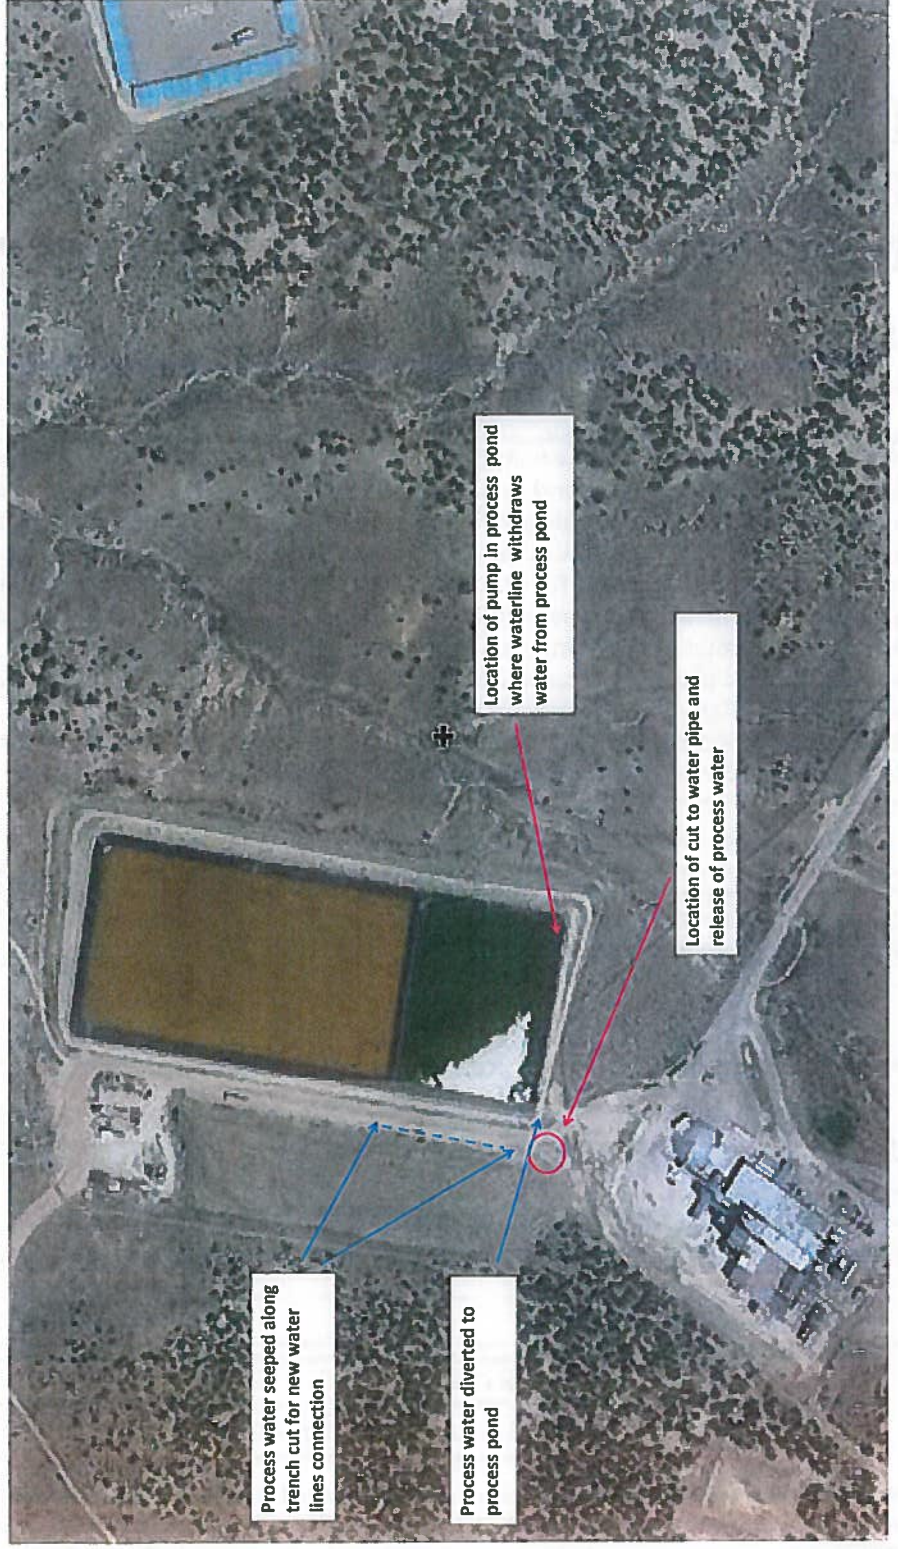
Process water seeped along
trench cut for new water
lines connection

Process water diverted to
process pond

Location of pump in process pond
where waterline withdraws
water from process pond

Location of cut to water pipe and
release of process water
