COLORADO DIVISION OF RECLAMATION, MINING AND SAFETY
MINERALS PROGRAM INSPECTION REPORT
PHONE: (303) 866-3567

MINE NAME: Revenue Mine Exploration	MINE/PROSPECTING ID#: P-2011-030	MINERAL: Silver and gold	COUNTY: Ouray
INSPECTION TYPE: Mineral Prospect Inspection	INSPECTOR(S): Bob Oswald	INSP. DATE: August 20, 2014	INSP. TIME: 14:30
OPERATOR: Silver Star Resources	OPERATOR REPRESENTATIVE: John E. Trujillo	TYPE OF OPERATION: MP - Mineral Prospecting

REASON FOR INSPECTION: Surety Release Requested	BOND CALCULATION TYPE: None	BOND AMOUNT: \$19,813.00
DATE OF COMPLAINT: NA	POST INSP. CONTACTS: None	JOINT INSP. AGENCY: None
WEATHER: Clear	INSPECTOR'S SIGNATURE:

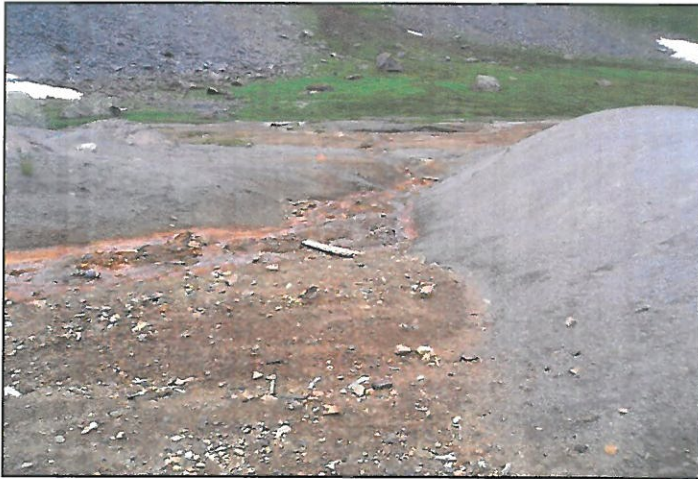
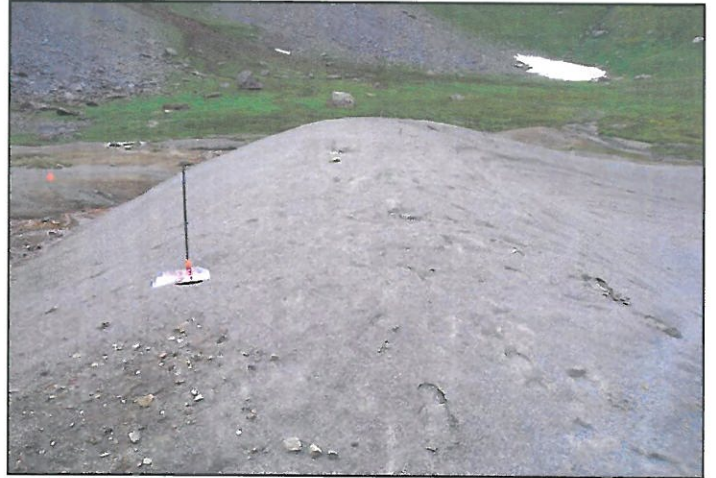
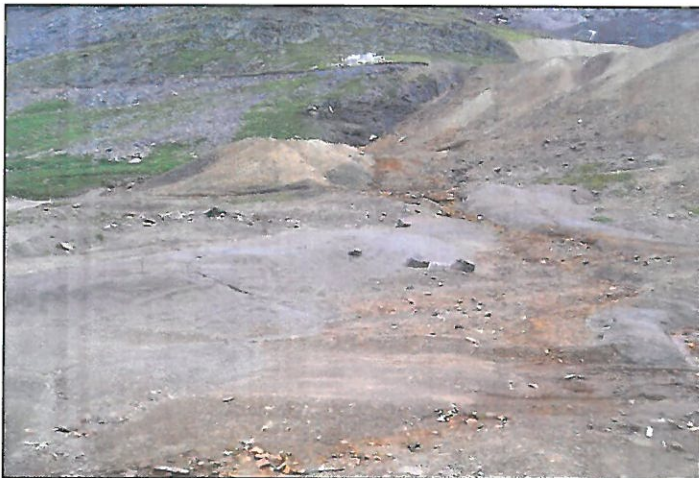
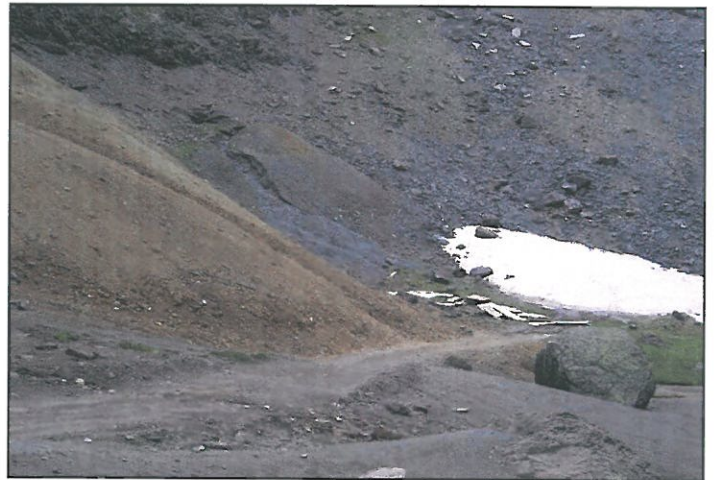
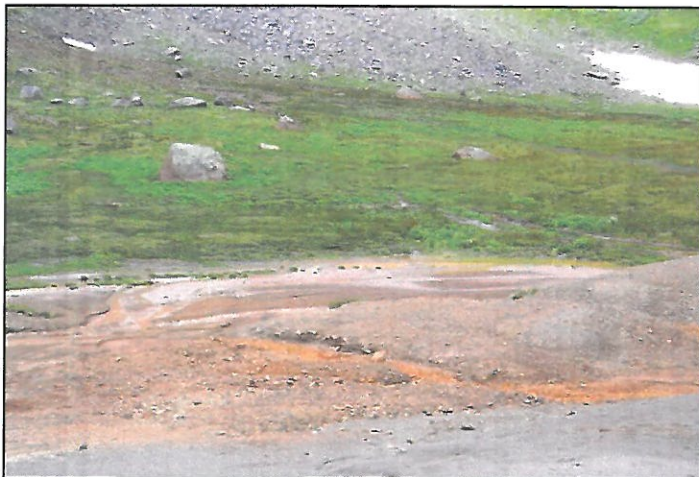
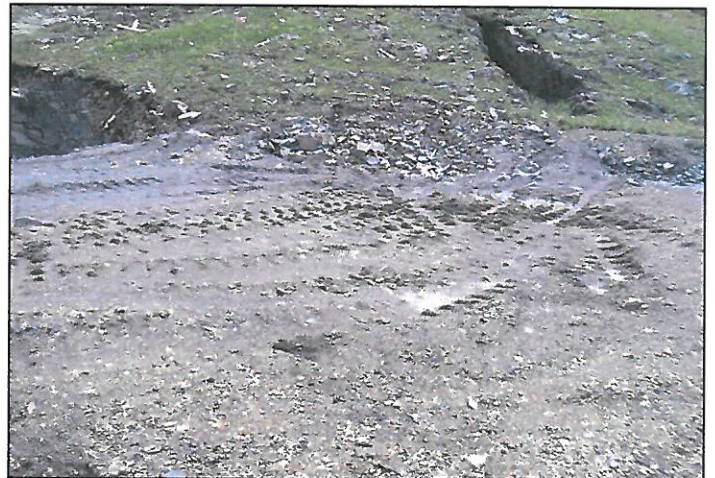
The drill hole sites in upper Governor Basin, specifically on the pad of the Virginius #3 level, and at the toe of the waste rock/low grade dump, were found to be nearly reclaimed. Surface grading was complete, and no drill holes were found to be open. However, there was still a pile of damaged plywood sheets at the location which the operator indicated were used by drilling equipment to travel over, to protect native vegetation. These sheets need to be removed and disposed of.
