COLORADO DIVISION OF RECLAMATION, MINING AND SAFETY
MINERALS PROGRAM INSPECTION REPORT
PHONE: (303) 866-3567

MINE NAME: Revenue Mine	MINE/PROSPECTING ID#: P-2013-006	MINERAL: Ag, Au, Pb, Cu, Zn	COUNTY: Ouray
INSPECTION TYPE: Mineral Prospect Inspection	INSPECTOR(S): Bob Oswald	INSP. DATE: August 20, 2014	INSP. TIME: 15:00
OPERATOR: Star Mine Operations	OPERATOR REPRESENTATIVE: John E. Trujillo	TYPE OF OPERATION: MP - Mineral Prospecting

REASON FOR INSPECTION: Surety Release Requested	BOND CALCULATION TYPE: None	BOND AMOUNT: \$7,720.00
DATE OF COMPLAINT: NA	POST INSP. CONTACTS: None	JOINT INSP. AGENCY: None
WEATHER: Clear	INSPECTOR'S SIGNATURE:

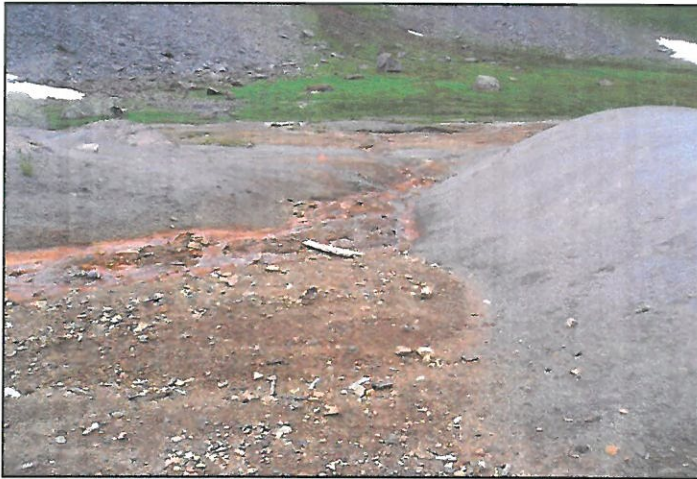
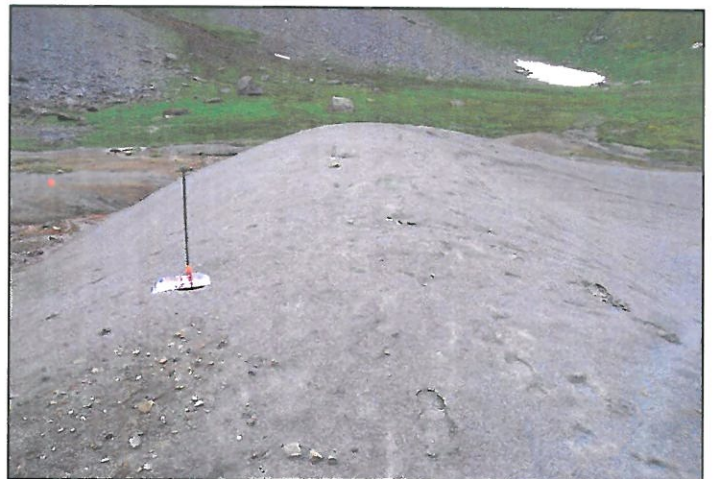
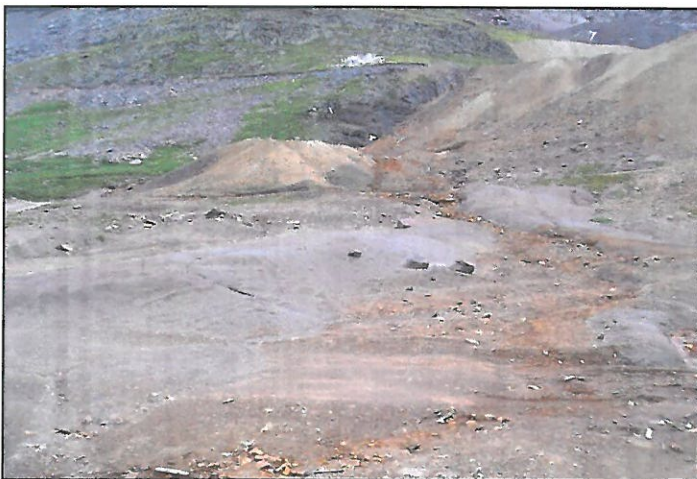
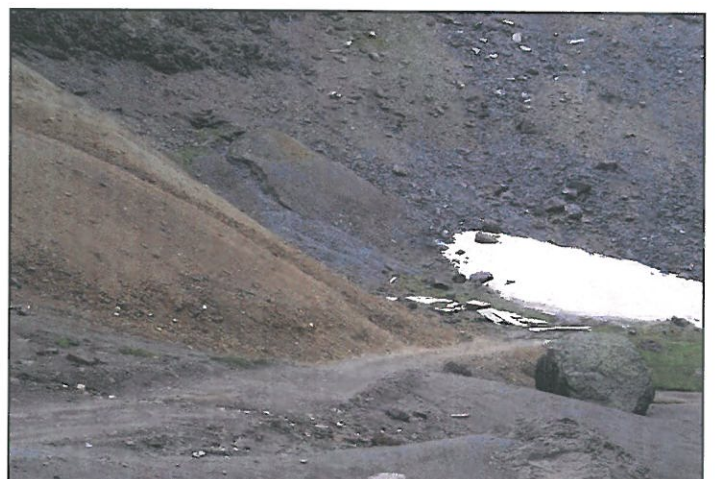
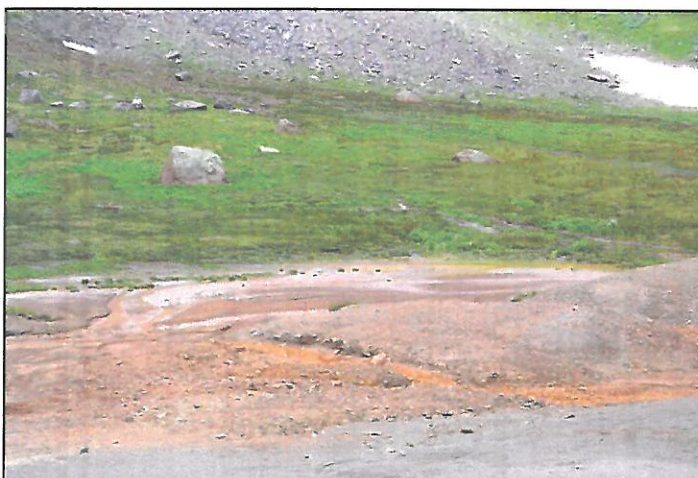
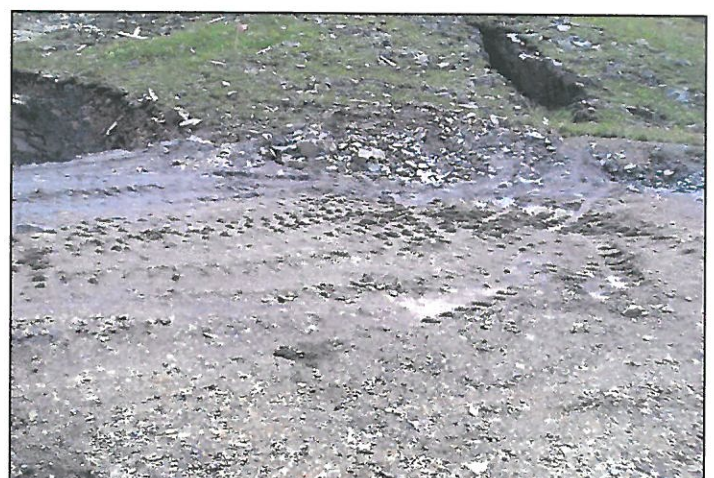
The drill hole sites in upper Governor Basin, specifically on the pad of the Virginius #3 level, and at the toe of the waste rock/low grade dump, were found to be nearly reclaimed. Surface grading was complete, and no drill holes were found to be open. However, there was still a pile of damaged plywood sheets at the location which the operator indicated were used by drilling equipment to travel over, to protect native vegetation. These sheets need to be removed and disposed of.
