COLORADO DIVISION OF RECLAMATION, MINING AND SAFETY
MINERALS PROGRAM INSPECTION REPORT
PHONE: (303) 866-3567

MINE NAME: Butala Gravel Pit	MINE/PROSPECTING ID#: M-1977-170	MINERAL: Sand and gravel	COUNTY: Chaffee
INSPECTION TYPE: Monitoring	INSPECTOR(S): Dustin M. Czapla	INSP. DATE: September 10, 2014	INSP. TIME: 15:00
OPERATOR: Butala Construction Company	OPERATOR REPRESENTATIVE: Tom Eve	TYPE OF OPERATION: 112c - Construction Regular Operation

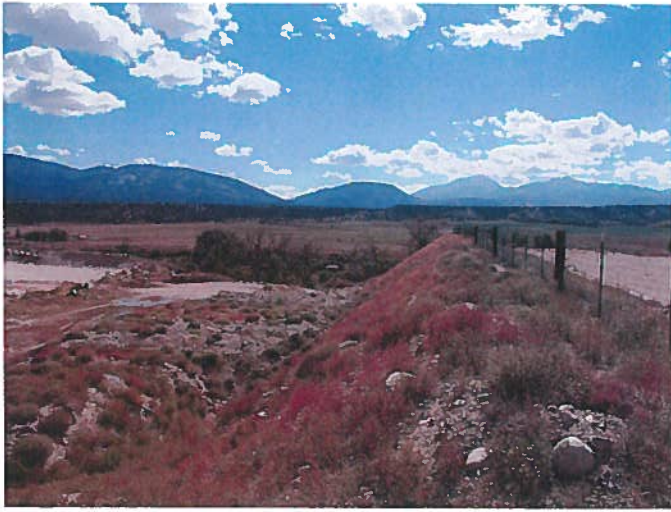
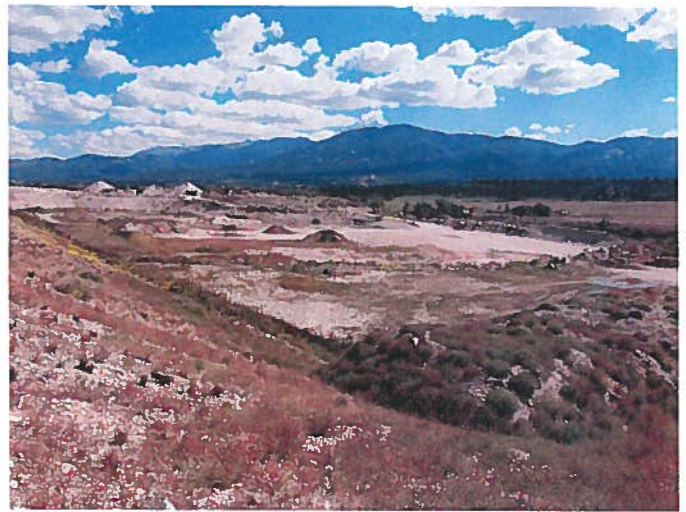
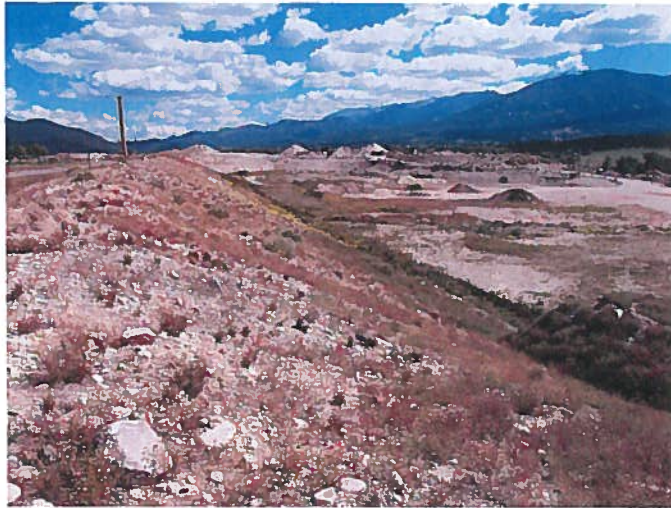
This area is mined out. Slope reduction is progressing on the east highwall. The current slope is approximately 1H:1V. Backfill material has been placed at the base of the highwall. The north highwall has been graded to approximately 2H:1V.

Figure 1: Phase 1 reclamation area

Figure 2: Phase 1 reclamation area

Figure 3: Phase 1 reclamation area

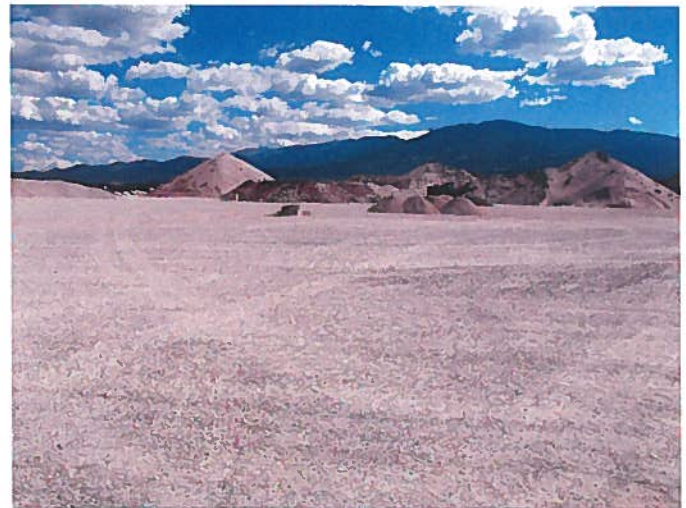
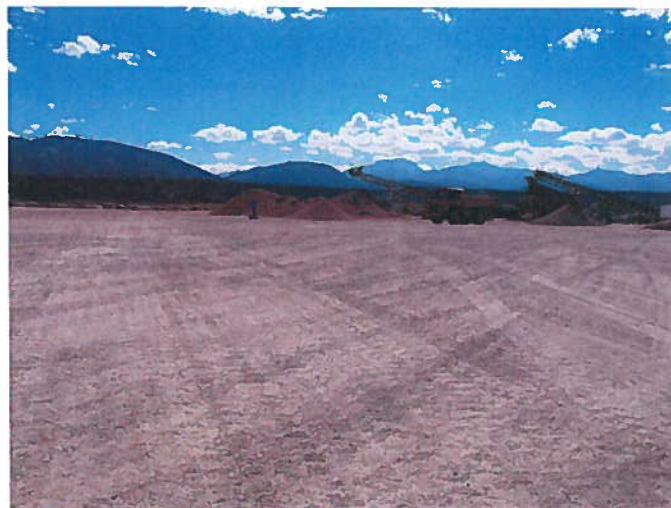
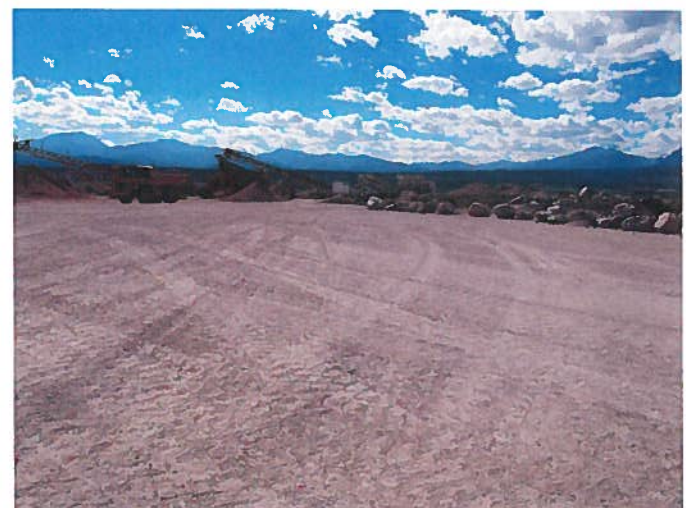
This is the creosote evaluation area. Excavation is not allowed here. Mining activity is limited to surface disturbance. The area is used for stockpile storage and materials processing. Various materials stockpiles are located in this area.

Figure 4: Creosote evaluation area

Figure 5: Creosote evaluation area

Figure 6: Creosote evaluation area

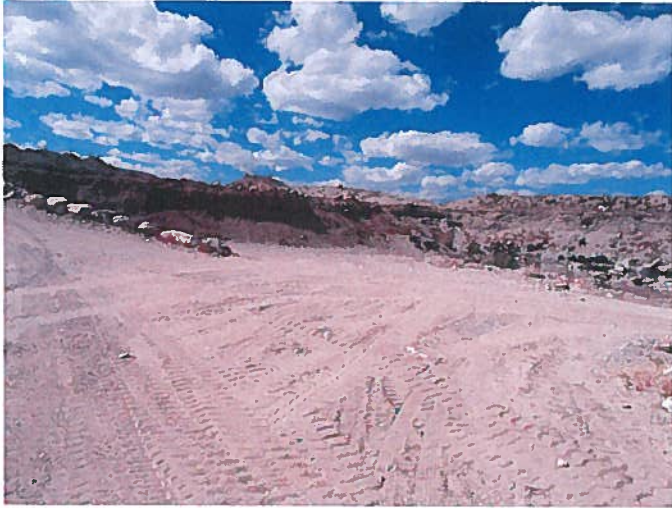
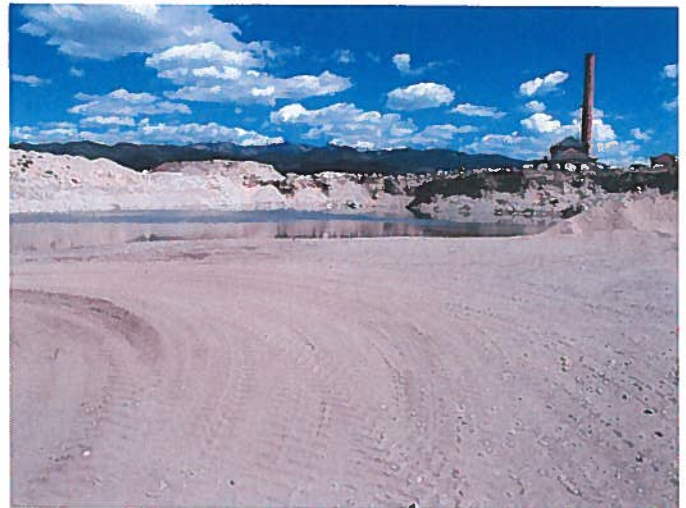
Mining has progressed into the Phase 3 area. Highwalls are approximately 20-30 feet high and near vertical. Water has collected in the pit floor. The operator stated the water is sourced from irrigation of neighboring fields.

Figure 7: Phase 3 active mining area

Figure 8: Phase 3 active mining area

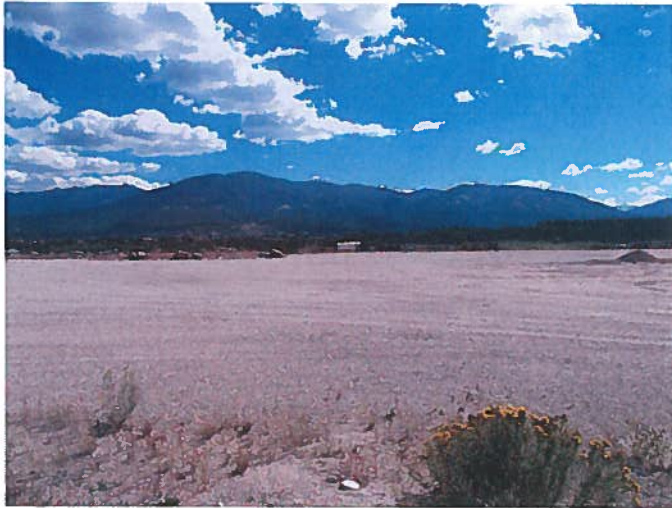
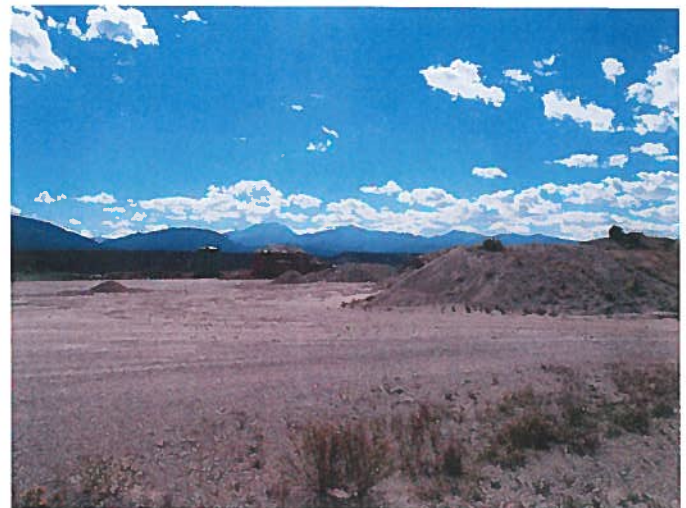
Mining has not commenced in these areas. These are currently used for stockpile and equipment storage.

Figure 9: Phase 4 storage area

Figure 10: Phase 4 storage area
