COLORADO DIVISION OF RECLAMATION, MINING AND SAFETY
MINERALS PROGRAM INSPECTION REPORT
PHONE: (303) 866-3567

MINE NAME: Hard Rock 291 Pit	MINE/PROSPECTING ID#: M-1977-195	MINERAL: Sand and gravel	COUNTY: Chaffee
INSPECTION TYPE: Monitoring	INSPECTOR(S): Dustin M. Czapla	INSP. DATE: September 10, 2014	INSP. TIME: 15:30
OPERATOR: Hard Rock Paving and Redi-Mix, Inc.	OPERATOR REPRESENTATIVE: None	TYPE OF OPERATION: 110c - Construction Limited Impact

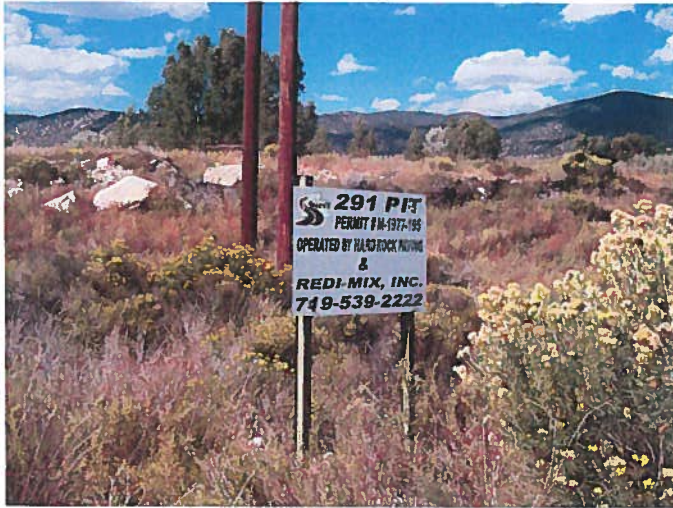
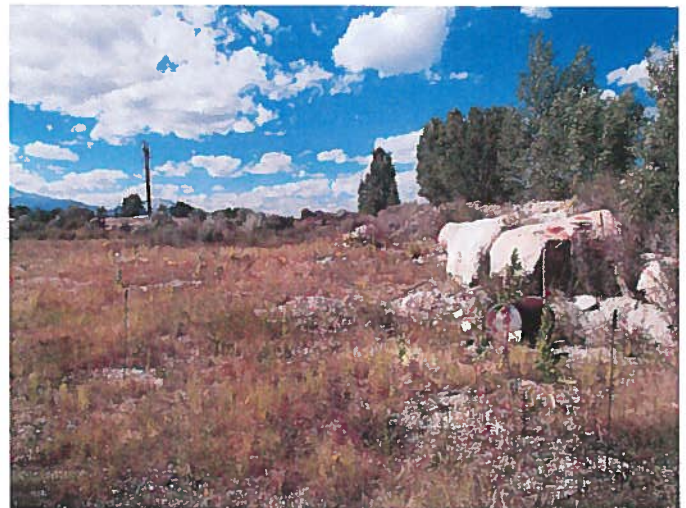
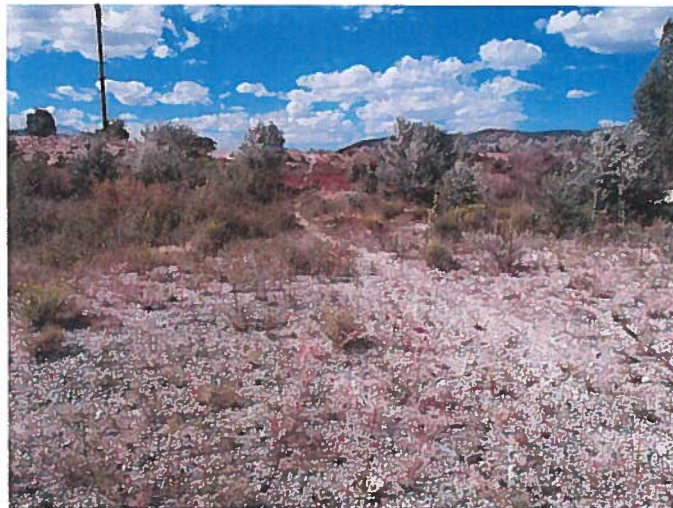
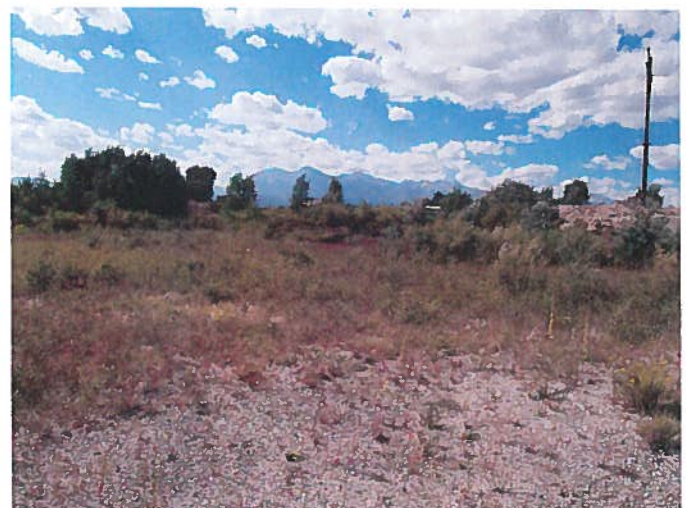
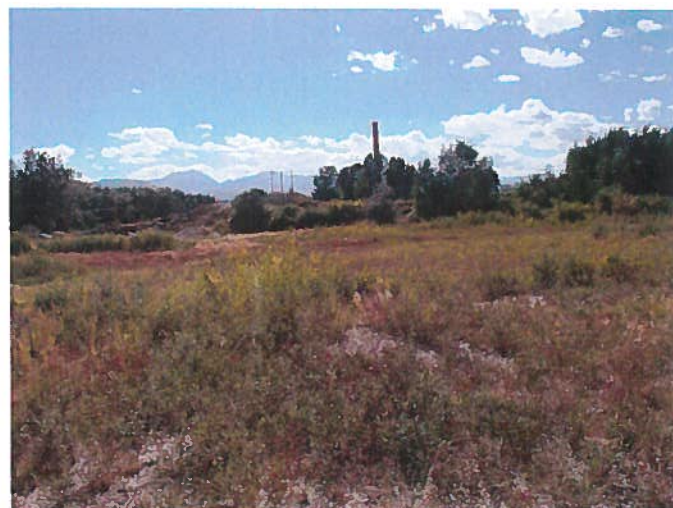
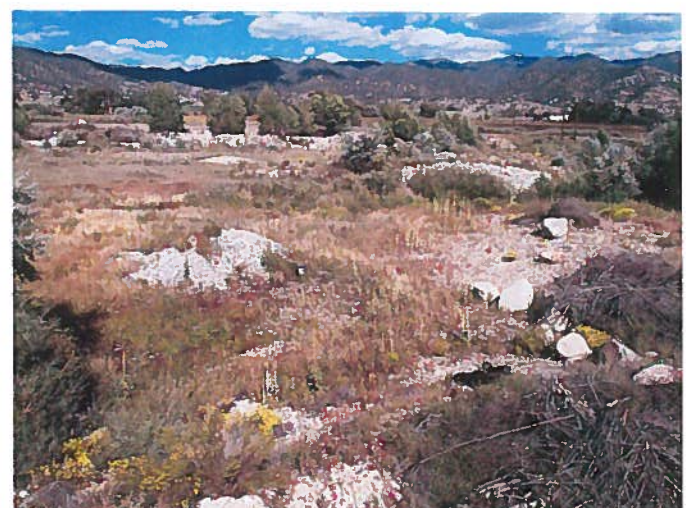
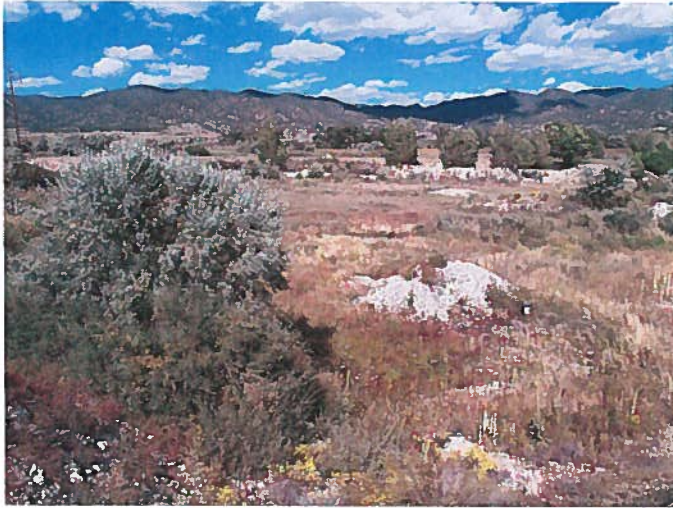
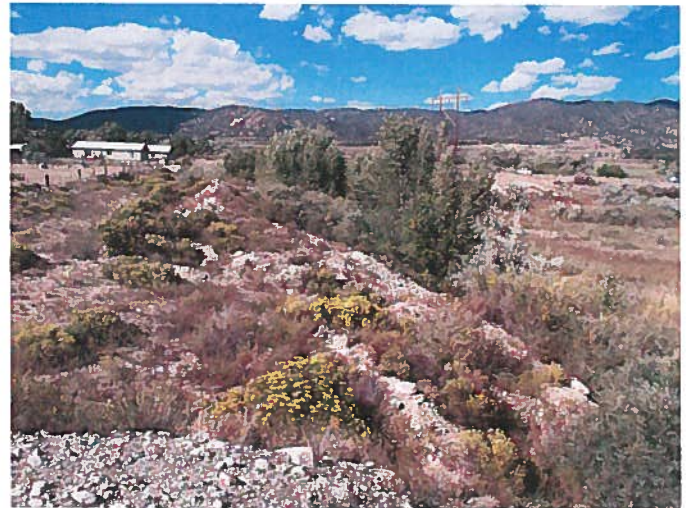
Adequate mine identification signage was noted at the entrance to the site.

The affected area was marked by t-posts that were clearly visible and adequate to delineate the affected area boundary.

There has been no mining at this site since at least 2003. Volunteer vegetation is well established throughout the permit area. However, reclamation grading and topsoil application have not been completed. Rule 3.1.3 requires that all reclamation be carried to completion by the Operator with all reasonable diligence within five years of completing mining. This has been noted above as a problem. The site has been approved for intermittent operations, which applies to operations that operate less than 180 days per year. This site, however, has not operated for more than ten years and the operator has provided no indication to the Division for planning to resume operations.

CORRECTIVE ACTIONS: Commence and complete reclamation of the site in accordance with the approved reclamation plan, Act and Rules.
