COLORADO DIVISION OF RECLAMATION, MINING AND SAFETY
MINERALS PROGRAM INSPECTION REPORT
PHONE: (303) 866-3567

MINE NAME: DDD	MINE/PROSPECTING ID#: M-1984-076	MINERAL: Clay (general)	COUNTY: Elbert
INSPECTION TYPE: Monitoring	INSPECTOR(S): Amy Eschberger	INSP. DATE: August 12, 2014	INSP. TIME: 09:30
OPERATOR: General Shale Brick, Inc.	OPERATOR REPRESENTATIVE: Jason McGraw	TYPE OF OPERATION: 112c - Construction Regular Operation

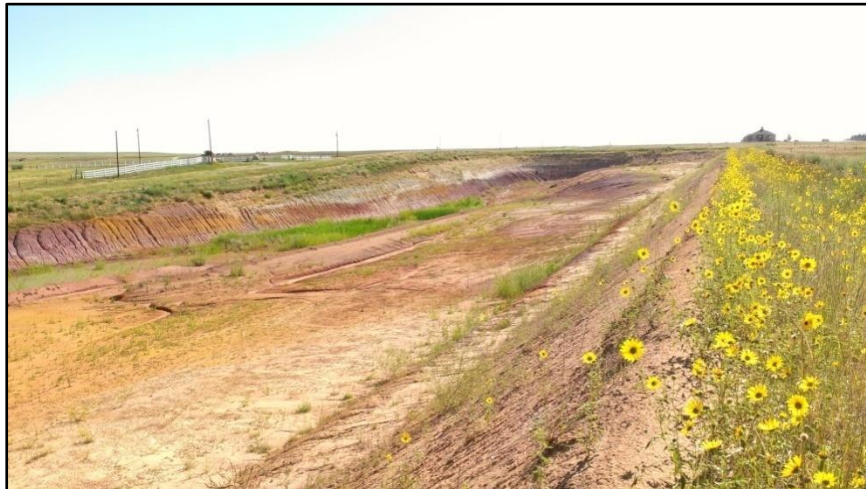
The West pit includes an excavation on the eastern portion that is approximately 750 feet in length (Photo 2), a stockpile pad area constructed out of overburden material on the western portion that includes three clay product stockpiles (Photo 3), a topsoil stockpile on the northern edge (Photo 4), and a stockpile of scrap brick fill material lining the northern and western edges of the area (see Photo 3), an overburden stockpile on the southern edge, and a settling pond in the southwestern corner to collect runoff from the mine (Photo 5). All stockpiles appeared to be stable.

The excavation area has highwalls that are up to approximately 25 feet in height, with slope gradients of 1.5H:1V to 2H:1V (see Photo 2). The northwestern portion of the excavation has standing water with a surface area of approximately 0.1 acre and a depth of approximately 1-2 feet (Photos 6 and 7). Standing water has been observed in this pit in inspections going back to 1999. A Problem was cited for this issue in the 03/23/2006 inspection report. The Operator was instructed to determine whether water in the pit is groundwater or surface runoff, and to develop an appropriate plan to deal with its management. The Problem was considered abated on 06/01/2006, when the Operator submitted a letter stating that water levels in the pit were monitored for a few months in the spring, and there appeared to be no groundwater component to the standing water. The Operator stated that the pit remains routinely dry during much of the year, but that any significant accumulation of water would be removed from the pit in a timely manner. Also, to prevent water from being retained in the pit, the Operator committed to completing some minor grading modifications to divert stormwater flow away from the pit, and to refrain from placing snow in areas that drain to the pit.

Photo 2. View looking east, showing excavation present in eastern portion of permit area.

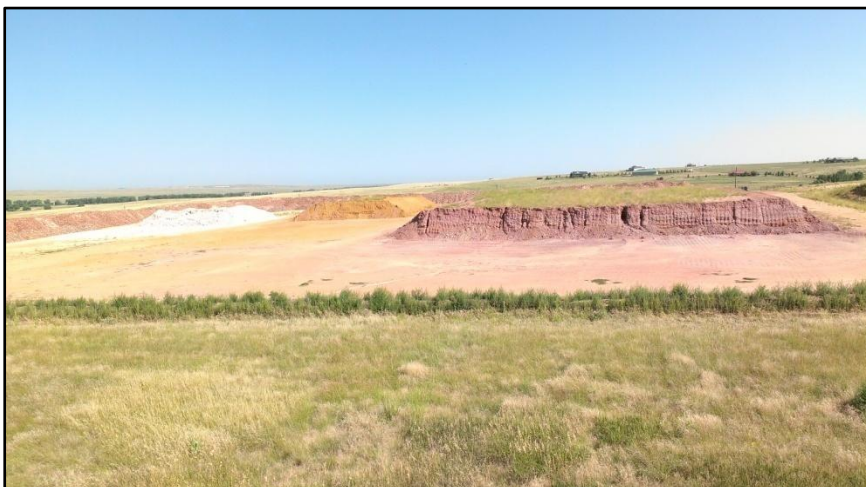
Photo 3. View looking north, showing stockpile pad, including three clay product stockpiles. Note scrap brick stockpile lining northwestern portion of stockpile pad (at left).

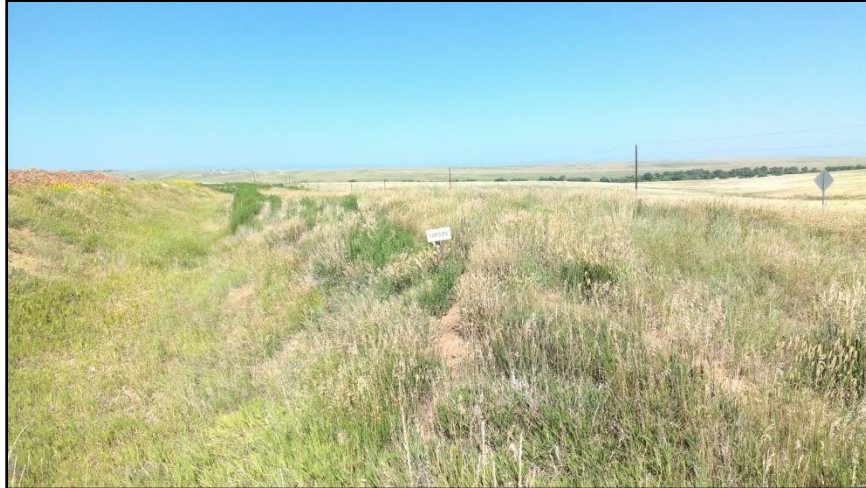
Photo 4. View of topsoil stockpile stable with vegetative cover, stored along northern permit boundary.

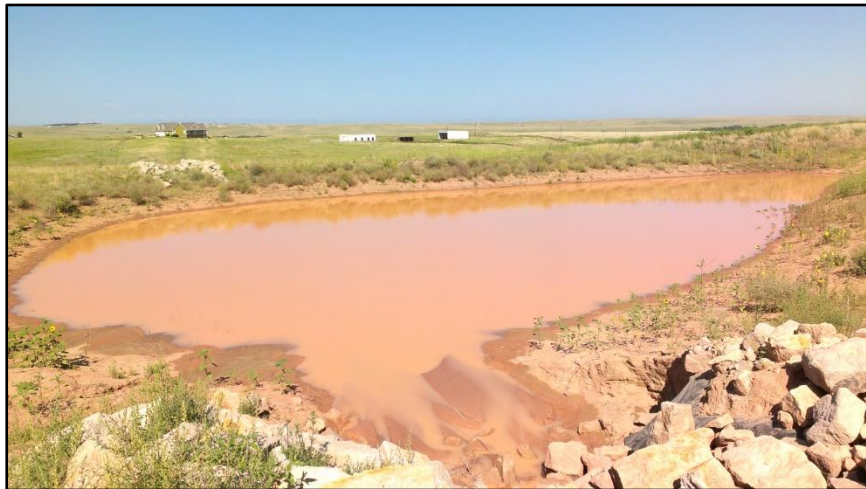
Photo 5. View of sediment pond located in southwestern portion of permit area.

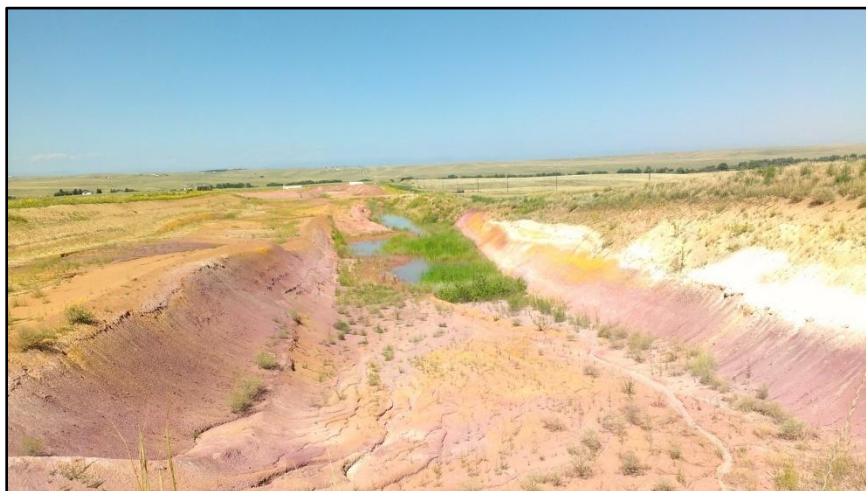
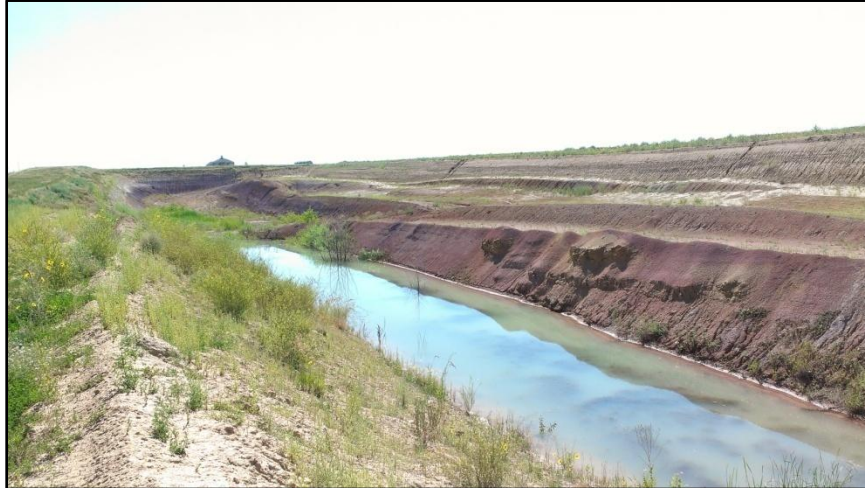
PROBLEM/POSSIBLE VIOLATION: Problem: The Division has no evidence that the Operator has a valid well permit, substitute water supply plan, or approved water augmentation plan for possible exposed groundwater at the site. This is a problem related to 34-32.5-116(4)(h) of the Colorado Revised Statutes and 3.1.6(1)(a) of the Construction Materials Rules and Regulations governing injury to existing water rights.

During the current inspection, Mr. McGraw stated that based on previous drilling, he believes the groundwater level in the area to be 10's of feet below the current pit floor. He also indicated that the standing water does not typically remain in the pit for very long. The Division understands that because this is a clay pit, water may be retained longer

than if the ground consisted of more permeable sediments. However, if water is retained on site for more than 72 hours, the Division of Water Resources (DWR) requires the Operator to obtain a substitute water supply plan or augmentation plan approved by water court.

The Division has no evidence that the Operator has a valid well permit, substitute water supply plan, or approved augmentation plan for this site. **A Problem will be cited in this report for failure to comply with C.R.S. 34-32.5-116(4)(h), which requires the Operator to minimize disturbances to the prevailing hydrologic balance of the affected land and of the surrounding area, and with Rule 3.1.6(1)(a), which requires the Operator to be in compliance with applicable Colorado water laws and regulations governing injury to existing water rights (see page 1).** The Operator will need to demonstrate to the Division that the operation is in compliance with the Office of the State Engineer (SEO), or show evidence that the Operator is taking measures to bring the site into compliance with the SEO, or backfill the pit to at least two feet above the static groundwater level. The Operator should contact the Colorado Division of Water Resources for more information. Proof of action regarding this matter will need to be submitted to the Division by the corrective action due date.

Photo 6. View looking west, showing standing water in pit located in eastern portion of permit area.

Photo 7. View looking east, showing standing water in pit located in eastern portion of permit area.

CORRECTIVE ACTIONS: The Operator shall demonstrate that the operation is in compliance with the Office of the State Engineer (SEO), or show evidence that the Operator is taking measures to bring the site into compliance with the SEO, or backfill the pits to at least two feet above the static groundwater level by the corrective action date specified.

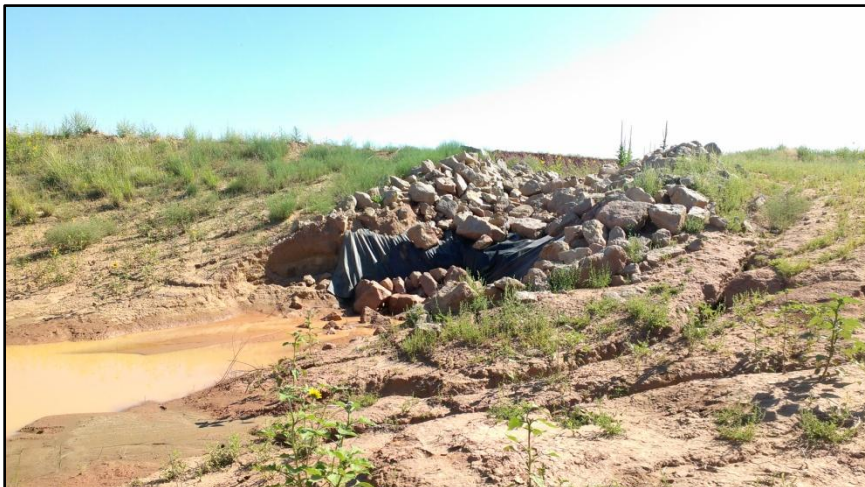
The settling pond located in the southwestern corner of the West pit appears to be functioning properly. The inlet is rather steep, but is lined with a rubber liner and riprap to help control erosion (Photo 8). This erosion control structure will need some repair as it appears that water is undercutting the structure during heavy storm events. During the inspection, Mr. McGraw committed to getting this structure repaired very shortly. Water in the pond currently has a surface area of approximately 0.15 acre. The water level in the pond was well below the outlet height by approximately 2-3 feet.

Photo 8. View of eastern portion of sediment pond with plastic liner and riprap. Note how water appears to be undercutting the structure when levels are higher.

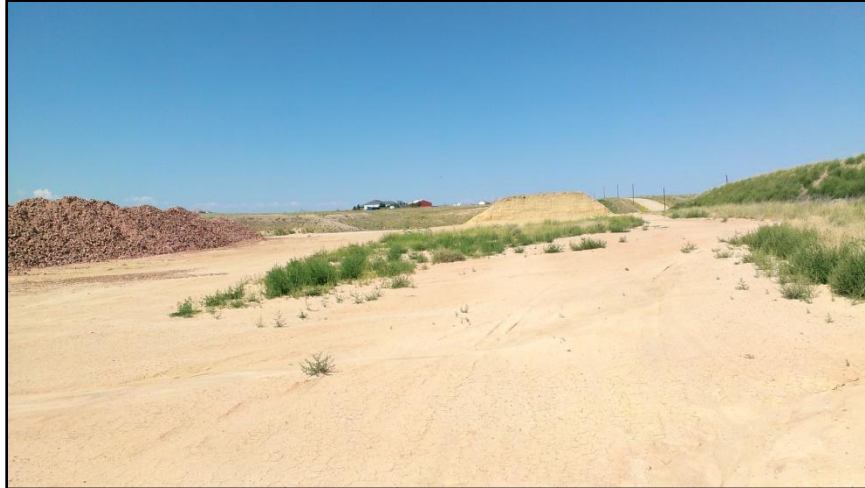
The East pit includes a main stockpile pad that has been stripped of topsoil (Photo 10), an exposed flat mine bench (Photo 11), an excavation (see Photo 11), a stockpile pad that was constructed on the northwest side of the permit area in 2007, three topsoil stockpiles located along the northern and southern edges of the permit area (Photo 12), one overburden stockpile located south of the excavation (Photo 13), and one small product stockpile and a stockpile of scrap brick fill material located on the northern portion of the pit (see Photo 10). All stockpiles appeared to be stable.

Photo 10. View looking west, showing main stockpile pad area located in northern portion of permit area. Note small material stockpile (at center, background), and portion of scrap brick fill material (at left).

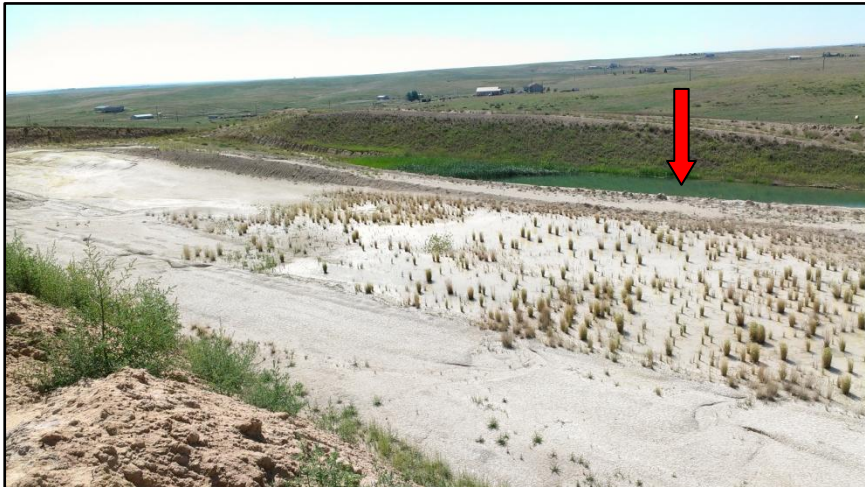
Photo 11. View looking southeast from southern edge of main stockpile pad area, showing exposed flat mine bench below. Excavation located south of bench is marked.

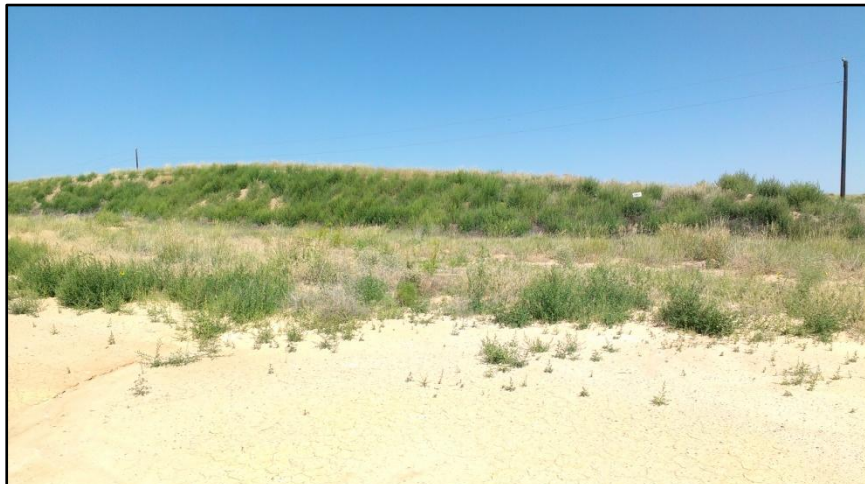
Photo 12. View of topsoil stockpile stable with vegetative cover, stored along northern permit boundary.

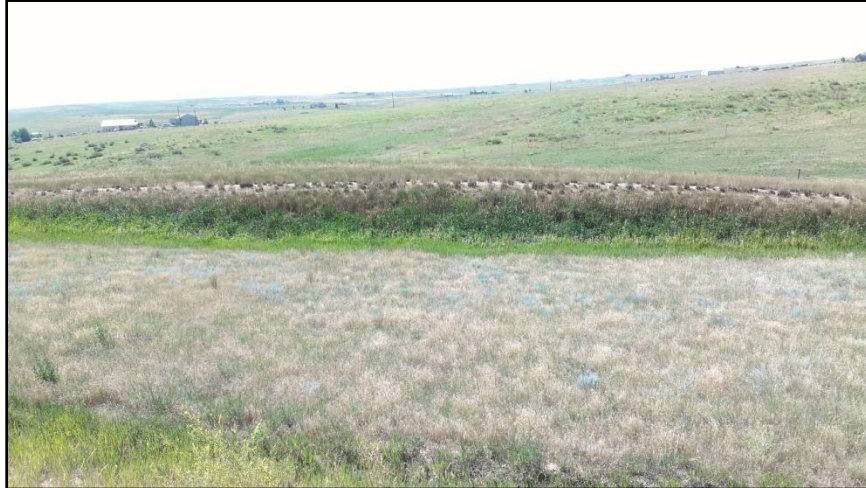
Photo 13. View of overburden stockpile stable with vegetative cover, located south of the excavation.

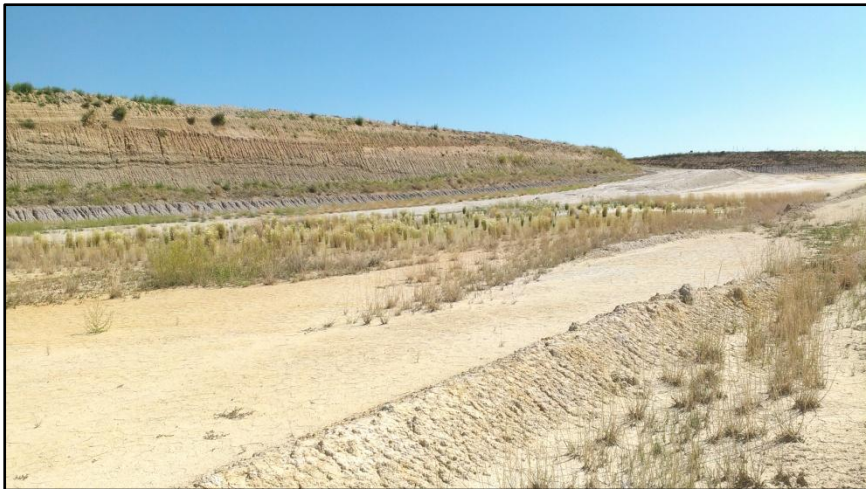
The south-facing highwall is approximately 600 feet long and up to 30 feet in height, with slope gradients of 1.5H:1V to 2H:1V (Photo 14). The excavated pit has standing water with a surface area of approximately 0.45 acre and a maximum depth of approximately 15 feet (Photos 15 and 16). According to historical imagery of this site shown in Google Earth, this pit started retaining water in 2007. As mentioned above, the DWR requires the Operator to obtain water rights for water that is retained on site for more than 72 hours. **The Problem cited in this report pertains to both the West pit and the East pit.**

Photo 14. View of south-facing highwall (at left).

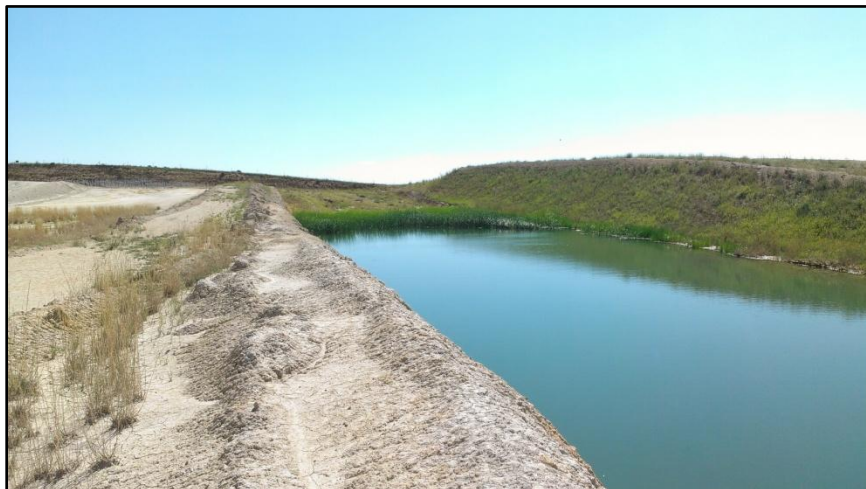
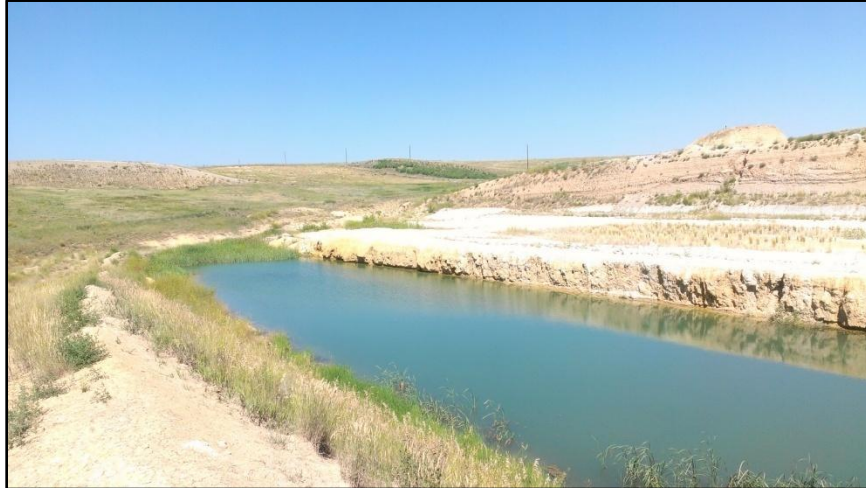
Photo 15. View looking east, showing water retained inside excavated pit.

Photo 16. View looking west, showing water retained inside excavated pit.

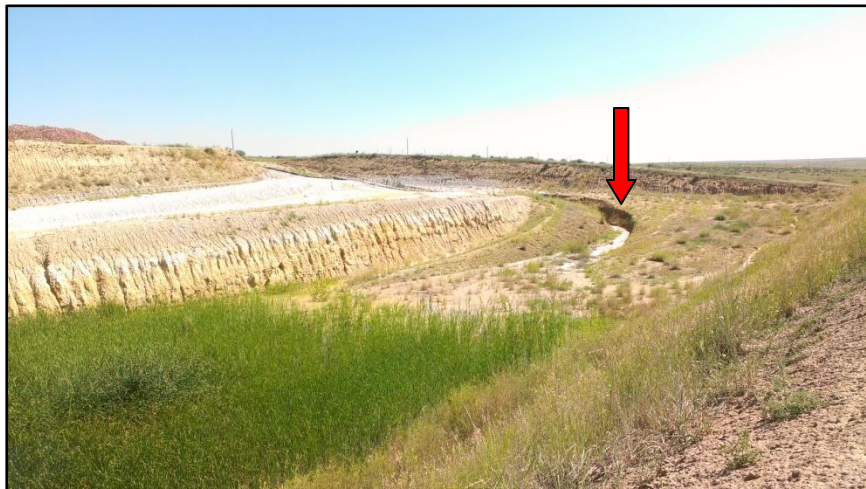
It appears that stormwater runoff flows into the excavation at this site from the east and the west, but is concentrated more from the east, where a deep gully has formed (Photo 17). According to Mr. McGraw, this erosion damage will be repaired shortly when the roads are regraded for entry into the pit to resume mining. Mining is expected to resume at this pit within a year or so. Other activities to prepare the site for mining will include constructing a few sediment ponds around the mining area (most likely on the western end, which is downgradient from the pit), and constructing small diversion ditches or berms to help divert water into the sediment ponds. Mr. McGraw indicated the Operator must be out of the West pit by 2016. Therefore, the stockpiles in the West pit will need to be used up or relocated to the East pit within a year so that the West pit can be reclaimed. The Operator should be aware that any changes to the approved mining plan, reclamation plan, and/or maps, (including the addition of sediment ponds, or mining to deeper depths than previously stated) should be updated with the Division. Unless these changes include an increase in permit acreage or significant changes to the approved permit files, they can be updated through the submittal of a Technical Revision.

Photo 17. View looking east, showing gully forming (marked) where stormwater runoff flows into excavated pit.
