COLORADO DIVISION OF RECLAMATION, MINING AND SAFETY
MINERALS PROGRAM INSPECTION REPORT
PHONE: (303) 866-3567

MINE NAME: Navajo Clay Pit	MINE/PROSPECTING ID#: M-1993-004	MINERAL: Clay (general)	COUNTY: Elbert
INSPECTION TYPE: Monitoring	INSPECTOR(S): Amy Eschberger	INSP. DATE: August 12, 2014	INSP. TIME: 11:40
OPERATOR: General Shale Brick, Inc.	OPERATOR REPRESENTATIVE: Jason McGraw	TYPE OF OPERATION: 112c - Construction Regular Operation

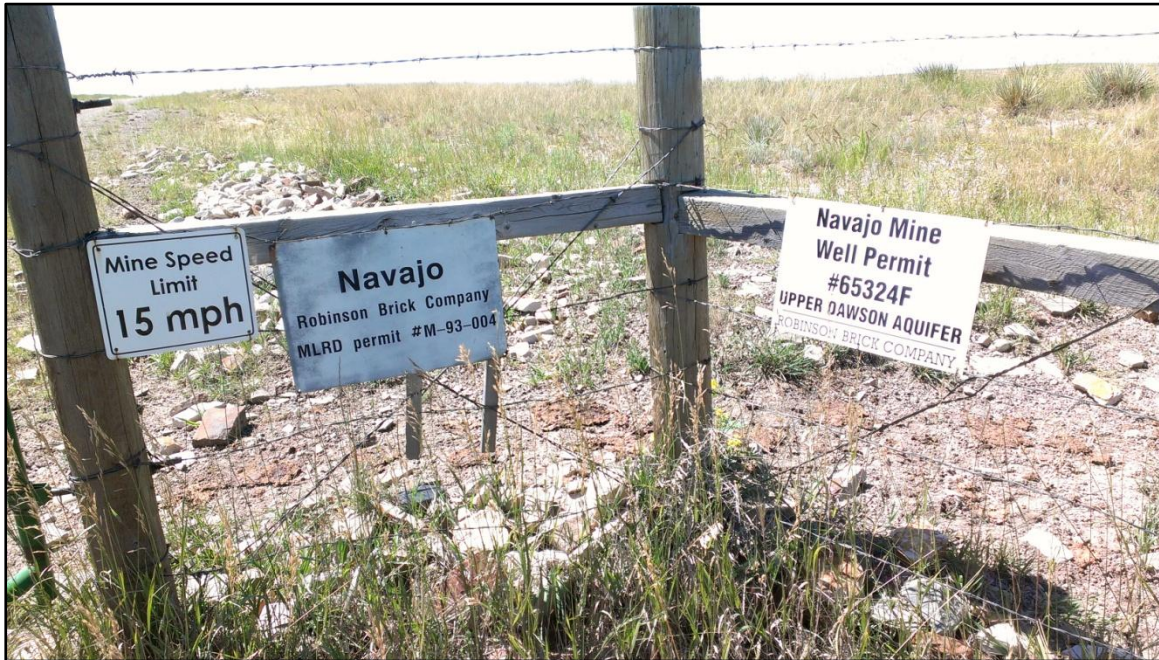
During the recent inspection, a permit sign was posted at the gated entrance to the site off of Co Rd 174 (Photo 1). However, the sign should have the current Operator's name (not Robinson Brick Company), and "MLRD" should be corrected to "MLRB" for Mined Land Reclamation Board. The permit boundary was delineated by property fencelines. **However, the area proposed to be disturbed by the operation for which the Financial Warranty has been posted was not delineated as required by Rule 3.1.12(2). This will be cited as a Problem in this report, and will require corrective action (see page 1).** No mining activities were occurring during the inspection, and no mining equipment was stored on site. According to Mr. McGraw, product is hauled off from the site every year.

Photo 1. View of permit sign posted at entrance to site off of Co Rd 174.

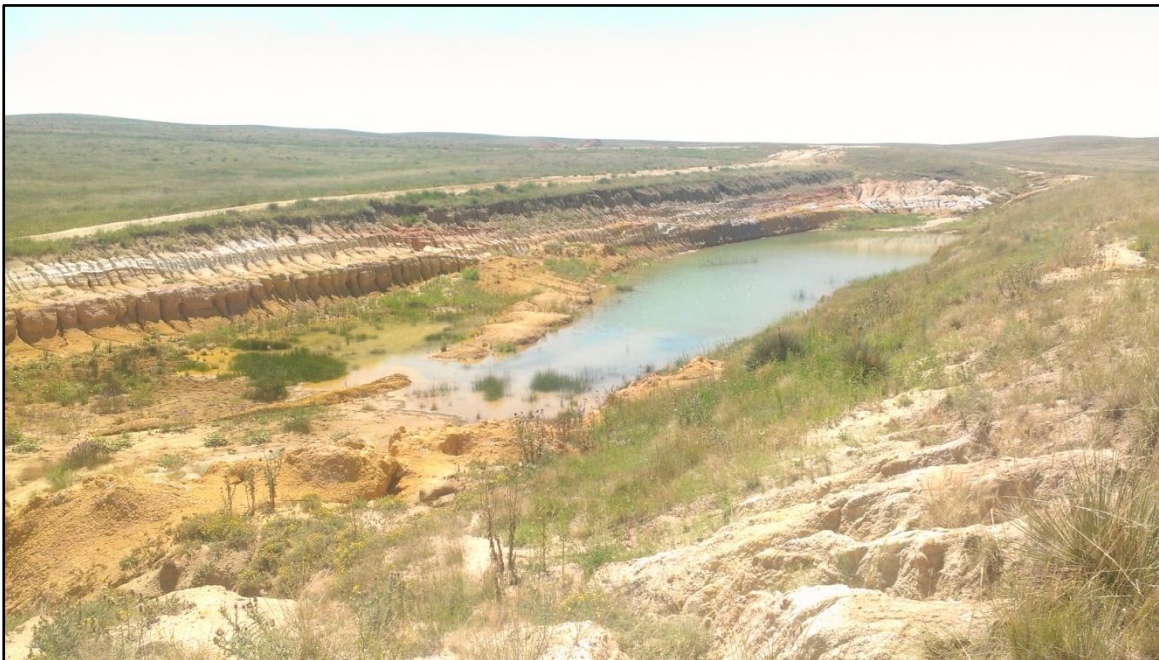
Currently, this operation has disturbed approximately 16 acres. The disturbed area includes an access road that is approximately 0.35 mile long, a rectangular-shaped excavation area (Photo 2), a stockpile pad area constructed out of overburden (located just southeast of the excavation; Photo 3), a haul road approximately 500 feet long that connects the pad area to the excavation area, and a stormwater impoundment pond with a water surface area of approximately 0.2 acres (located southwest of the pad area; Photo 4). Overburden and topsoil stockpiles are stored along the western and northern edges of the excavation and along the eastern and southern edges of the pad area. These stockpiles appeared to be stable with vegetative cover. Two small product stockpiles are stored in the northeastern portion of the pad area (Photo 5).

Photo 2. View looking southeast at excavated pit located in northwestern portion of permit area.

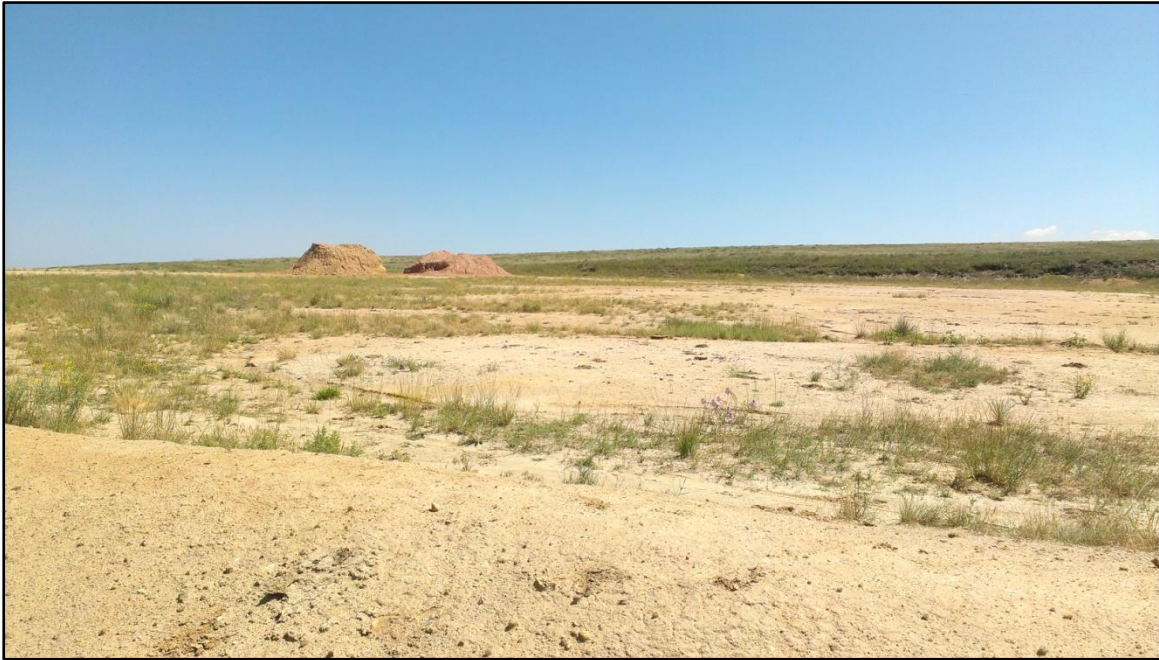
Photo 3. View looking northeast across stockpile pad area located in southern portion of permit area. Note presence of two small product stockpiles.

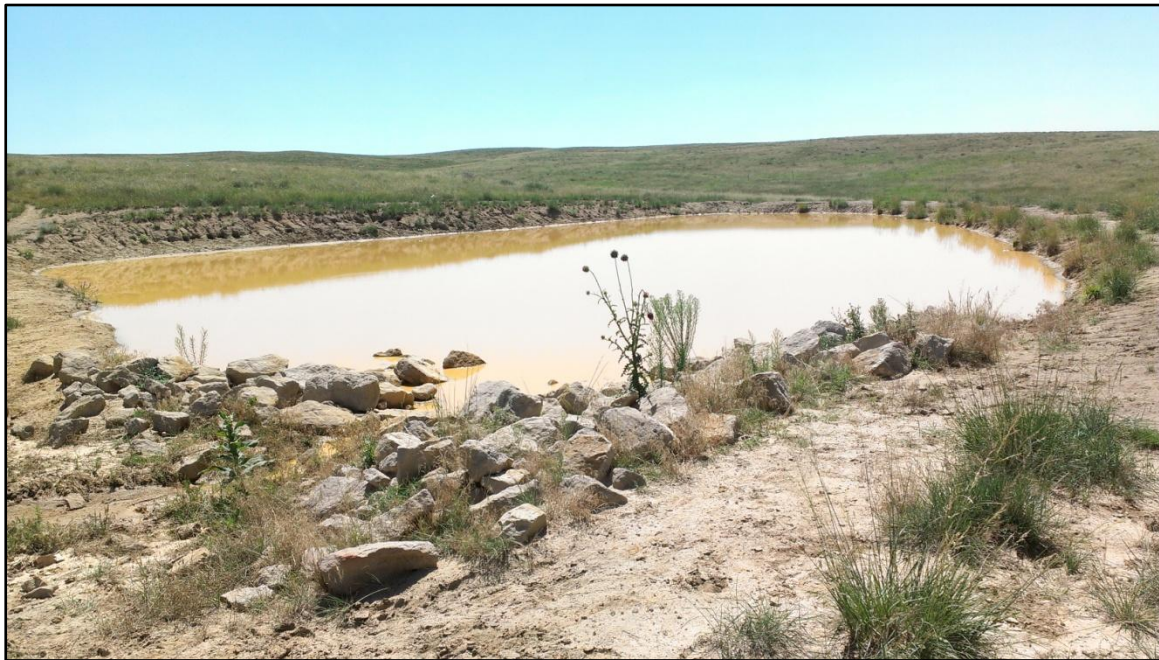
The stormwater impoundment pond (see Photo 4) located south of the pad area appeared to be functioning properly. According to the inspection report from June 17, 2009, the impoundment was constructed to handle a 10-year rain event. Around that time, the riprap inlet had been reconstructed and a rubber liner was placed under the riprap to help control erosion. During the recent inspection, there was no rubber liner under the riprap, but there did not appear to be any problems with erosion of the inlet. However, the riprap does need some repair as a portion of it has

washed out into the pond (see Photo 4).

Photo 4. View looking southeast at stormwater impoundment pond located southwest of stockpile pad area. Note inlet riprap (at bottom left) needs some repair.

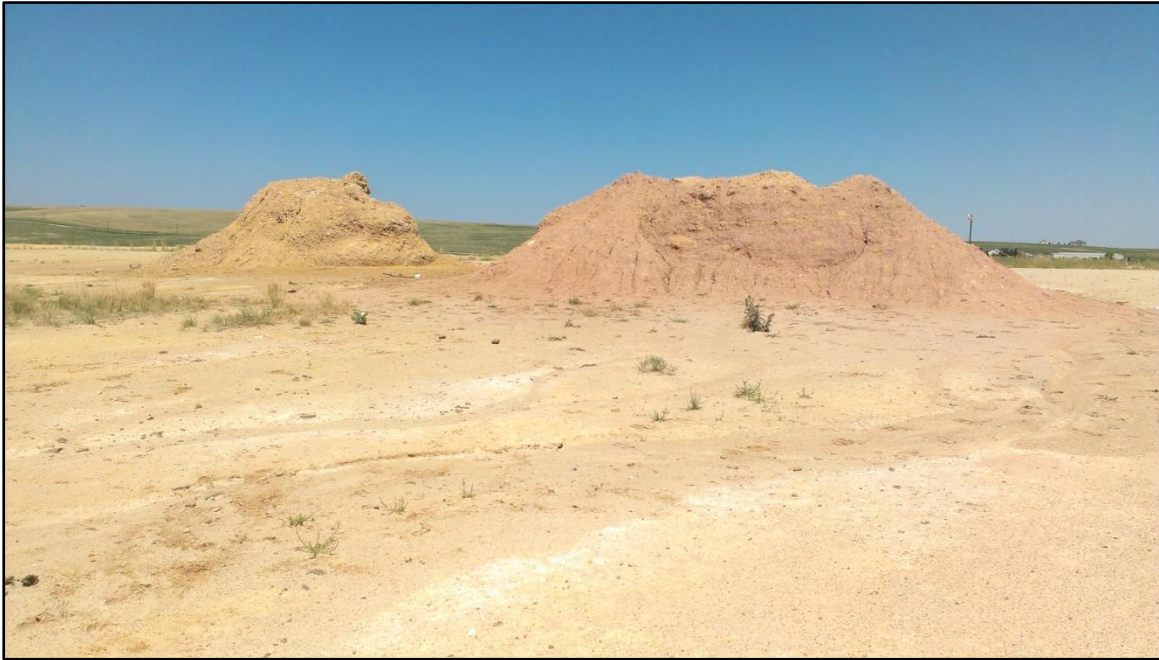
Photo 5. View of two material stockpiles stored in northeastern corner of stockpile pad area.

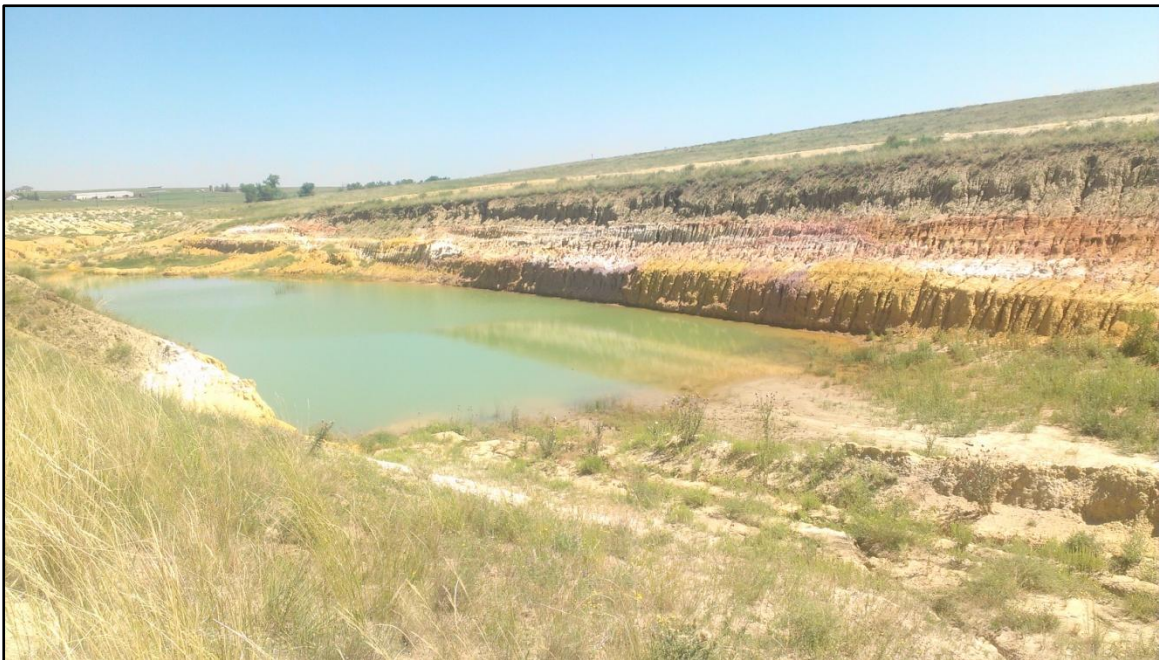
The excavated pit is approximately 30-45 feet deep. The highwall slope gradients are 1H:1V to 2H:1V. The pit was retaining water during the inspection (Photo 6; also see Photo 2). The retained water has a surface area of approximately 0.4 acre, with a depth of approximately 10-15 feet. The Operator submitted a letter to the Division on May 31, 2006 stating they determined a likely groundwater component to the retained water in the pit as a result of seepage from the Lower Dawson aquifer. It appears that the Operator has a valid well permit (Division of Water Resources Well Permit No. 65324-F) and water rights (Colorado Ground Water Commission Determination No. 1029-BD) to account for the exposed groundwater in the pit.

Photo 6. View looking northeast at excavated pit that is retaining water.

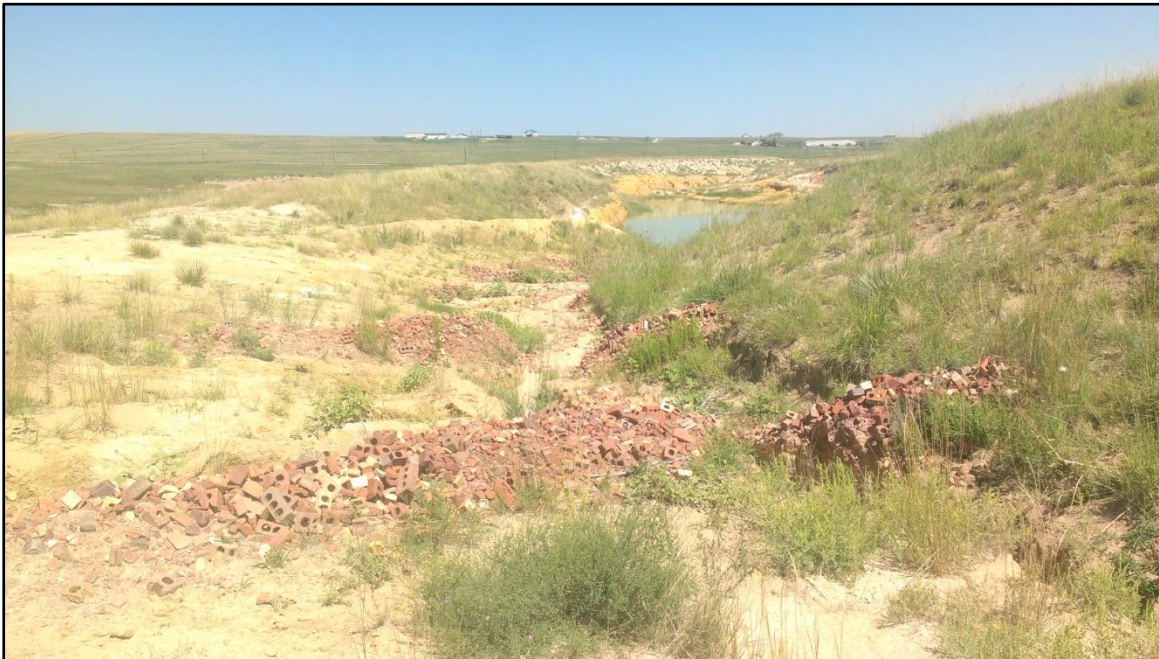
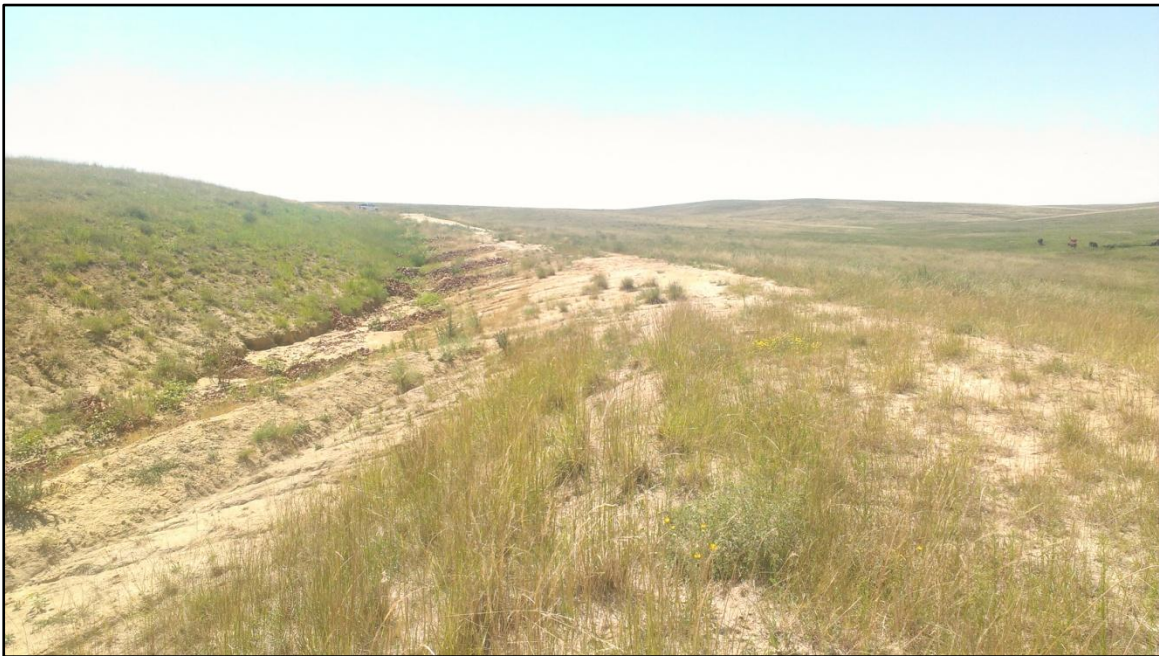
The Operator has constructed a series of check dams (composed of scrap brick) along the drainage south of the excavation (Photos 7 and 8) to help reduce erosion. This drainage appears to receive a significant amount of stormwater runoff which flows toward the excavated pit. Overall, the structures appear to be effectively reducing erosion of this drainage area. However, many of the structures will need some minor repairs where stormwater flow has washed out their centers.

Photo 7. View looking north down drainage south of excavated pit, showing a series of check dams constructed with scrap brick.

Photo 8. View looking south up drainage with check dams.
