COLORADO DIVISION OF RECLAMATION, MINING AND SAFETY
MINERALS PROGRAM INSPECTION REPORT
PHONE: (303) 866-3567

MINE NAME: Buffalo No 1	MINE/PROSPECTING ID#: M-1978-011	MINERAL: Clay (general)	COUNTY: Elbert
INSPECTION TYPE: Monitoring	INSPECTOR(S): Amy Eschberger	INSP. DATE: August 12, 2014	INSP. TIME: 13:15
OPERATOR: General Shale Brick, Inc.	OPERATOR REPRESENTATIVE: Jason McGraw	TYPE OF OPERATION: 112c - Construction Regular Operation

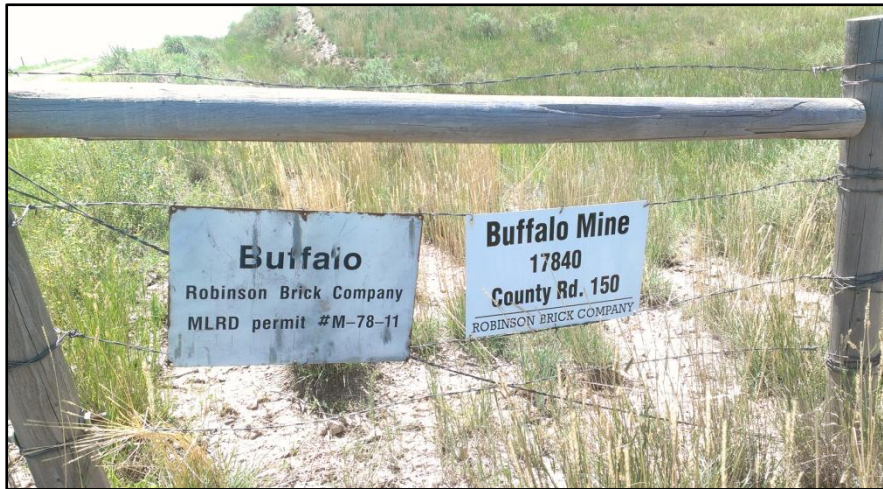
During the inspection, it was warm and sunny, and the ground was dry. A permit sign was posted at the gated entrance to the site off of Co Rd 150 (Photo 1). However, the sign should have the current Operator's name (Not Robinson Brick Company), and "MLRD" should be corrected to "MLRB" for Mined Land Reclamation Board. The permit boundary was delineated by fencelines. No mining activities were occurring during the inspection. A small wheeled dozer was stored on site (Photo 2). Mr. McGraw indicated that no mining has occurred at this site since 2006; however, stockpiled material is hauled off site every year. According to Division records, this is not an intermittent operation. As discussed with Mr. McGraw during the inspection, if mining activities (e.g., excavating, processing, hauling) occur at the site for less than 180 days per year, the Operator is required to apply for Intermittent Status per C.R.S. 34-32.5-103(11)(b). If mining activities do not occur every year at the site, the Operator is required to file for Temporary Cessation per C.R.S. 34-32.5-103(11)(b) and Rule 1.13.5(1-2).

Photo 1. View of permit sign posted at entrance to site off of Co Rd 150.

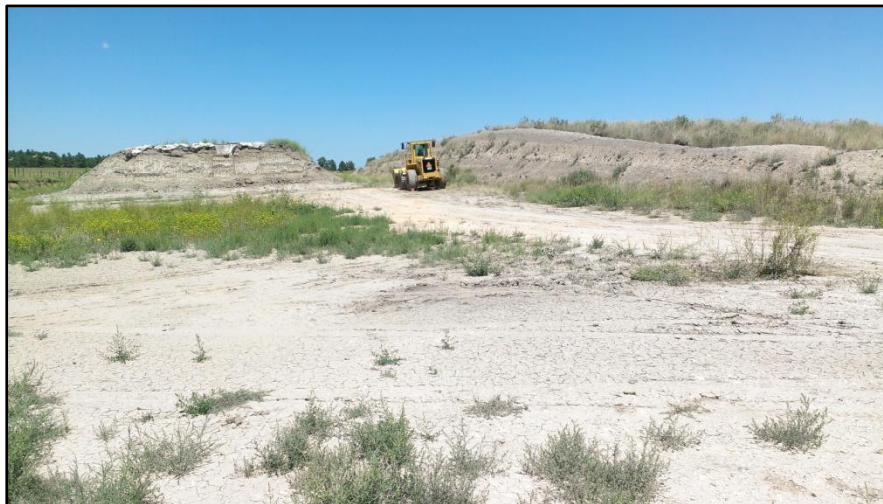
Photo 2. View looking north at stockpile pad area where wheeled dozer is stored.

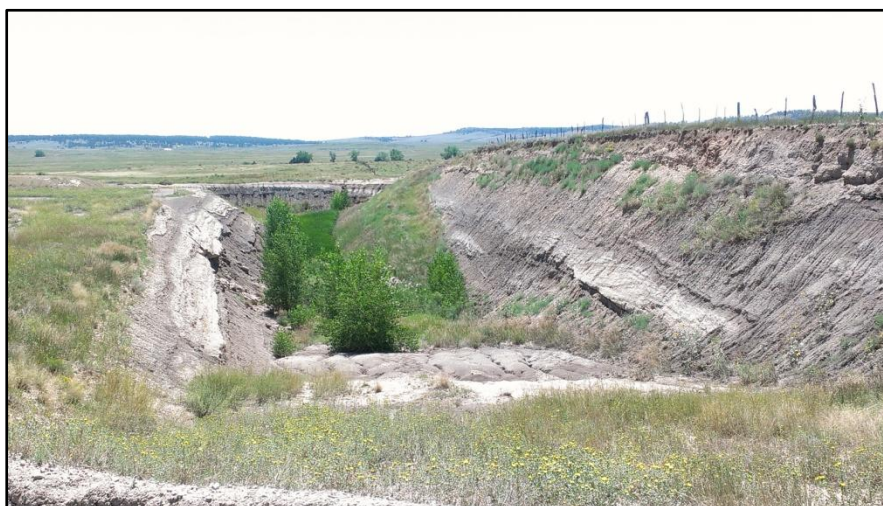
Current disturbance in the Phase III area is approximately 8.9 acres, and includes an excavated pit (in the southwestern portion; Photo 3), a stockpile pad area with a product stockpile (in the northern portion; Photo 4), and a stockpile of topsoil/overburden (in the southern portion). The short access road located north of the site which was previously used by the operation appears to no longer be in use. The road currently used for pit access runs along the northeastern permit boundary (Photo 5), and appears to be shared by a residence located east of the pit. According to historical imagery shown in Google Earth, the access road was moved to its current location in 2006. **Because the current access road is not included in the approved permit files for this site, a Problem will be cited in this report and corrective actions will be required (see page 1).** The Operator shall submit a Technical Revision to update the Mining Plan and Mining Plan Map for this site (Phase III). In addition, the Operator shall provide the Division with a signed lease agreement from the owner of the residence, stating the Operator is allowed to use the private road for mine access, and whether or not the road is to be reclaimed. The approved reclamation plan for this site states the haul road will be reclaimed. However, much of the currently used haul road is located outside of the permit area. If the road is to be reclaimed, it will need to be added to the permit area through the submittal of an Amendment. If the road will not be reclaimed, then including it in the updated Mining Plan and Mining Plan Map will be sufficient.

Photo 3. View looking south at excavated pit located in southwestern portion of site.

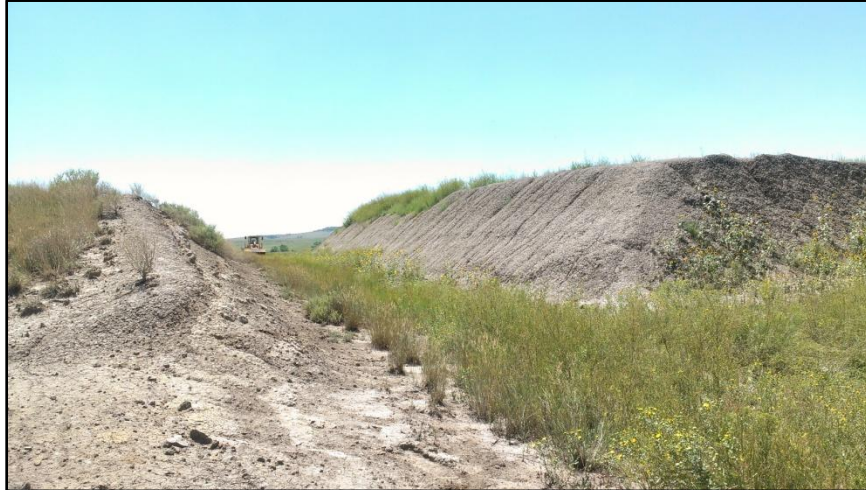
Photo 4. View looking south at stockpile pad area, showing material stockpile (at right).

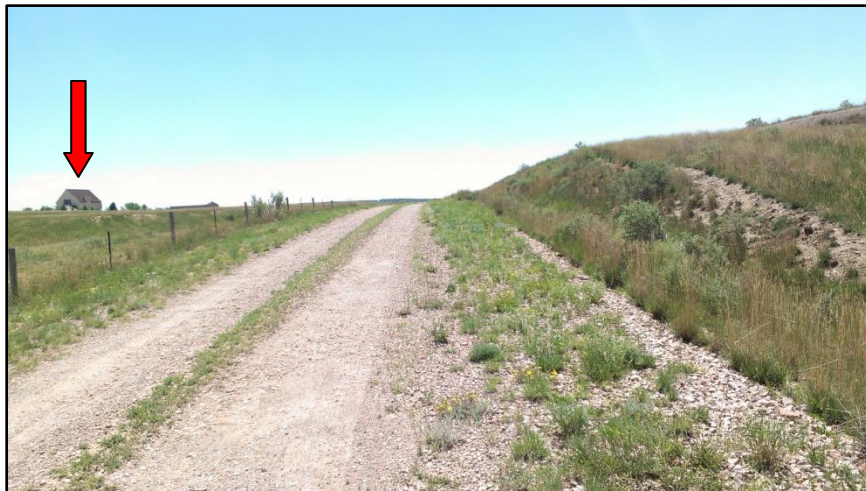
Photo 5. View of mine access road located on eastern edge of site. The road is also used as residential access by adjacent homeowner (indicated).

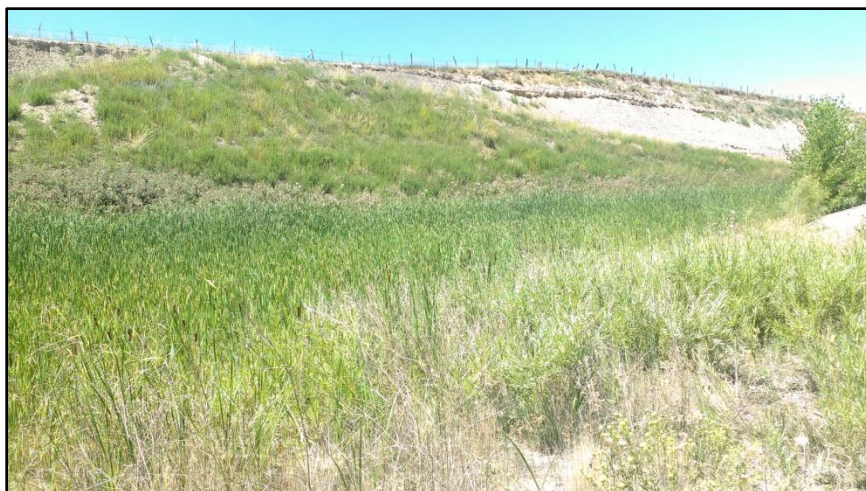
The excavated pit is 30-45 feet deep with highwall slope gradients of 1H:1V to 2H:1V. No standing water was observed in the pit during the inspection. However, wetland vegetation has established on the pit floor (Photo 6), indicating the pit floor is inundated to a depth and a period long enough for emergent wetland vegetation to persist. C.R.S. 34-32.5-116(4)(h) requires the Operator to minimize disturbances to the prevailing hydrologic balance of the affected land and of the surrounding area. In addition, Rule 3.1.6(1)(a) requires the Operator to be in compliance with applicable Colorado water laws and regulations governing injury to existing water rights. Therefore, the Division recommends the Operator backfill the pit and/or implement the water management plan for this site to divert surface runoff around the pit. Otherwise, the Operator will need to demonstrate that the operation is in compliance with the Office of the State Engineer (SEO). Mr. McGraw indicated during the inspection that mining of this portion of the permit area is complete, and the pit will be backfilled in the near future. The Division will follow up on this issue in the next inspection.

Photo 6. View showing wetland vegetation established on pit floor.
