M-1998-080

RESPONSE TO DRMS BOND
ESTIMATE

SUBJECT: M1998-080 H&H Quarry #2

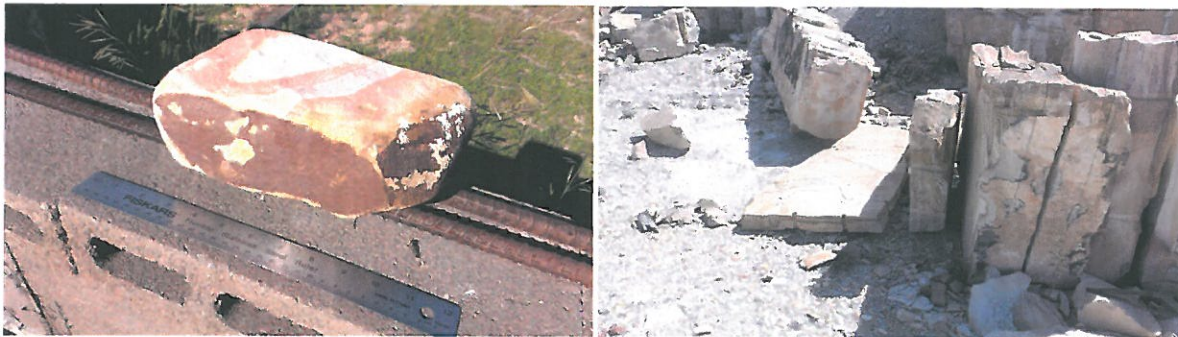
Photos 1 and 2. Sandstone "loaf" and sandstone drilled and split prior to further shaping and shipping from site.

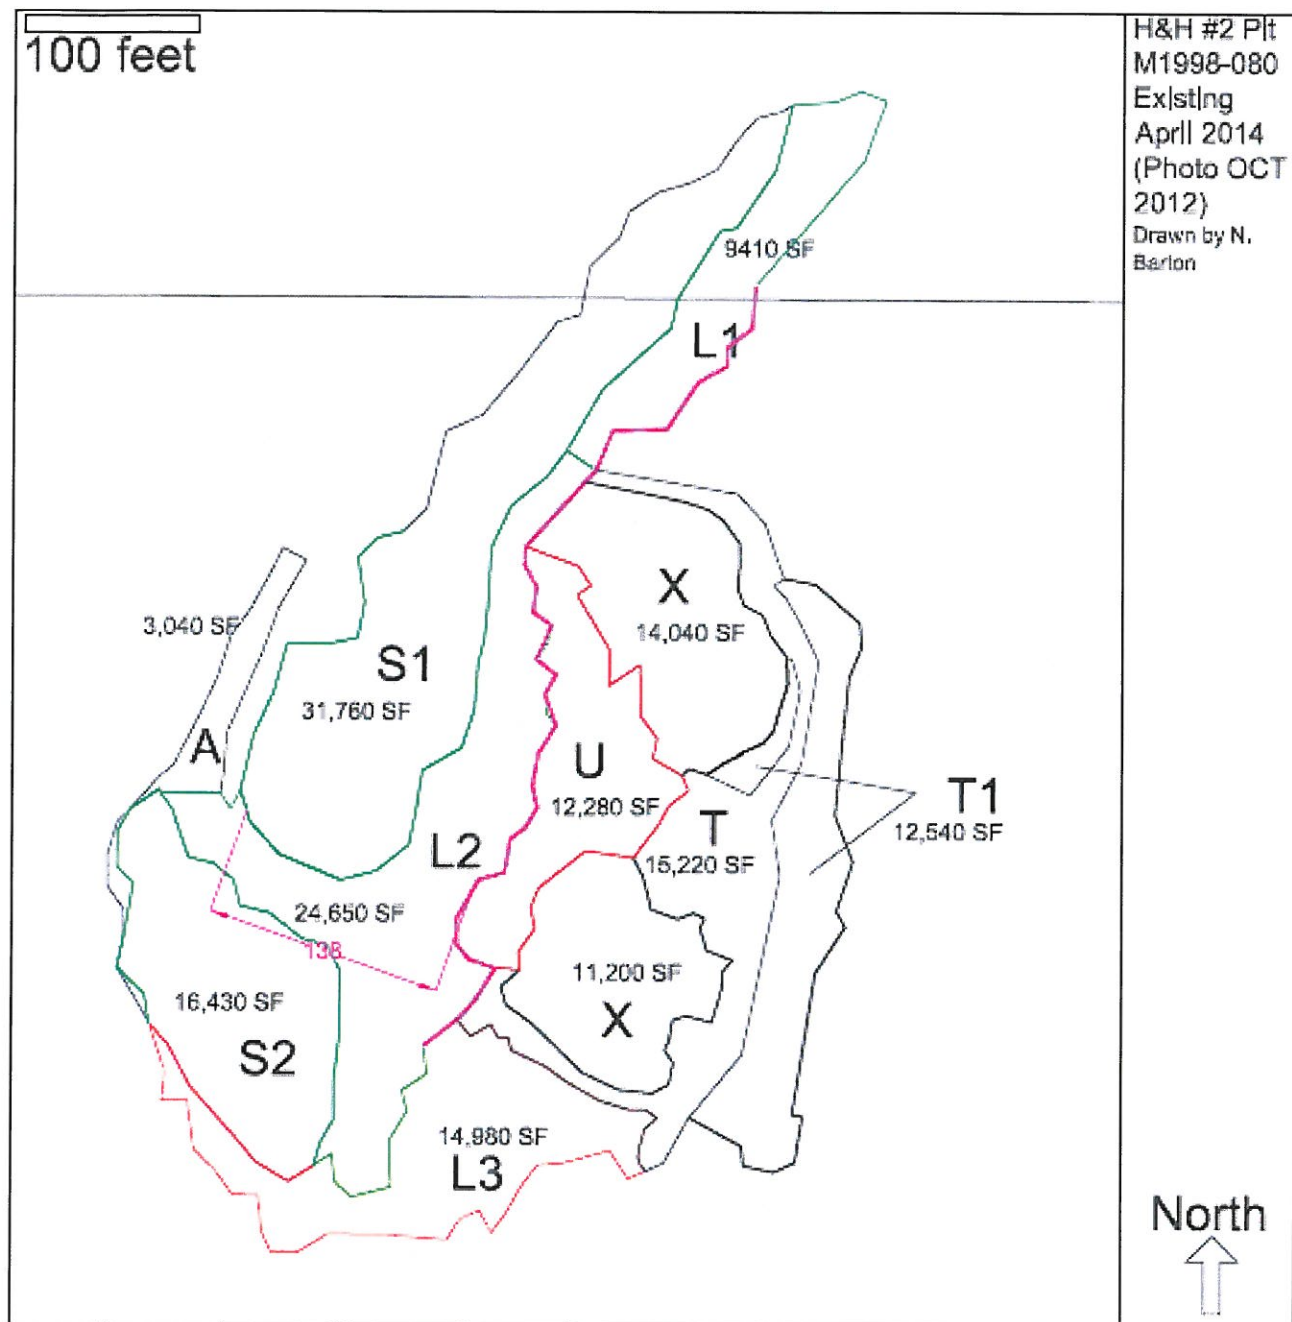
Map 2. Map showing affected areas (labeled, see Table 1) as of April 2014.

Total affected acreage is estimated at 3.22 acres, including the access road. There are two areas (X, each about 0.3 acres) of undisturbed areas on the upper level surrounded by affected land.

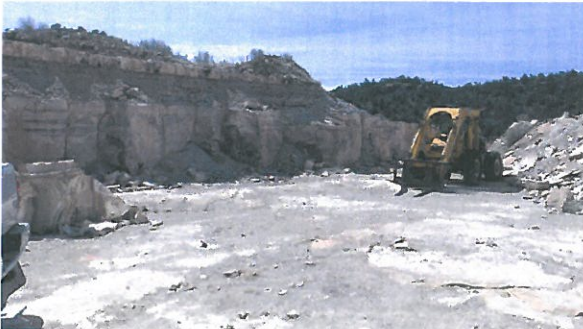
The highwall is estimated to be 580 feet in length (cyan line on Map 2), and consists of the exposed sandstone, mostly in large (8 ft to 20 ft high, up to 20 feet wide, 10 feet or more deep), which are very stable. Some areas are significantly fractured but still stable. Although the original application indicated there was some overburden (and may refer to the darker band of shaly sandstone between the caprock

and thicker formation), only residual soil in fractures appears to be present, except in a single area which appears to be the remnants of a ravine, near the center of the highwall.

Photo 3. Highwall in main quarry area showing coherent sandstone blocks, shale layer, and upper sandstone capstone. Material stockpile to right. Bedrock floor.

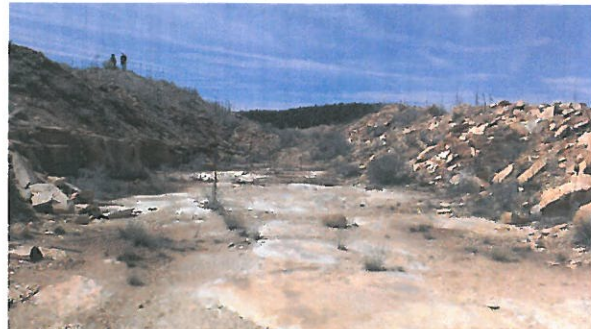
Photo 4. Highwall and natural undisturbed upper slope in northern part of quarry. Material stockpile on right. Bedrock floor. Figures in distance are about 5-8.

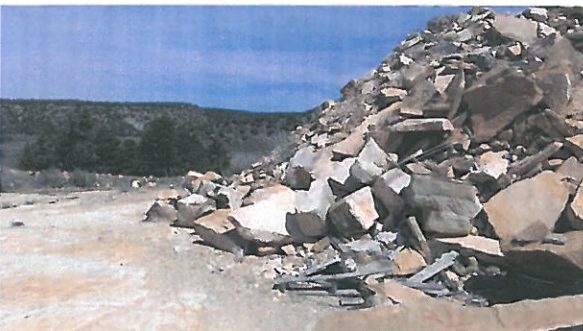
Photo 5. Material stockpile near entry. Height about 20 feet at this point. Note size of sandstone fragments.

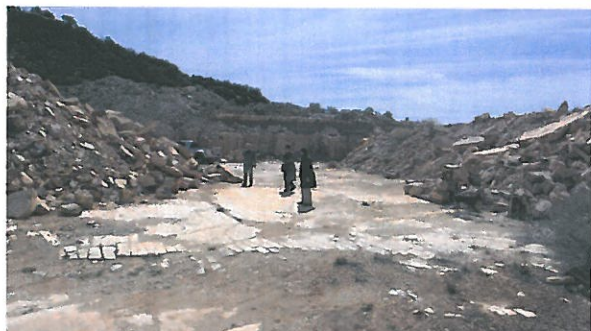
Photo 6. North and south stockpiles near entry, with highwall behind. Right (south) stockpile 8-10 feet high at this point. Note bedrock floor of pit.

The lower level is close to equally divided between two areas: 1.1 acres of "pit floor" (L1, L2) which is bedrock at the base of the sandstone being mined, and another 1.1 acres of materials stockpiles (S1, S2), consisting of sandstone boulders, rubble, and smaller fragments. There does not appear to be more than approximately 6000 CY (already loose) of sandstone in the two stockpiles on the lower level², in pieces ranging in size from sand/gravel to boulders of 6 feet and more. However, to create a level bench that is capable of sustaining any vegetation, approximately 50% of that would need to be left in place, since the total area of the two stockpiles is about 48,000 SF and the lower floor to be covered is only about 34,000 SF (a total of 82,000 SF (9000 SY). Therefore, there is only enough material to cover the lower level with 2-4 feet depth of material fractured enough to serve as bedding zone material, on which the 4 inches of available topsoil can be placed on approximately 65% of the surface. However, this should be adequate, so that no ripping of the pit floor bedrock is needed. This would also allow the bench height to be nearer the 10 foot height as per the reclamation plan. Although the dark shaly sandstone layer may be more erodable than the more pure sandstone above and below, the caprock protects it from erosion.

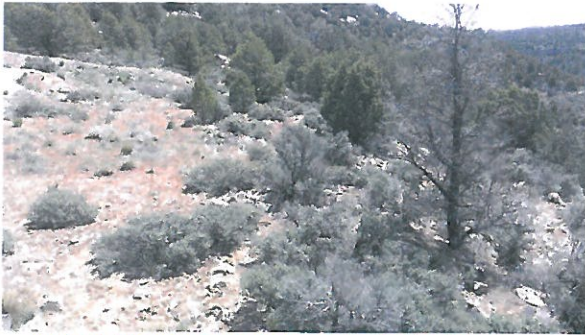
The upper level is divided into soil stockpiles and areas (T) where vegetation has been beaten down by equipment parking and traffic but original soil is present, and areas which have been disturbed (T1) but in which vegetation has reestablished itself or remains despite some activities.

Photo 7. Edge of upper area showing both original and post-disturbance vegetation.

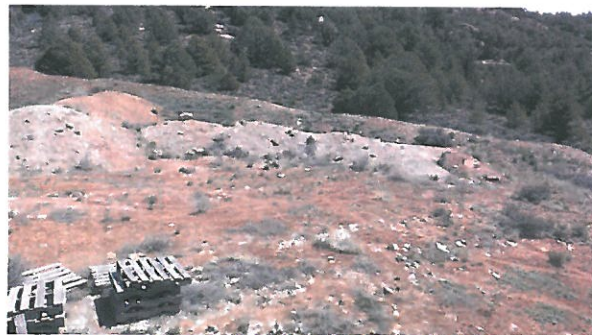
Photo 8. Soil stockpiles and disturbed area, on upper level (and edge of area where caprock is put on pallets).
