**COLORADO DIVISION OF RECLAMATION, MINING AND SAFETY**  
**MINERALS PROGRAM INSPECTION REPORT**  
**PHONE: (303) 866-3567**

| <b>MINE NAME:</b><br>City of Las Animas Sand Excavation Area | <b>MINE/PROSPECTING ID#:</b><br>M-2012-008 | <b>MINERAL:</b><br>Sand | <b>COUNTY:</b><br>Bent |
| <b>INSPECTION TYPE:</b><br>Monitoring | <b>INSPECTOR(S):</b><br>Amy Eschberger | <b>INSP. DATE:</b><br>August 13, 2014 | <b>INSP. TIME:</b><br>14:00 |

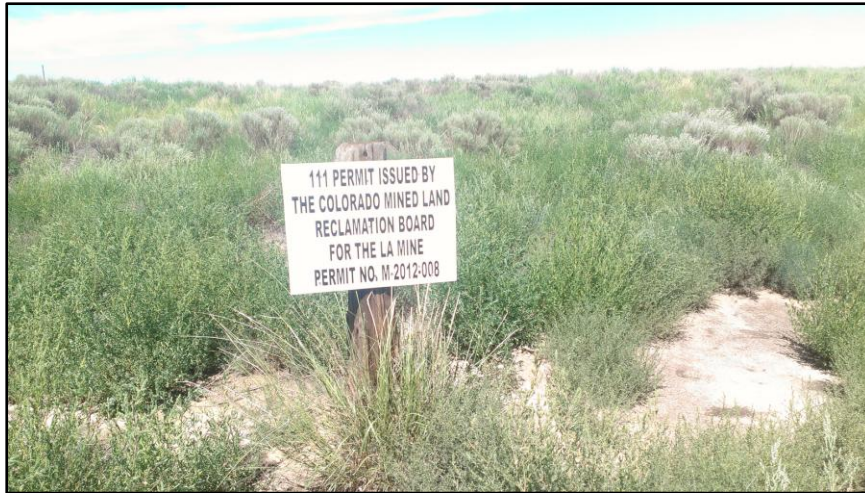
At the time of the inspection, the weather was warm and sunny, and the ground was dry. A permit sign was posted at the entrance to the site (Photo 1). The affected area was clearly marked by metal posts (Photo 2). No mining activities were occurring during the inspection and no equipment was present on site. The approximate 1.7 acres of disturbance includes an open sand pit with mined walls along the northern (Photo 3) and western (Photo 4) edges, a mined material stockpile in the western portion of the pit (see Photo 3), and a topsoil stockpile stored at the southwestern corner of the pit (Photo 5).

**Photo 1.** View of permit sign posted at entrance to site.

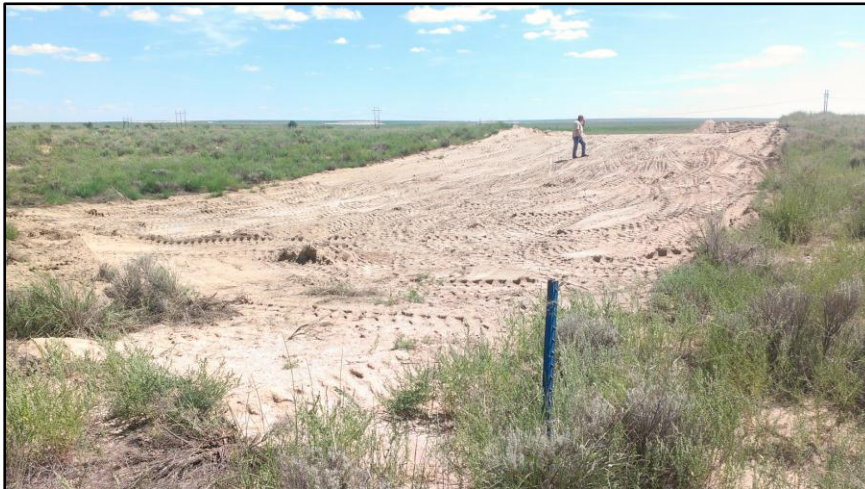
**Photo 2.** View of metal post marking northwest corner of affected area.

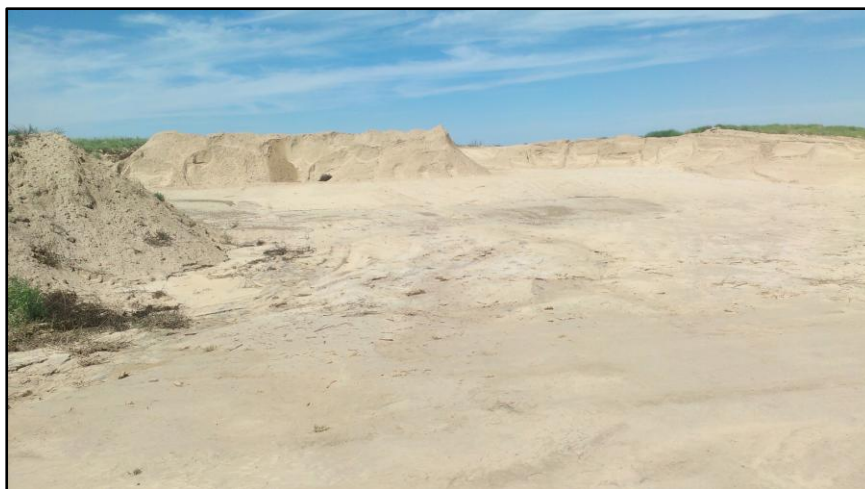
The mined wall that runs along the northern edge of the pit is 5-10 feet in height, and daylights to the south (see Photo 3). The mined wall that runs along the western edge of the pit is up to 5 feet in height and daylights to the east (see Photo 4). The Operator should be careful not to disturb much more land going westward, as the western extent of disturbance is currently within 30 feet of the required setback from the county road. All stockpiles appeared to be stable. Vegetation consisting mainly of annual weeds has volunteered across the topsoil stockpile.

**Photo 3.** View looking north into pit, showing mined wall that daylights to the south, material stockpile, and portion of topsoil stockpile (at left).

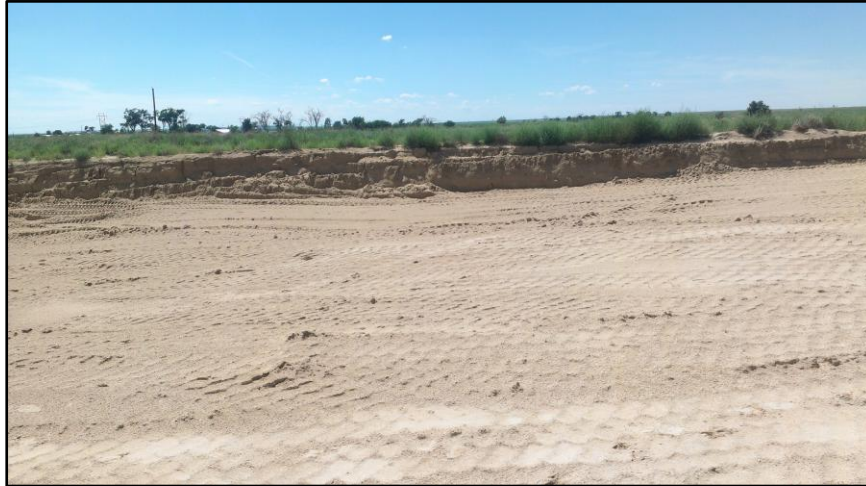
**Photo 4.** View looking west at mined wall of pit that daylights to the east.

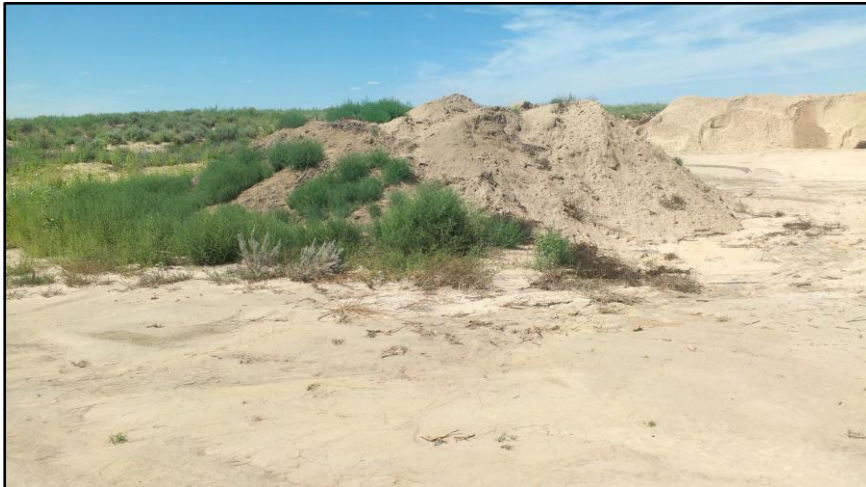
**Photo 5.** View of topsoil stockpile located at southwestern corner of pit

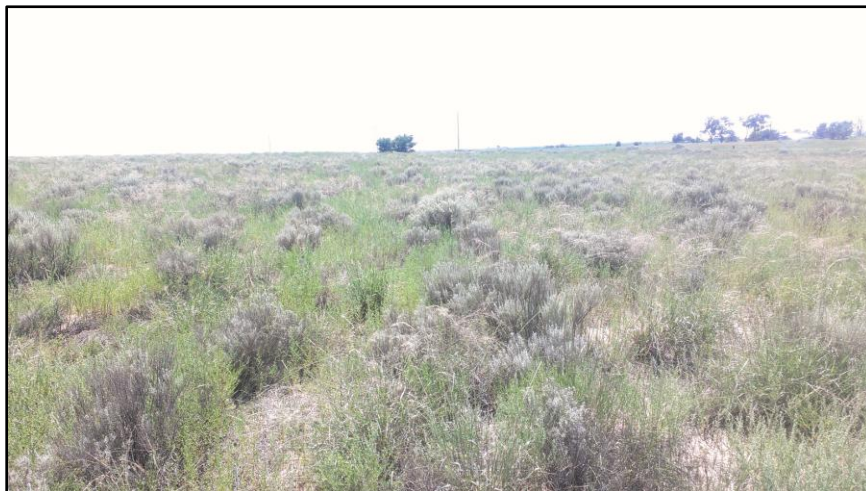
No vegetation is present on the pit floor. Vegetation in the undisturbed portions of the permit area (Photo 6) consists of native grasses and forbs, sagebrush, and annual weeds (mostly Russian thistle). Some wild sunflowers are present in disturbed areas around the edges of the pit. No problems were observed at this site with the growth of state-listed noxious weeds.

**Photo 6.** View looking southwest from northwestern corner of disturbed area, showing native vegetation present in undisturbed portions of permit area.
