COLORADO DIVISION OF RECLAMATION, MINING AND SAFETY MINERALS PROGRAM INSPECTION REPORT

MINE NAME:	MINE/PROSPECTING ID#:	MINERAL:	COUNTY:
San Luis Project	M-1988-112	Au, Ag	Costilla
INSPECTION TYPE:	INSPECTOR(S):	INSP. DATE:	INSP. TIME:
Multi Person Inspection	Wallace H. Erickson, G. Russell Means	July 24, 2014	13:00
OPERATOR:	OPERATOR REPRESENTATIVE:	TYPE OF OPERATION:	
Battle Mountain Resources, Inc.	Julio Madrid, Steve Carino	112d-3 - Designated Mining Operation	
REASON FOR INSPECTION:	BOND CALCULATION TYPE:	BOND AMOUNT:	
Normal I&E Program	Partial Bond	\$7,400,000.00	
DATE OF COMPLAINT:	POST INSP. CONTACTS:	JOINT INSP. AGEN	CY:
NA	None	None	
WEATHER:	INSPECTOR'S SIGNATURE:	SIGNATURE DATE:	
Cloudy	Wallace H. Sil	October 17, 2014

PERMIT #: M-1988-112 INSPECTOR'S INITIALS: WHE INSPECTION DATE: July 24, 2014

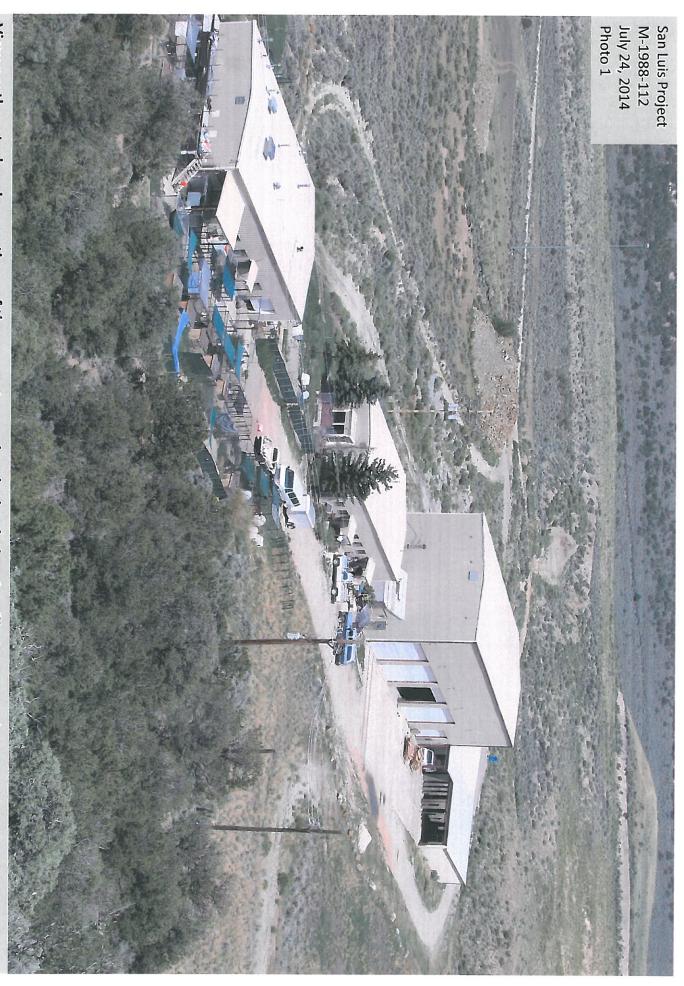
Valley Animal Welfare Society. On-site discussions included potential release of the property from the permit area. View northeast, showing portions of the property previously deeded to Costilla County and currently owned by San Luis

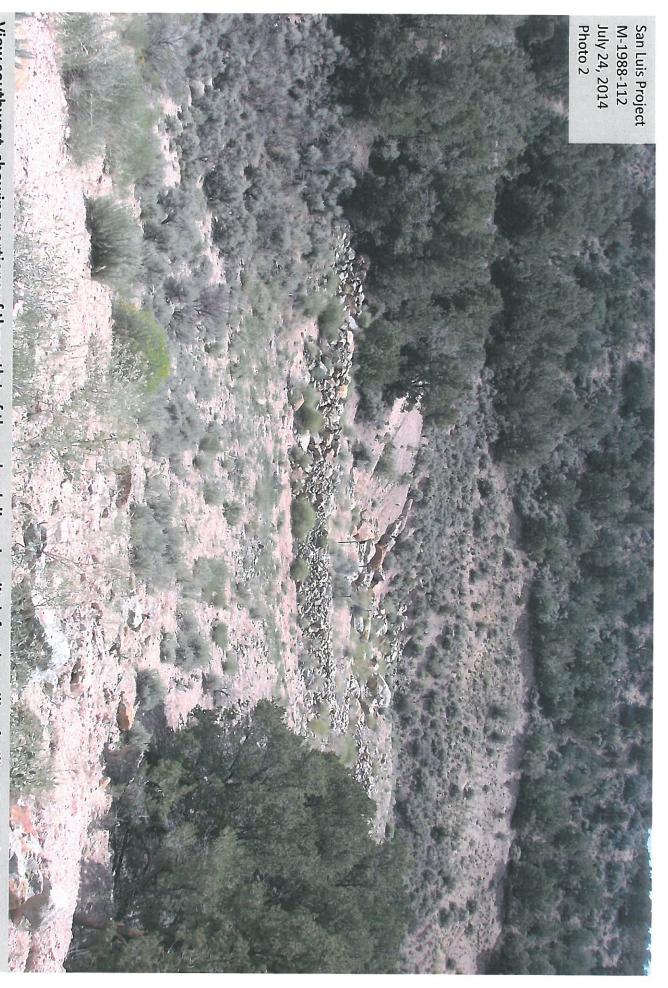
As shown in Photo 2, the outlet of the upland diversion ditch for the tailing repository appeared stable; evidence of slumping, sliding or excessive erosion was not observed.

of riprap and rock check dams. The channel appeared stable; evidence of excessive erosion was not observed. riprap and rock check dams were intact. Vegetative cover was establishing for areas recently disturbed by the placement View southwest, showing portions of the outlet of the upland diversion ditch for the tailing facility. Recently placed

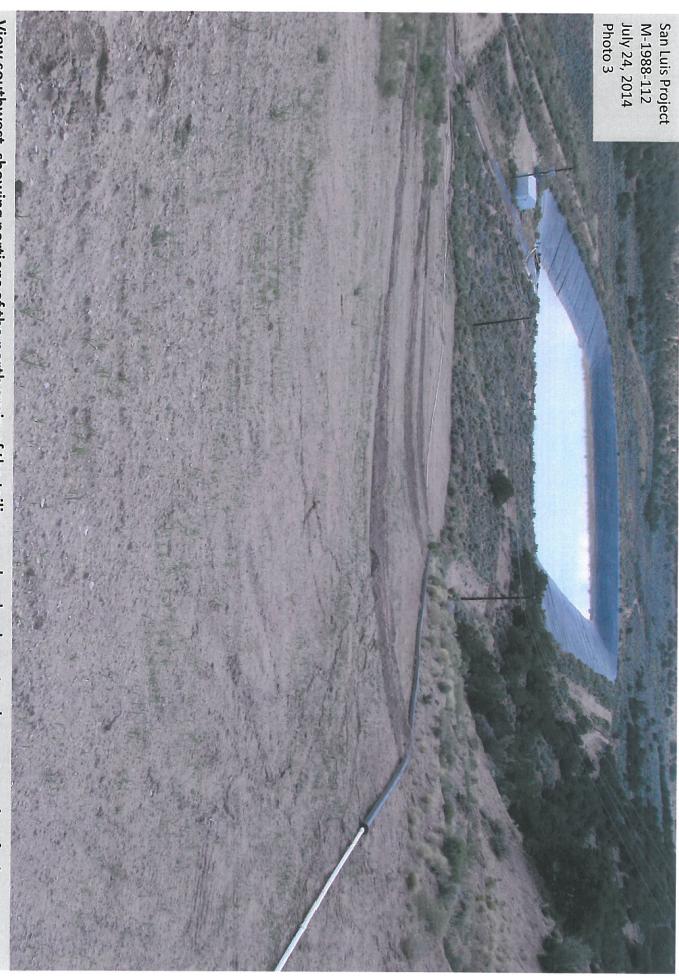
As shown in Photo 3, the Operator had completed recent repairs to minor erosion at the north groin for the tailing pond embankment. The Division recommends the Operator submit a Technical Revision for Division review and approval, updating erosion control methods for the tailing pond embankment.

erosion. On-site discussion included erosion control methods in addition to the construction of contour berms/ditches. View southwest, showing portions of the north groin of the tailing pond embankment and recent repairs of minor
