**COLORADO DIVISION OF RECLAMATION, MINING AND SAFETY**  
**MINERALS PROGRAM INSPECTION REPORT**  
**PHONE: (303) 866-3567**

| <b>MINE NAME:</b><br>Well Field Pit | <b>MINE/PROSPECTING ID#:</b><br>M-1984-154 | <b>MINERAL:</b><br>Sand and gravel | <b>COUNTY:</b><br>Prowers |
| <b>INSPECTION TYPE:</b><br>Monitoring | <b>INSPECTOR(S):</b><br>Amy Eschberger | <b>INSP. DATE:</b><br>August 14, 2014 | <b>INSP. TIME:</b><br>09:30 |
| <b>OPERATOR:</b><br>City of Lamar | <b>OPERATOR REPRESENTATIVE:</b><br>John Sutherland and Patrick Mason | <b>TYPE OF OPERATION:</b><br>110c - Construction Limited Impact | |

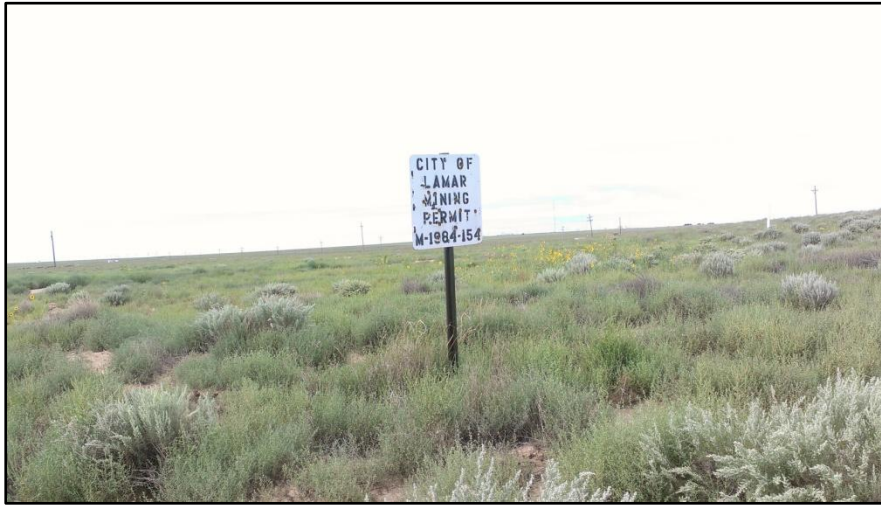
At the time of the inspection, the weather was warm and breezy, and the ground was dry. A permit sign was posted at the entrance to the site (Photo 1). The permit boundary corners were marked by large white posts (Photo 2). The mined pit was holding water during the inspection (Photos 3 and 4). According to documents provided by the Operator during the 10/25/2007 inspection, the City of Lamar operates its wells pursuant to a "Post 85 Rule 14 Plan" annually approved by the State Engineer. This plan envelops the plan for augmentation decreed in Case No. W-4015 and other augmentation sources. Therefore, it appears that this site is in compliance with regard to the retained water.

**Photo 1.** View of permit sign posted at site entrance.

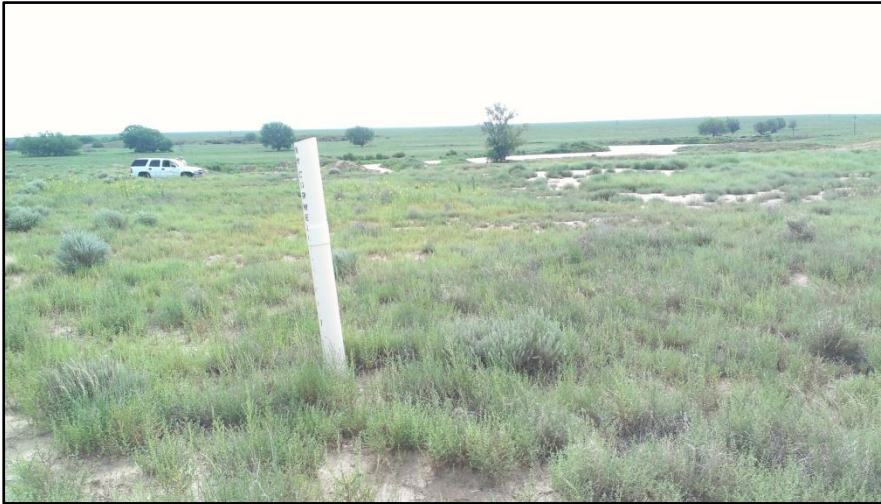
**Photo 2.** View of white post marking northwestern corner of permit boundary.

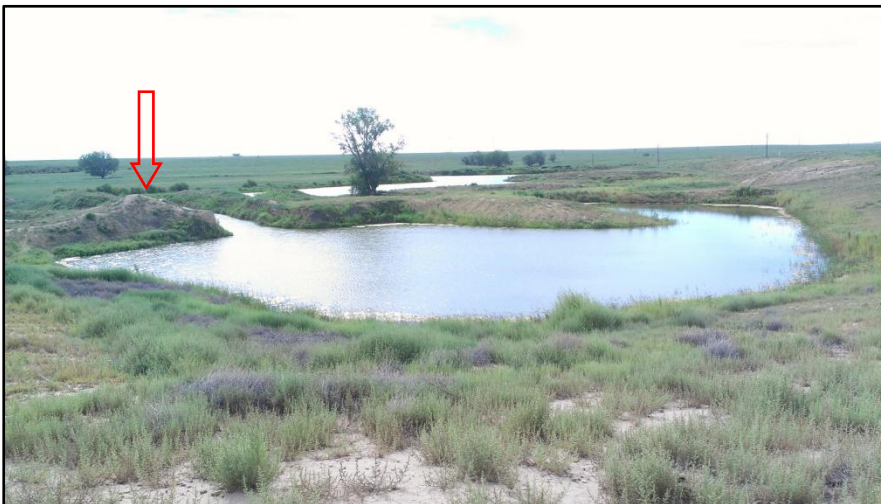
During the recent inspection, no material stockpiles were present in the permit area. All mined slopes have been graded to 3H:1V or flatter (Photos 5 and 6), except for one knob that protrudes into the recharge pond from the northern (south-facing) bank (see Photo 3). The Operator will need to level off this portion of the pond bank and seed it with the approved seed mixture. The topsoil stockpile that was present in the northwest corner of the permit area in previous inspections has been used up in reclamation of the site.

**Photo 3.** View looking southeast from northwestern portion of permit area, showing water present in recharge pond. Note knob (indicated) that will need to be graded to 3H:1V.

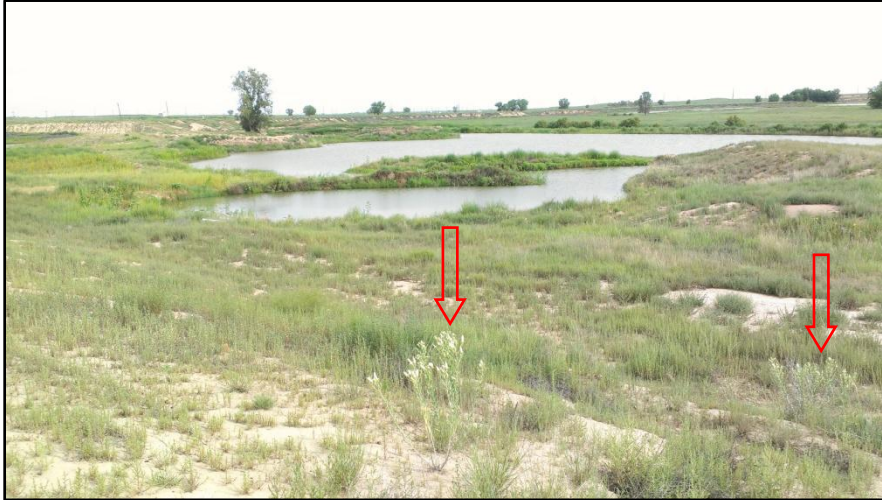
Vegetation has volunteered throughout the permit area, and consists of native grasses and forbs, annual weeds (mainly Russian thistle), sand sagebrush, wild sunflowers, a cottonwood tree (located near the center of the permit area), and a small population of Diffuse knapweed (see Photo 4). Diffuse knapweed is a state-listed noxious weed species and should be closely monitored and controlled in disturbed areas. The pond banks are vegetated primarily with Russian thistle (see Photos 5 and 6). The Division recommends the Operator implement the approved weed management plan for this site, and reseed the mined slopes with the approved seed mixture. These slopes will need to be reclaimed in accordance with the approved post-mining land use of rangeland before the site is releasable. No problems with erosion were observed during the inspection.

**Photo 4.** View looking northeast from southwestern portion of permit area, showing water present in recharge pond. Note small population of Diffuse knapweed (indicated).

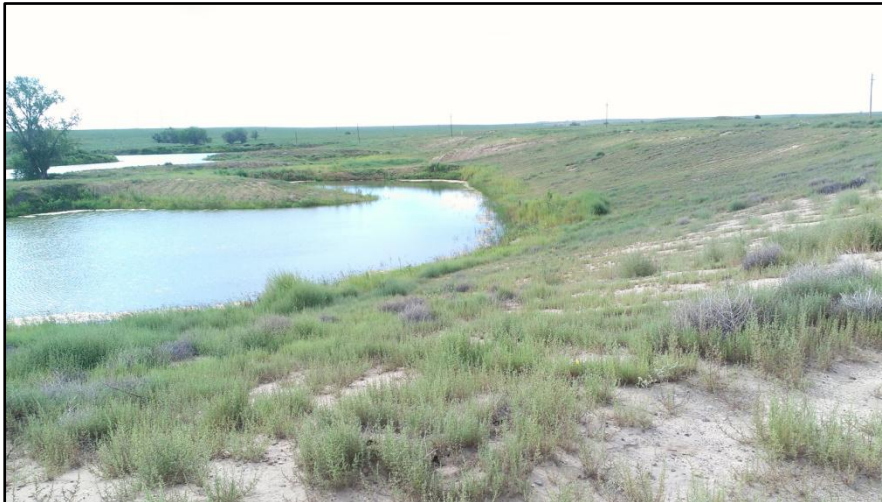
**Photo 5.** View looking south from northwestern portion of permit area, showing mined slope gradients of 3H:1V or flatter.

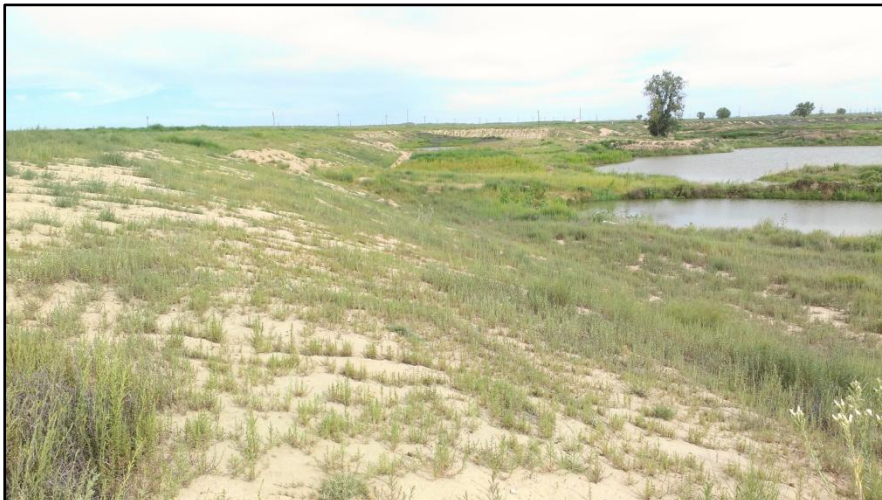
**Photo 6.** View looking north from southwestern portion of permit area, showing mined slope gradients of 3H:1V or flatter.
