COLORADO DIVISION OF RECLAMATION, MINING AND SAFETY MINERALS PROGRAM INSPECTION REPORT

MINE NAME:	MINE/PROSPECTING ID#:	MINERAL:	COUNTY:
Revenue Mine	P-2013-006	Ag, Au, Pb, Cu, Zn	Ouray
INSPECTION TYPE:	INSPECTOR(S):	INSP. DATE:	INSP. TIME:
Mineral Prospect Inspection	Bob Oswald	October 3, 2014	14:30
OPERATOR:	OPERATOR REPRESENTATIVE:	TYPE OF OPERATION:	
Star Mine Operations	None	MP - Mineral Prospecting

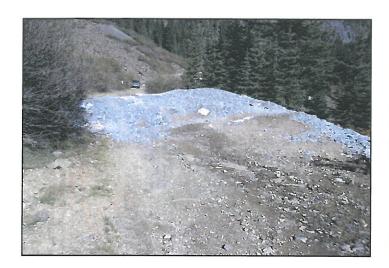
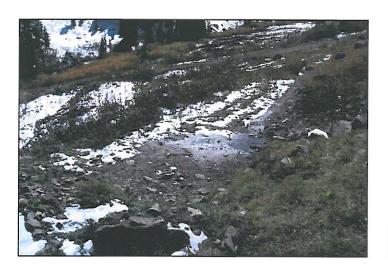
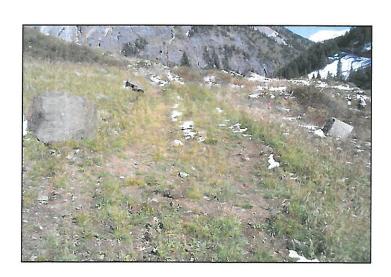
The drill sites along the access road to the Lower Mountain Top Mine (lower Governor Basin area) were inspected. The three sites indicated on the operator's release request (revision SL-01) map were located. These sites exhibited no open drill holes and clean up was complete. The lowest drill site was on the primary dirt road, the upper two drill sites were on a short spur road.
