**COLORADO DIVISION OF RECLAMATION, MINING AND SAFETY**  
**MINERALS PROGRAM INSPECTION REPORT**  
**PHONE: (303) 866-3567**

<b>MINE NAME:</b> South Asphalt Plant	<b>MINE/PROSPECTING ID#:</b> M-2009-004	<b>MINERAL:</b> Gravel and sand	<b>COUNTY:</b> El Paso
<b>INSPECTION TYPE:</b> Monitoring	<b>INSPECTOR(S):</b> Timothy A. Cazier	<b>INSP. DATE:</b> September 25, 2014	<b>INSP. TIME:</b> 12:55
<b>OPERATOR:</b> Rocky Mountain Materials & Asphalt, Inc.	<b>OPERATOR REPRESENTATIVE:</b> Tom Smith & Keith Kessler	<b>TYPE OF OPERATION:</b> 110c - Construction Limited Impact	
<b>REASON FOR INSPECTION:</b> Normal I&E Program	<b>BOND CALCULATION TYPE:</b> Partial Bond	<b>BOND AMOUNT:</b> \$59,055.00	
<b>DATE OF COMPLAINT:</b> NA	<b>POST INSP. CONTACTS:</b> None	<b>JOINT INSP. AGENCY:</b> None	
<b>WEATHER:</b> Clear	<b>INSPECTOR'S SIGNATURE:</b>

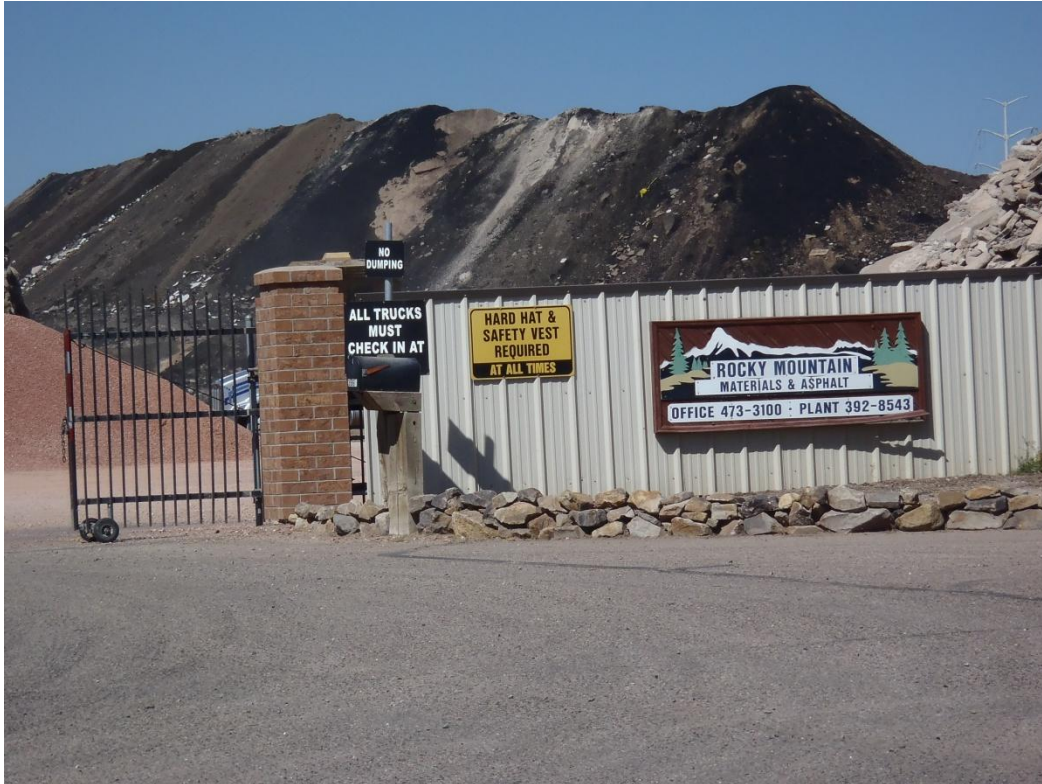
**PROBLEM/POSSIBLE VIOLATION:** Problem: The mine identification sign was not posted at the entrance of the mine site. This is a problem for failure to post a mine identification sign as required by Section 3.1.12(1) of the rule.

The permit sign was missing at the time of the inspection (see **Photo 1**). Mr. Smith stated a new sign is being made and he would send the Division photos of the permit sign in place once it is posted. The missing permit sign is cited as a problem on page 1 of this report for the purpose of tracking the corrective action. The operation consists of an open pit (see **Photos 2 and 3**), approximately 30 feet deep adjacent to Rocky Mountain Materials' asphalt and concrete batch plants. The mined material is used in the two plants. The pit operation is separated from adjacent operations using safety berms and concrete barricades.

Photo 1. Site entrance, missing permit sign.

**CORRECTIVE ACTIONS:** The operator shall, at the entrance of the mine site, post a sign which shall be clearly visible from the access road with the following: the name of the operator, a statement that a reclamation permit for the operation has been issued by the Colorado Mined Land Reclamation Board; and the permit number. The operator shall submit photo documentation that a proper sign has been posted by the corrective action date.

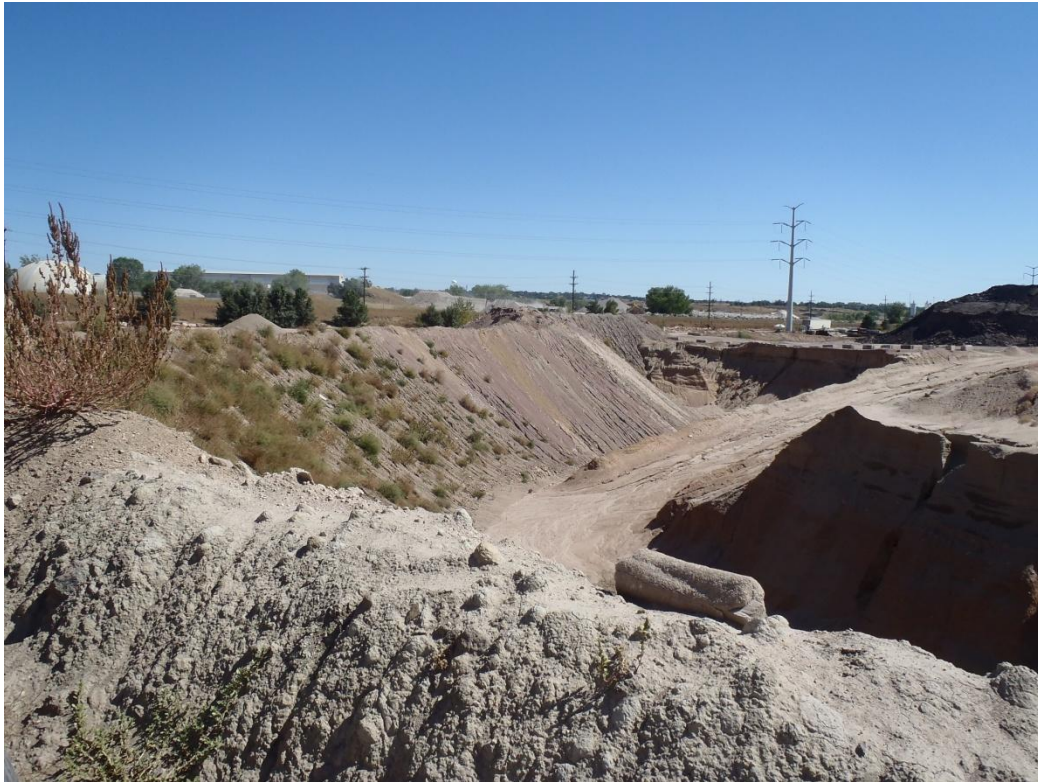
Photo 2. Active pit (looking east).

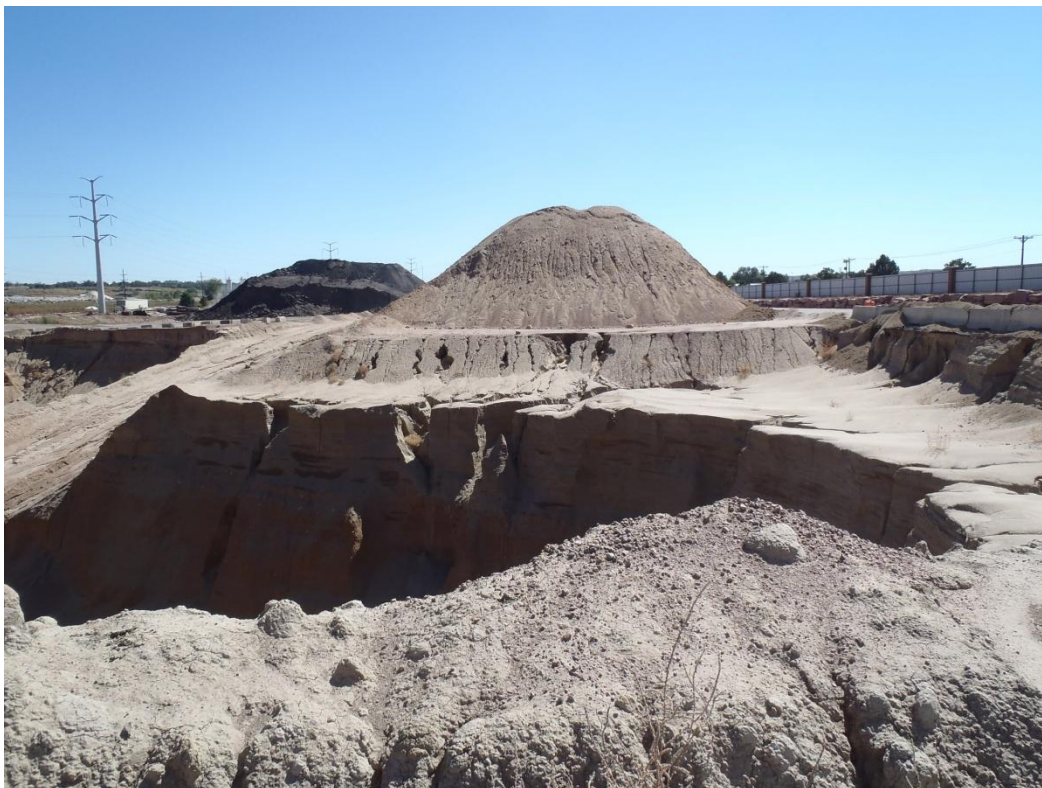
Photo 3. Active pit (looking SE).
