COLORADO DIVISION OF RECLAMATION, MINING AND SAFETY
MINERALS PROGRAM INSPECTION REPORT
PHONE: (303) 866-3567

MINE NAME: Revenue Mine	MINE/PROSPECTING ID#: M-2012-032	MINERAL: Pb, Ag, Au	COUNTY: Ouray
INSPECTION TYPE: Monitoring	INSPECTOR(S): Bob Oswald	INSP. DATE: October 27, 2014	INSP. TIME: 10:00
OPERATOR: Fortune Revenue Silver Mine	OPERATOR REPRESENTATIVE: John Trujillo	TYPE OF OPERATION: 112d-1 - Designated Mining Operation

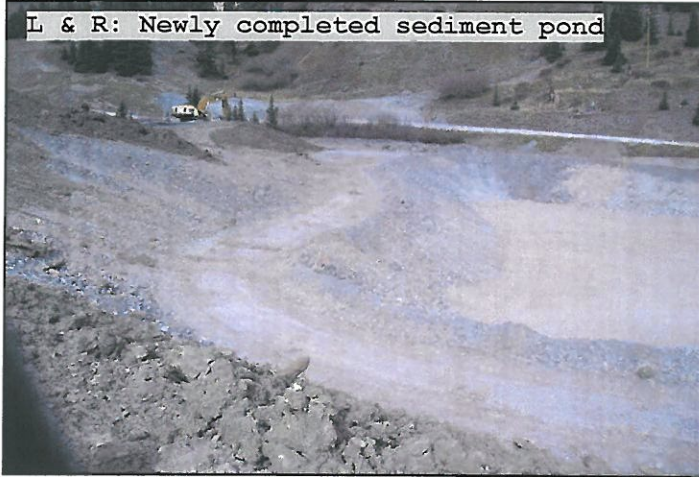
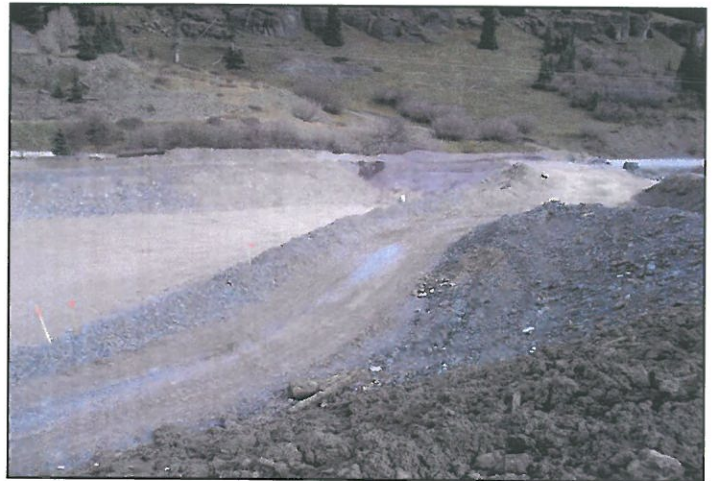
In addition to investigating this release event, the inspection involved other surface facilities for controlling mine water, stormwater, waste rock and future tails disposal areas. The liner installation and leak testing have been completed on the mine water pond. The emergency drain line is installed but the valve is not yet in place. The riprapped spillway has been constructed, but still lacks the grouting. The spillway will route the discharge to an in-ground concrete vault from which a corrugated poly culvert will convey water to Sneffels Creek. Mine staff were currently placing and bedding the vault and culvert. The operator will be submitting the mine pond certification soon. The first sediment pond near the entrance bridge is functional. The new sediment pond east of the mine pond has just been completed; the runoff conveyance ditches will be fully connected soon.

L & R: Newly completed sediment pond

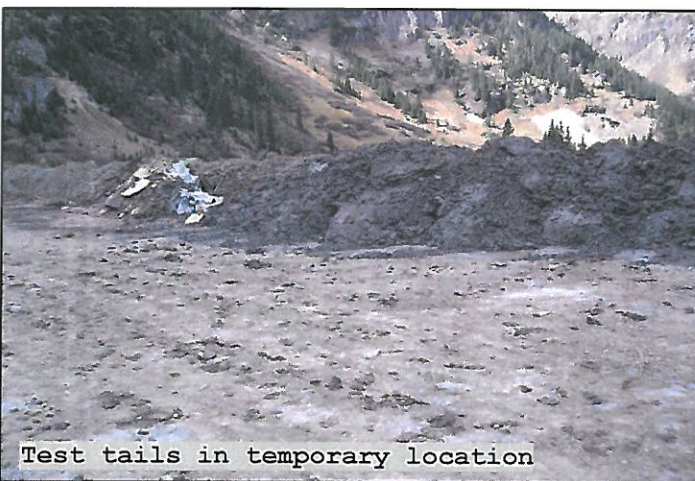
The waste rock disposal and temporary tails disposal areas continue to accumulate new materials from the underground drilling and mill tests. Test tails are presently up on the waste rock bench to dry, but the operator may move them to a temporary location in the old pond, in order to allow proper completion of the waste rock disposal area. The mine is not generating ore at a production level, since the mill has not been fully certified. The mill currently is running limited tests for future ore processing, but there is no production-level operation at this time.

Test tails in temporary location

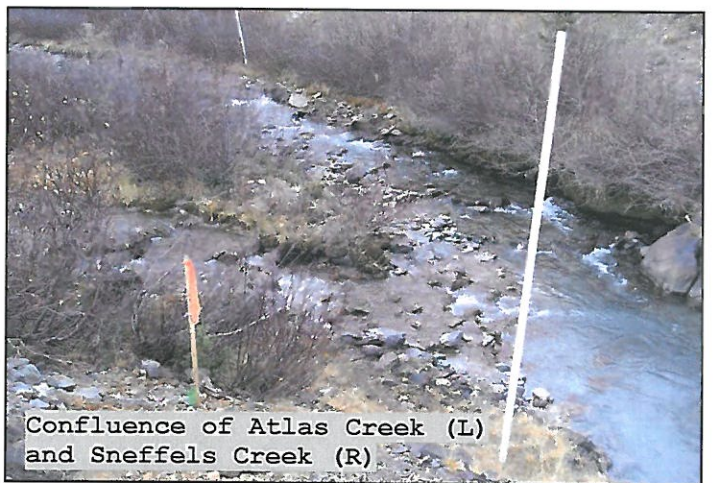
placed in a location to slough or erode off of the mine site. Also observed was the confluence of Atlas Creek (the initial receiving stream) and Sneffels Creek (to which Atlas Creek is tributary). Both branches were flowing clear and green, with no sign of red sediment in the water, on the banks, or on material in the channel.

Confluence of Atlas Creek (L)
and Sneffels Creek (R)

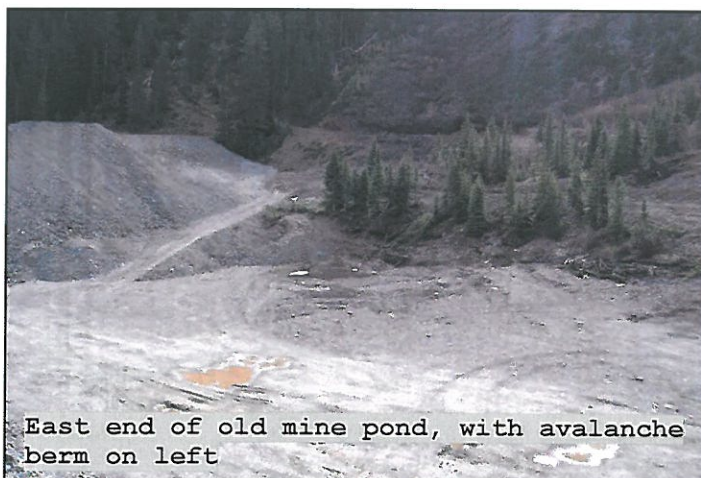
East end of old mine pond, with avalanche
berm on left

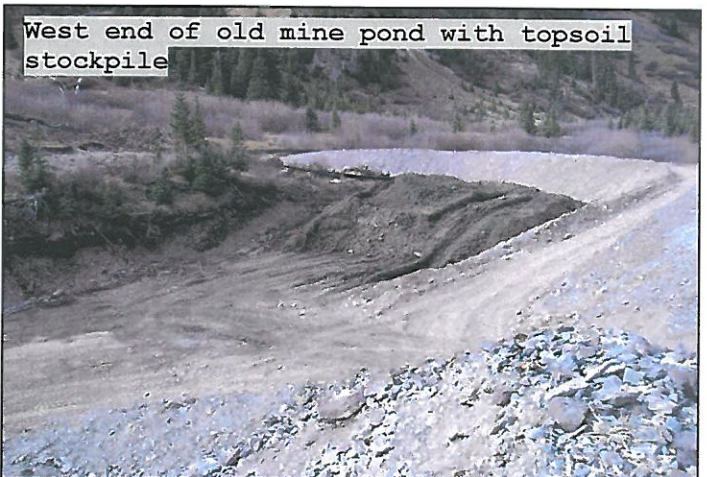
All earthen slopes above and below the various ponds were created with the final 3:1 gradient; most of the slope surfaces have been recently topsoiled with six inches or more of onsite-produced topsoil. This was produced from careful salvaging of the soil during excavation of new discharge pipeline and diversion ditch corridors. The operator will seed these topsoiled surfaces this year before winter. There is more such topsoil still stockpiled in the western end of the old mine pond. This soil will be used on all other areas that are graded to their final configuration and will not be redisturbed. If not spread this year, stockpiled soil must be protected from degradation.

West end of old mine pond with topsoil
stockpile
