**COLORADO DIVISION OF RECLAMATION, MINING AND SAFETY**  
**MINERALS PROGRAM INSPECTION REPORT**  
**PHONE: (303) 866-3567**

<b>MINE NAME:</b> Red Arrow – Drill 2 Project	<b>MINE/PROSPECTING ID#:</b> P-2012-007	<b>MINERAL:</b> Au, Ag, Cu	<b>COUNTY:</b> Montezuma
<b>INSPECTION TYPE:</b> Mineral Prospect Inspection	<b>INSPECTOR(S):</b> Bob Oswald	<b>INSP. DATE:</b> October 7, 2014	<b>INSP. TIME:</b> 13:00
<b>OPERATOR:</b> Red Arrow Gold Corp.	<b>OPERATOR REPRESENTATIVE:</b> None	<b>TYPE OF OPERATION:</b> MP - Mineral Prospecting

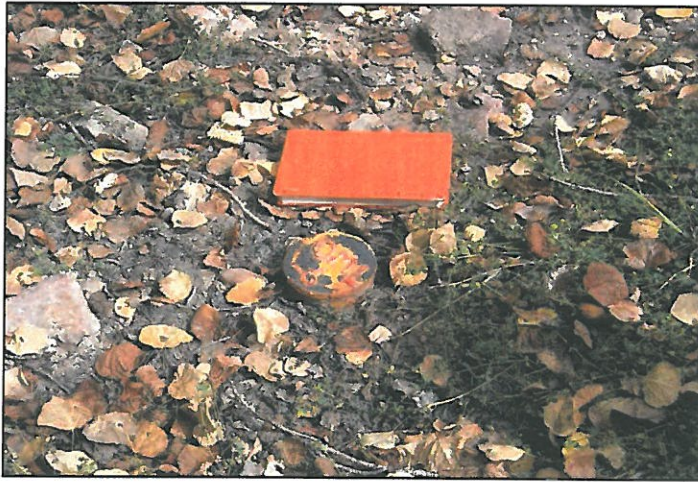
The project involved drilling up to ten drill holes, all from the bench road on the Red Arrow Mine property, near the Mill Level portal. There was no prospecting equipment on the site. There were no cuttings, drilling debris or other project-related features observed onsite. The bench road surface exhibits no erosion and it is adequately vegetated and stable. Only one drill hole location was found during the inspection, along the northern edge of the roadway. It consisted of a 3-inch diameter steel casing, extending 2 inches above the ground surface, with a closure consisting of a welded-on steel cap (with markings reading "DML 6"). No other drill holes could be found.

Left photo: Close-up of capped drill hole.

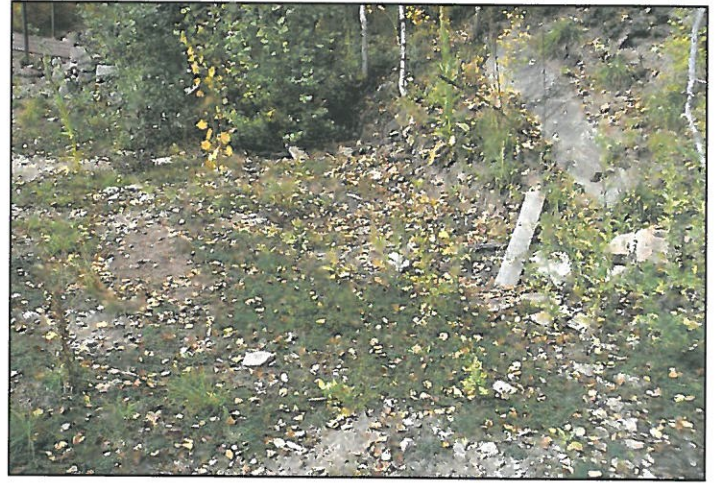
Right photo: View of roadway where drill hole is located (center of photo).
