**COLORADO DIVISION OF RECLAMATION, MINING AND SAFETY**  
**MINERALS PROGRAM INSPECTION REPORT**  
**PHONE: (303) 866-3567**

<b>MINE NAME:</b> Red Arrow Dome	<b>MINE/PROSPECTING ID#:</b> P-2009-018	<b>MINERAL:</b> Silver, gold & copper	<b>COUNTY:</b> Montezuma
<b>INSPECTION TYPE:</b> Mineral Prospect Inspection	<b>INSPECTOR(S):</b> Bob Oswald	<b>INSP. DATE:</b> October 7, 2014	<b>INSP. TIME:</b> 13:30
<b>OPERATOR:</b> Red Arrow Gold Corporation in Receivership	<b>OPERATOR REPRESENTATIVE:</b> None	<b>TYPE OF OPERATION:</b> MP - Mineral Prospecting

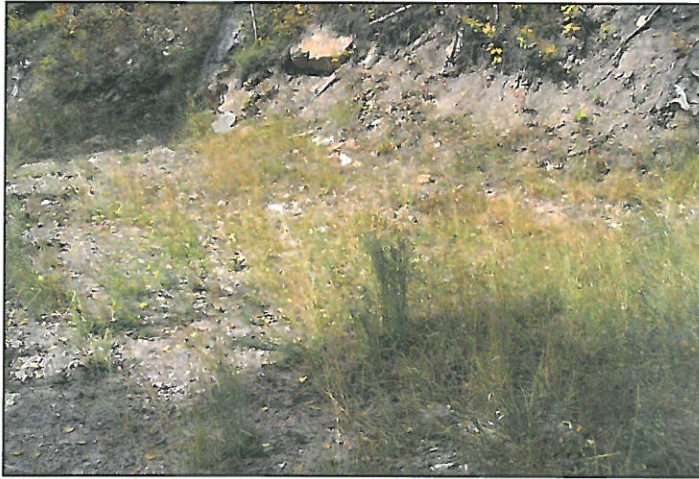
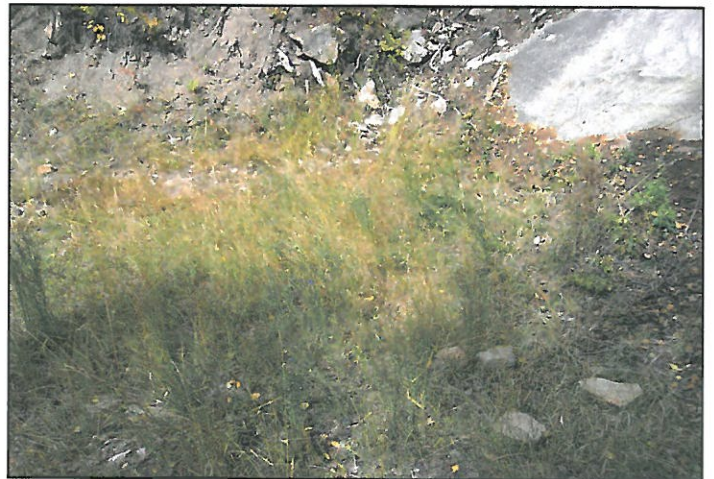
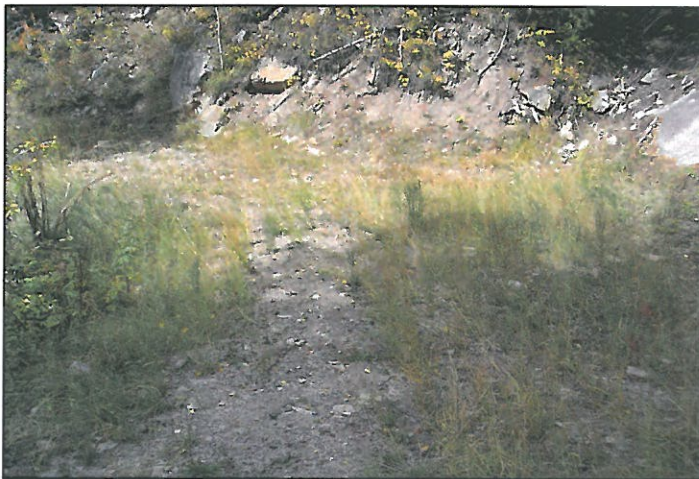
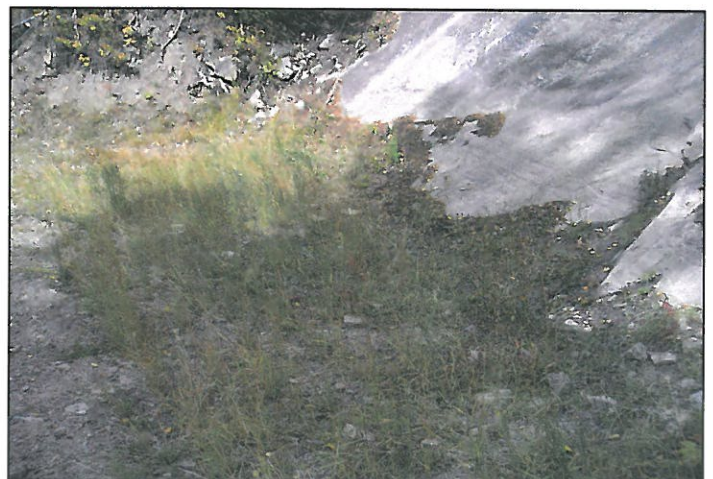
The project involved drilling up to three drill holes, all along a bend in a historic mining road west of the Red Arrow Mine property, approximately 0.4 miles west of the Mill Level portal. There was no prospecting equipment on the site. There were no cuttings, drilling debris or other project-related features observed onsite. The road surface exhibits no erosion and it is adequately vegetated and stable. During the Division's 2011 inspection, only one drill hole location was found. It was located at the bend of the roadway, and since it was still open, the operator was instructed to close it. Promptly after that inspection, the operator provided photos of the closure: the casing was cut off, and a steel cap was welded on to permanently close it. During this current inspection, no sign of the capped drill hole or any other drill disturbance was observed.
