**COLORADO DIVISION OF RECLAMATION, MINING AND SAFETY
MINERALS PROGRAM INSPECTION REPORT
PHONE: (303) 866-3567**

MINE NAME: C-JD-5	MINE/PROSPECTING ID#: M-1977-248	MINERAL: Uranium and vanadium	COUNTY: Montrose
INSPECTION TYPE: Monitoring	INSPECTOR(S): Dustin M. Czapla	INSP. DATE: October 31, 2014	INSP. TIME: 10:30
OPERATOR: Gold Eagle Mining, Inc.	OPERATOR REPRESENTATIVE: Don Coram	TYPE OF OPERATION: 112d-1 - Designated Mining Operation

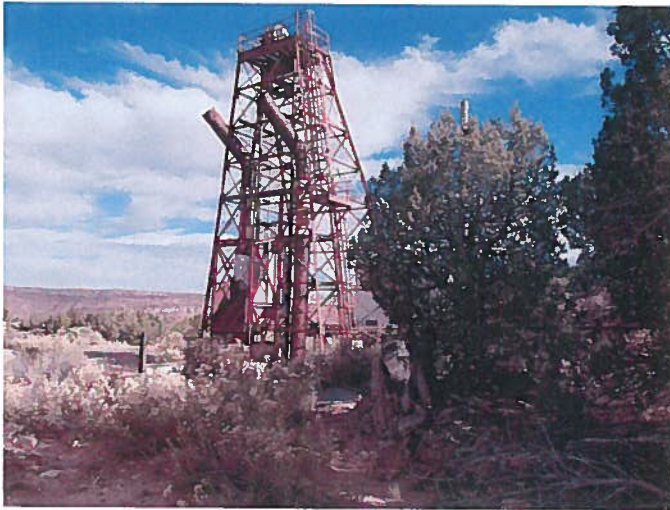
The primary and secondary shafts are securely safeguarded.

Figure 1: Primary shaft and hoist

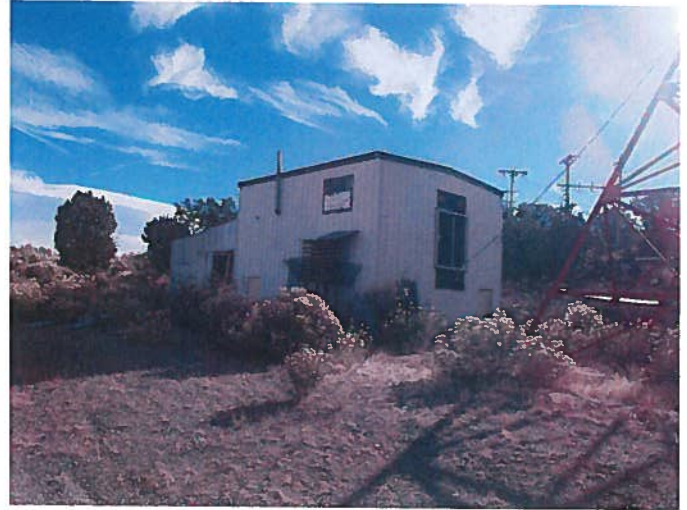
Adequate mine identification signage was posted on the hoist house visible from the entrance to the mine site.

The mine building has been damaged do to vandalism. A portion of the west facing wall was torn out during theft of an air tank.

Figure 2: Hoist house

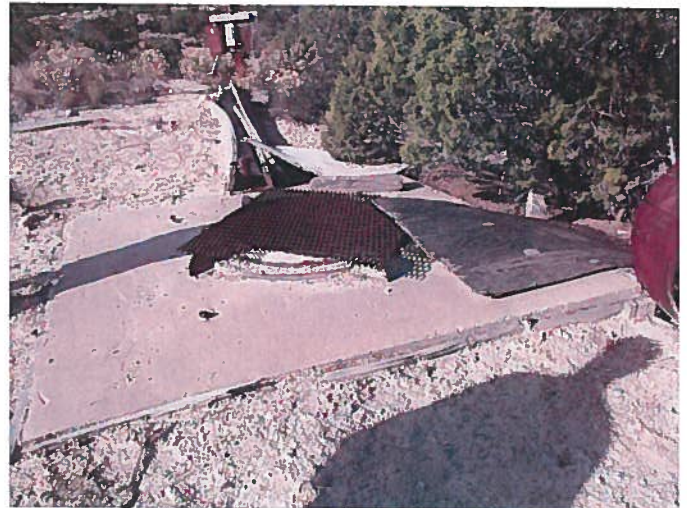
Figure 4: Secondary/ventilation shaft
