COLORADO DIVISION OF RECLAMATION, MINING AND SAFETY
MINERALS PROGRAM INSPECTION REPORT
PHONE: (303) 866-3567

MINE NAME: Hazeltine Mine	MINE/PROSPECTING ID#: M-2004-031	MINERAL: Sand and gravel	COUNTY: Adams
INSPECTION TYPE: Monitoring	INSPECTOR(S): Tyler V. O'Donnell	INSP. DATE: October 31, 2014	INSP. TIME: 09:00
OPERATOR: Aggregate Industries - WCR, Inc.	OPERATOR REPRESENTATIVE: Connie Davis	TYPE OF OPERATION: 112c - Construction Regular Operation

INSPECTION TOPIC: Hydrologic Balance and Off-site Damage

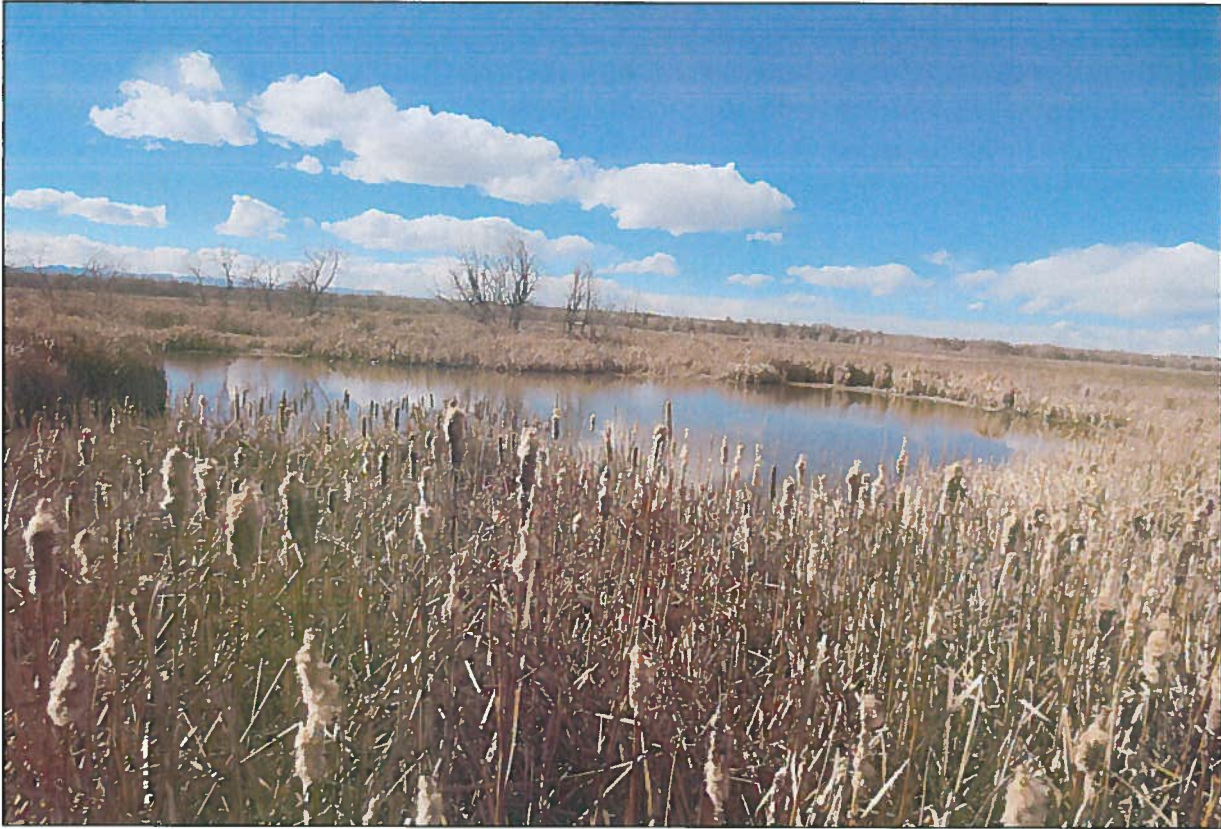
Photo 1: Submerged depression on the west side of the Orr property, photo taken on March 27, 2014.

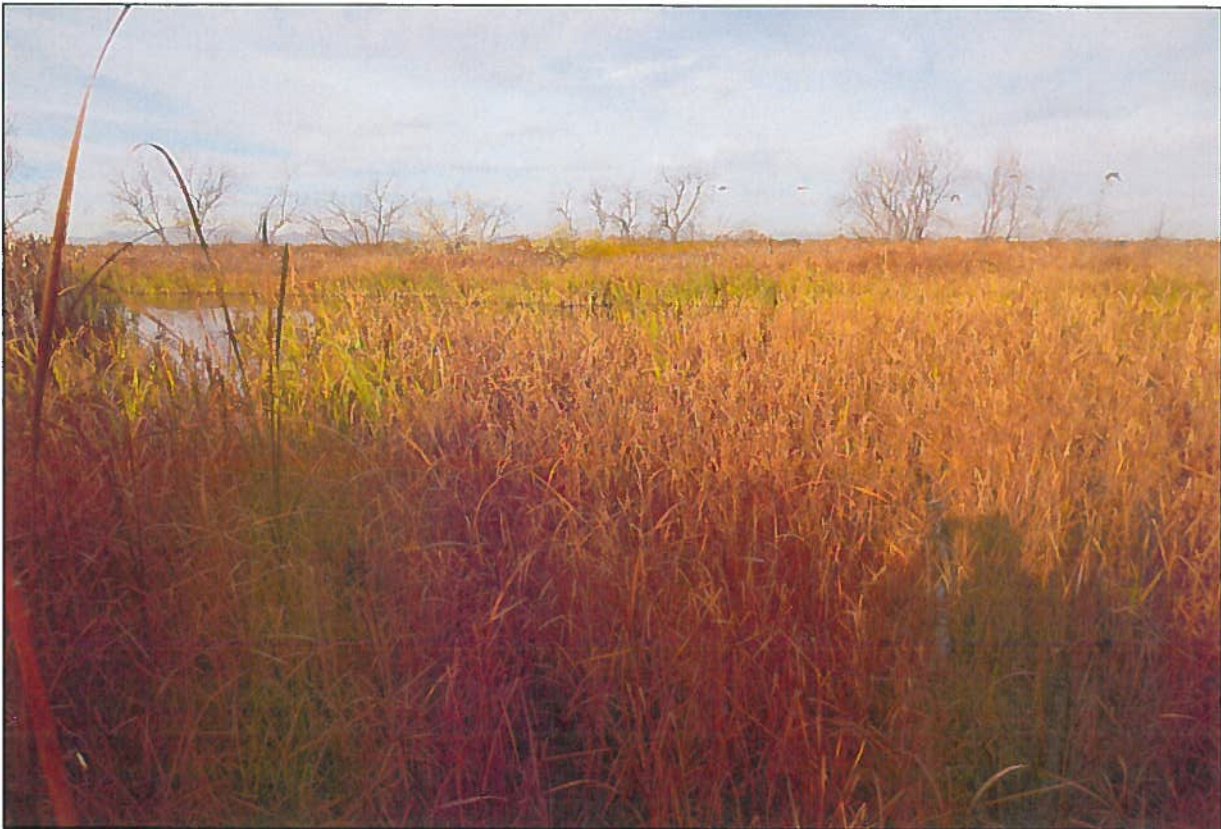
The inspection began at the Orr property. The inspection consisted of a visual examination of the Orr property and a discussion of the ongoing issues detailed in the complaint. The visual inspection of the Orr property found that portions of the land surface remain submerged. DRMS visually estimates that the water level on the Orr property has dropped approximately one foot since the March 27, 2014 inspection (see photo 1 from the March 27, 2014 inspection, compared to photo 2, which was taken during the October 31, 2014 inspection). DRMS believes the lowest point of the Orr property is located in the northwest corner with an approximate elevation of 5,038.5 feet. The northwest corner of the Orr property remains submerged (see photo 3 from the March 27, 2014 inspection, compared to photo 4, which was taken during the October 31, 2014 inspection). It appears that the groundwater elevation in the northwest corner of the Orr property has not changed much since the March 27, 2014 Inspection. Based on visual estimates made during the current inspection, portions of the Orr property were still covered by 1 to 2 feet of water.

Photo 2: Submerged depression on the west side of the Orr property, photo taken on October 31, 2014.

CORRECTIVE ACTIONS: Submit to DRMS by November 25, 2014 a groundwater mounding mitigation plan as either a Technical Revision or Amendment to the permit. The plan must include:

- 1) A detailed description of the measures the operator will take to reduce groundwater mounding outside the Hazeltine Mine to a level that eliminates flooding on the Orr property,
- 2) A time schedule for implementing the plan, and
- 3) Enough information for DRMS to estimate the cost of implementing the plan.

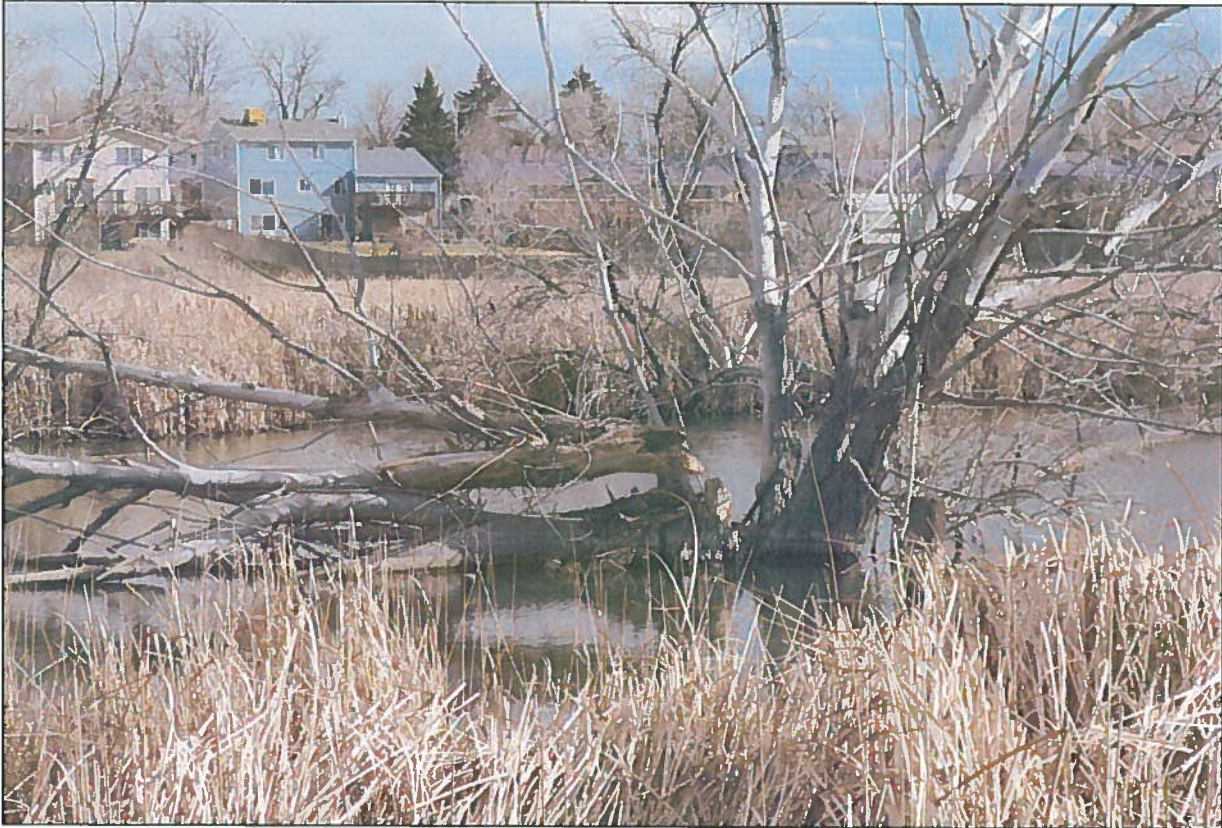
Photo 3: Northwest corner of the Orr property, photo taken on March 27, 2014.

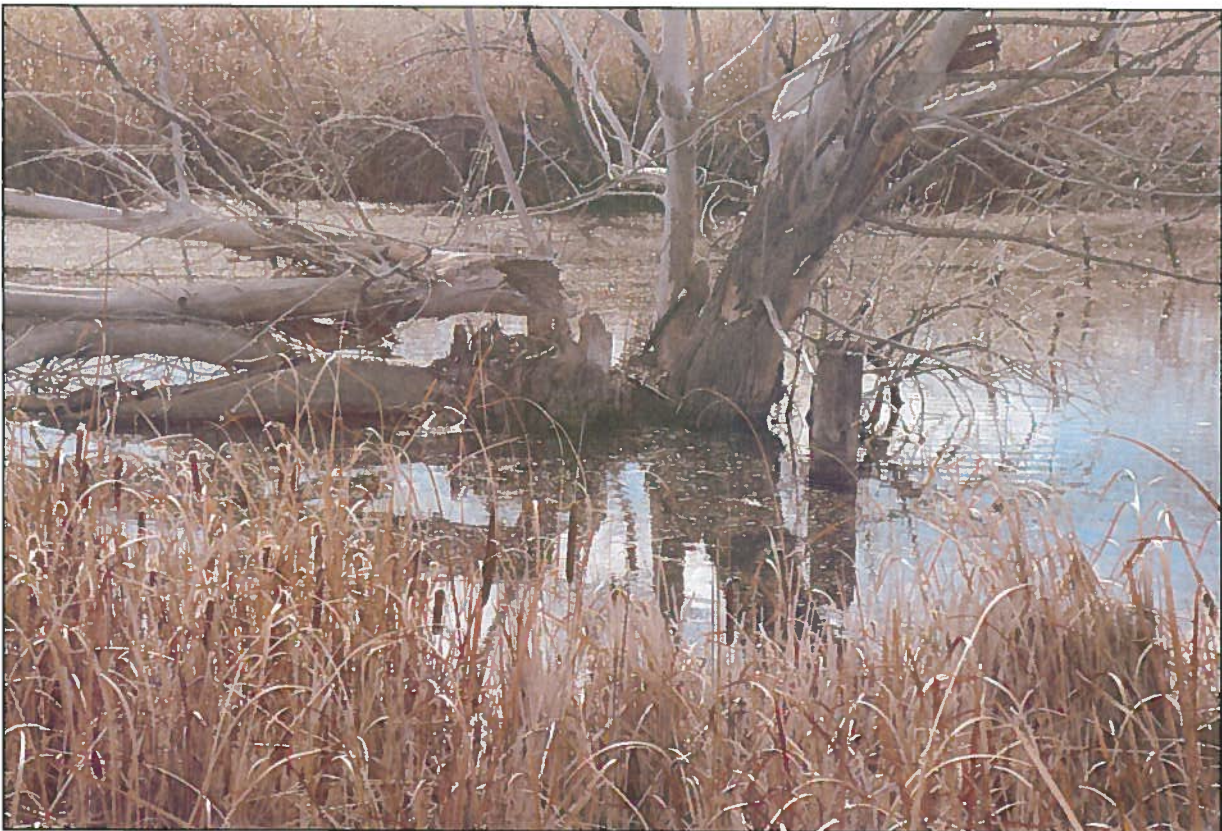
Photo 4: Northwest corner of the Orr property, photo taken on October 31, 2014.

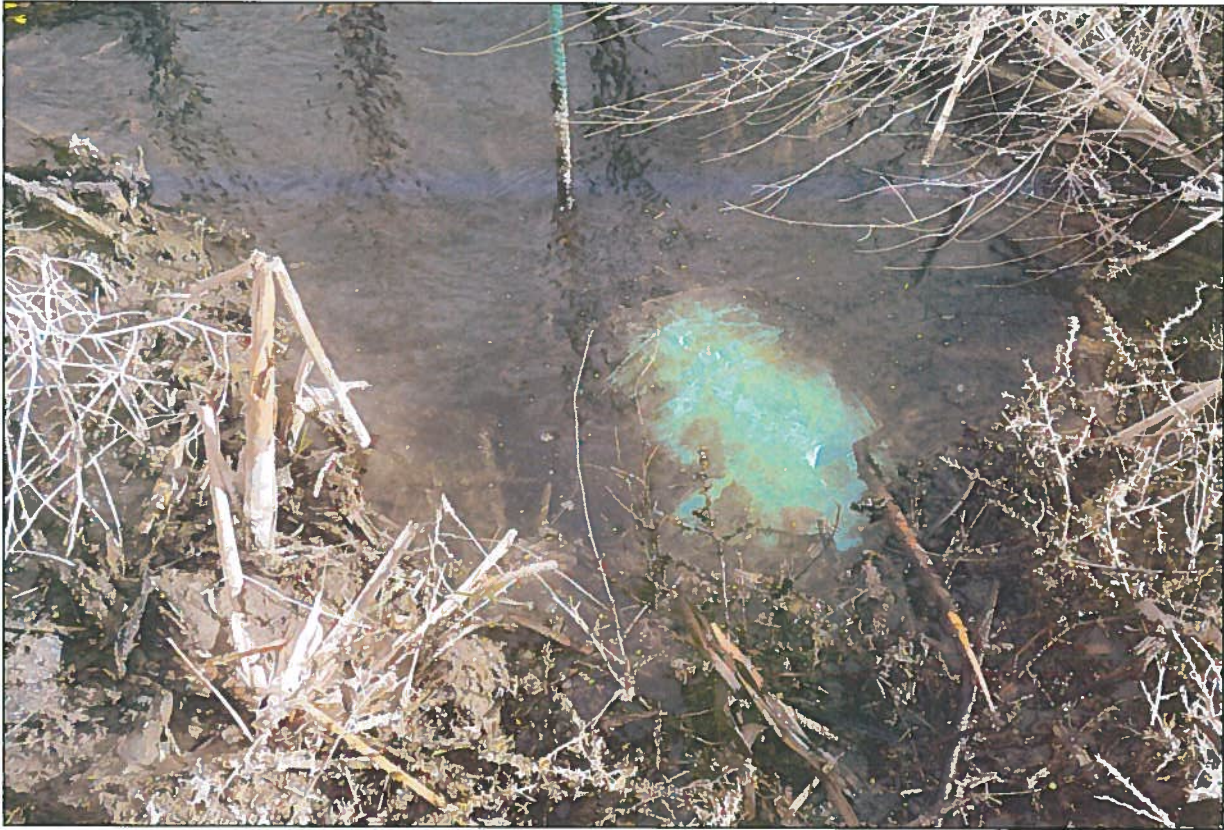
Following the investigation at the Orr property, DRMS entered the mine site to observe the operation of the Agridrain that was installed in the northeast end of the Hazeltine Mine for the purpose of draining the Orr Property. Water was flowing through the Agridrain (see photo 5 from the March 27, 2014 inspection compared to photo 6, which was taken during the October 31, 2014 inspection). It appears that the Agridrain has lowered the water level in the surrounding wetlands by approximately one foot.

Photo 5: Agridrain, photo taken on March 27, 2014.

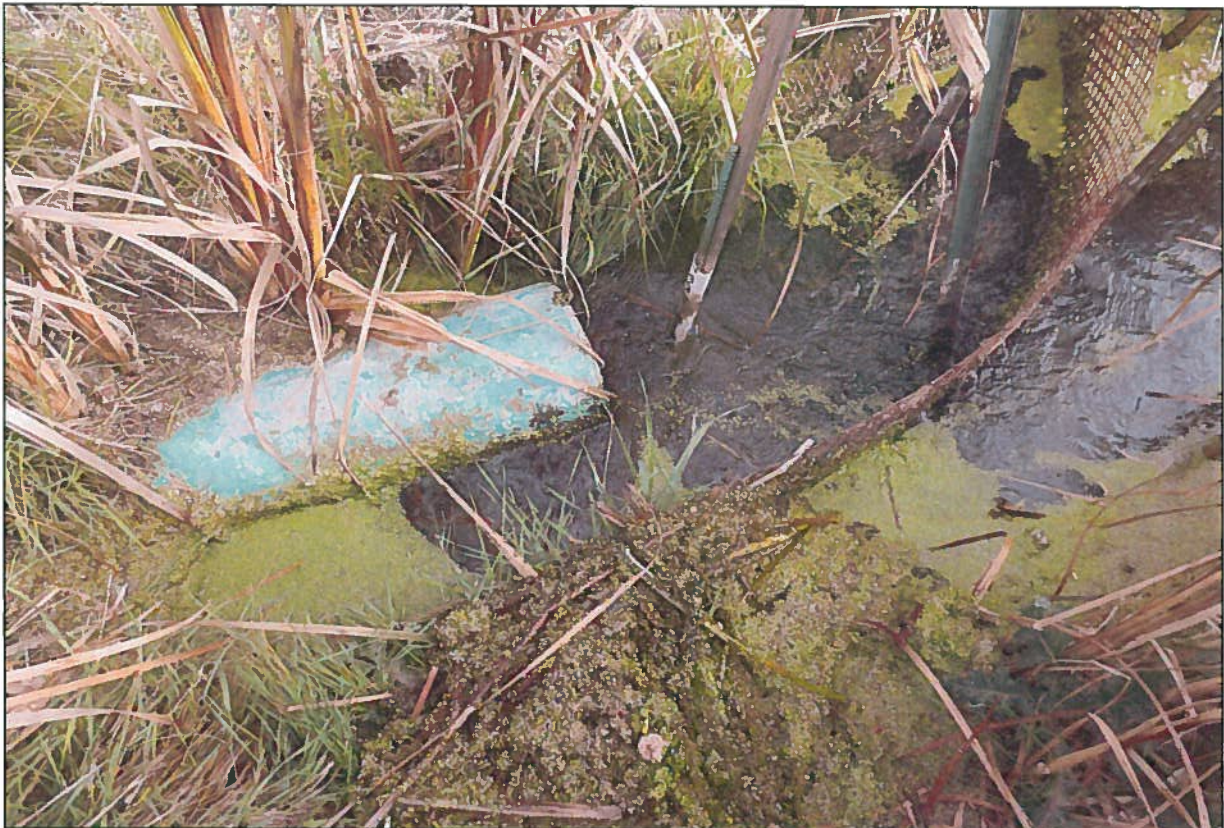
Photo 6: Agridrain, photo taken on October 31, 2014.
