REQUEST FOR TECHNICAL REVISION (TR) COVER SHEET

File No.: M- 1982-147 Site Name: Nyholt Pit (aka Mann)

To: Kurt Carlson, Adams County
From: Todd Street, LRE
Reviewed by: Monica Bortolini, LRE
Date: September 26, 2014
Project: Mann Lakes Flood Damage Repairs
Subject: Project Design Report

Mann Lakes Reservoir Flood Damage Repair

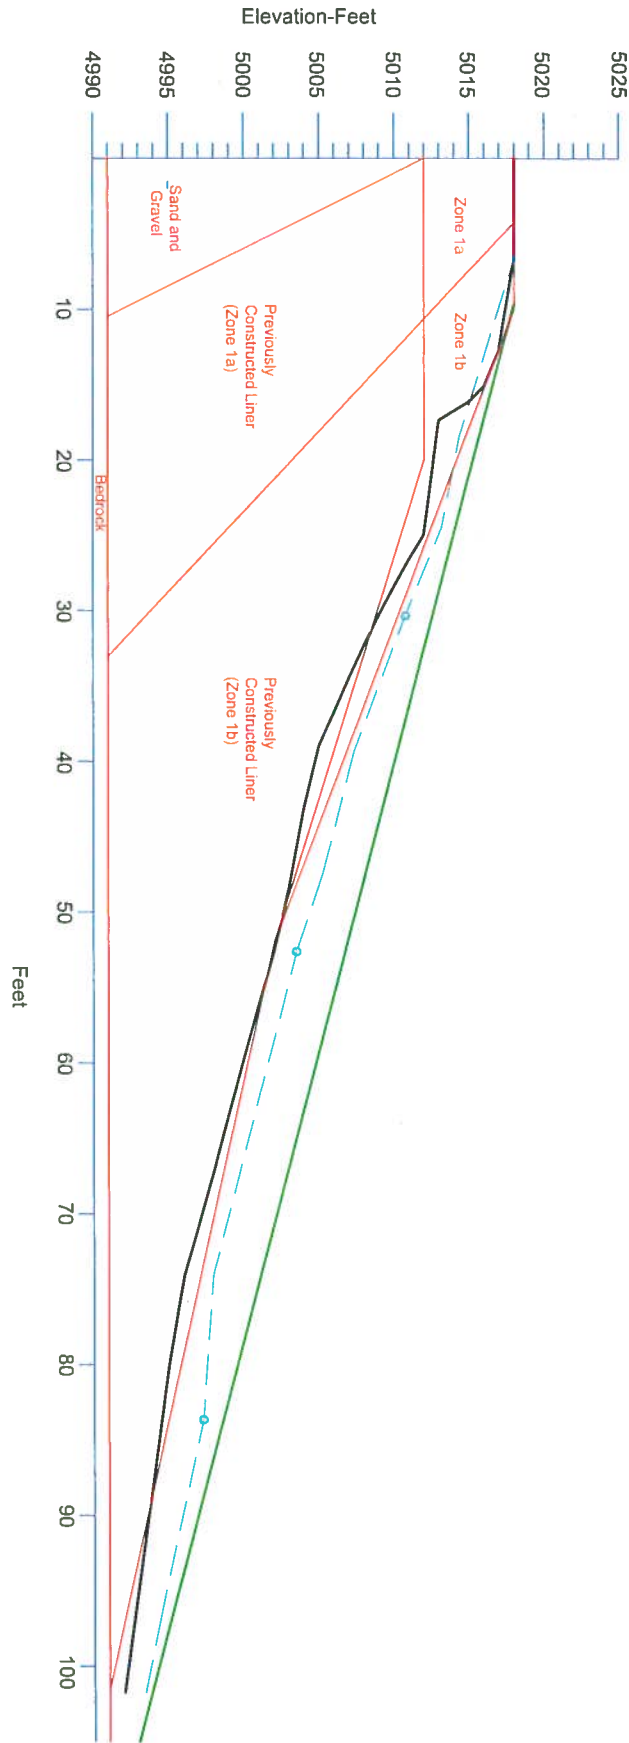
Figure 2
Damage Area A-1 Cross-section

Damage Area A-1 is located at the northwest corner of Lake 2 and corresponds with the cross section at Station 1+00 from the Tetra Tech design plans (Tetra Tech, 2007). At area A-1 the eroded scarp was observed to be approximately 4 feet high and the erosion extended approximately 1.5 feet into the Zone 1A liner. Zone 1b soil was classified as clayey sand with gravel (SC) with a liquid limit of 28 and a plasticity index of 15. Zone 1a soil was classified as sandy lean clay (CL) with a liquid limit of 48 and a plasticity index of 24.

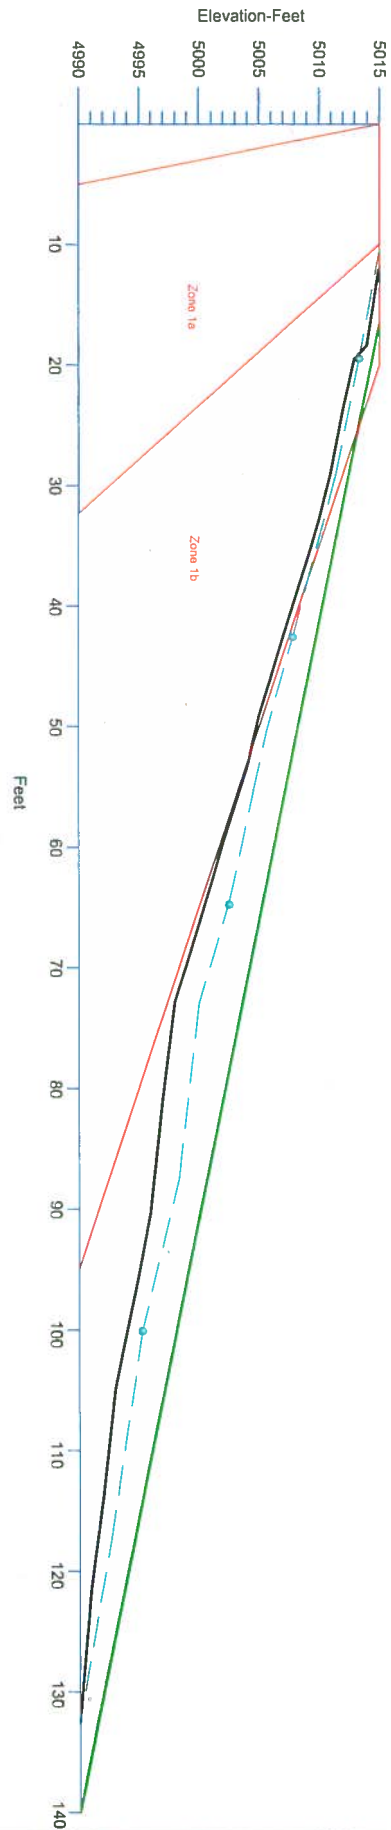
Figure 4
 Damage Area A-3 Cross-section

Damage Area A-3 is located in the northwestern corner of Lake 1. Erosion at damage area A-3 is approximately 4 feet deep. The depth of exposed Zone 1A liner ranges from 0.5 feet at the top of the slope to 2 feet midway down the slope. Zone 1A soil was classified as sandy lean clay (CL) with a liquid limit of 36 and a plasticity index of 19. Zone 1B soil was classified as silty, clayey, sand (SC-SM) with a liquid limit of 18 and a plasticity index of 4.

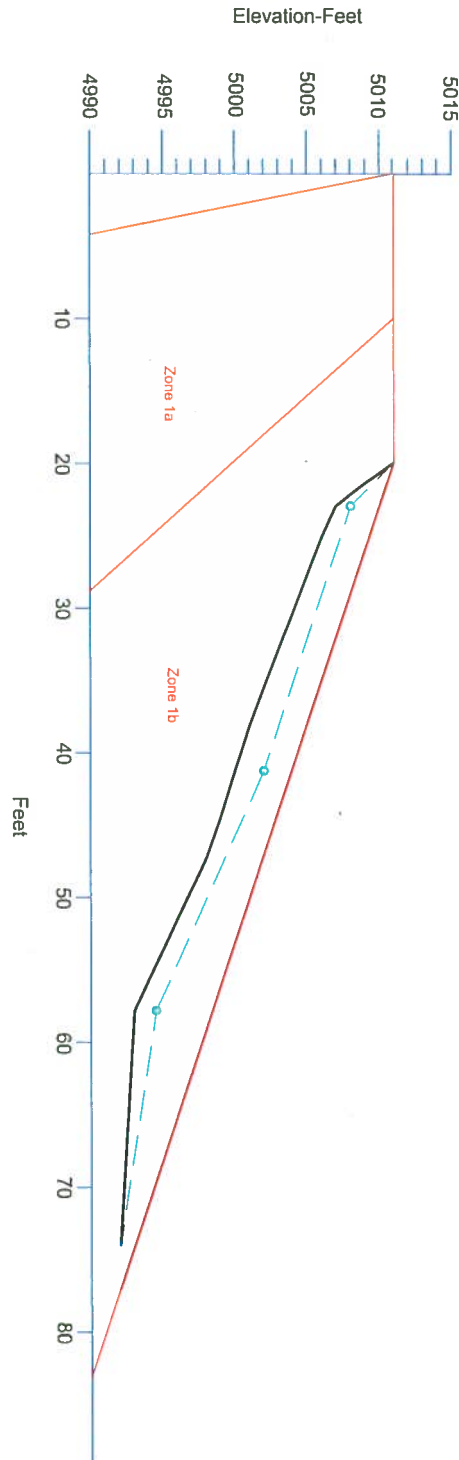
Figure 5
 Damage Area A-4 Cross-section

Damage Area A-4 is located at the northeastern corner of Lake 1. Erosion at Damage Area A-4 resulted from backflow through the spillway and does not extend above the spillway inlet. Scarp faces at Area A-4 range from 4 to 6 feet high and extend an average of 1.5 feet into the Zone 1A liner. Area A-4 Zone 1A was classified as clayey sand (SC) with a liquid limit of 24 and a plasticity index of 8. Zone 1B was classified as clayey sand with gravel (SC) with a liquid limit of 25 and a plasticity index of 12.

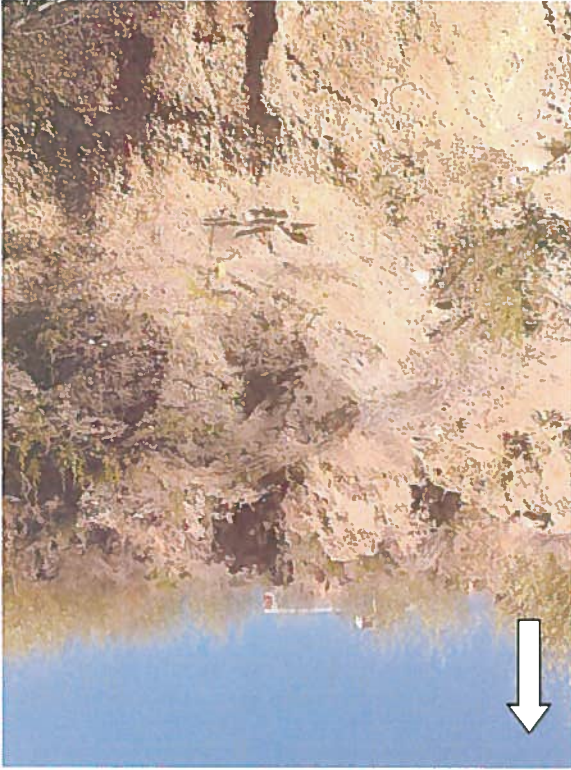
Photo 1 General view of location A-1.

Photos 1 and 2 show a general view of this location. At A-1 there was an initial eroded step down of 3 feet 7 inches, with approximately 1 foot 9 inches of Zone 1a exposed. This can be seen in Photo 3. Another 1 foot 6 inches in depth was investigated and a clay, described as silty, with some gravel, slightly moist to moist was encountered. Midway down the slope there was a 4 foot 7 inch eroded wall of exposed soil, with 1 foot 7 inches of Zone 1a exposed. This is shown in Photo 4. Zone 1a, continued after excavating down another 1 foot 6 inches. The clay was silty with some gravel and was moist. Near the bottom of the slope was a 4 foot eroded wall of exposed soil. The bottom 1 foot 4 inches consisted of Zone 1a. This is shown in Photo 5. Again, Zone 1a was encountered after excavating another 1 foot 6 inches. The clay was moist. There was 2 to 4 feet of

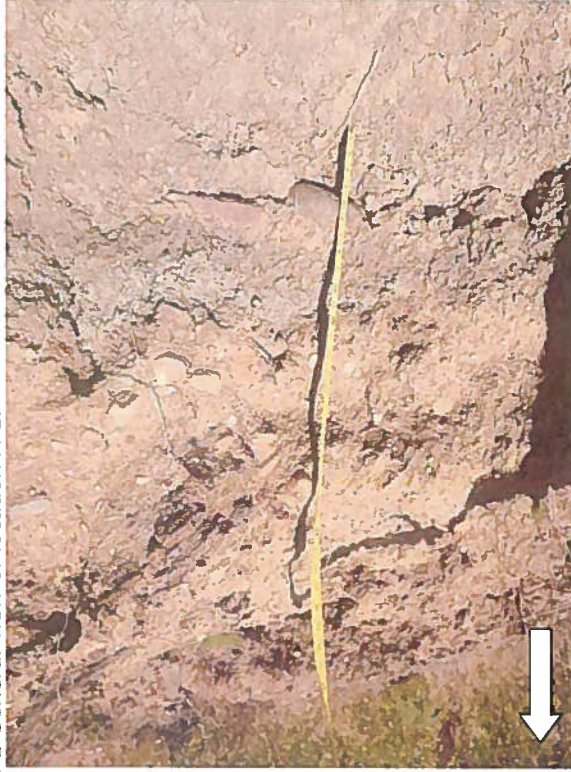
Photo 3 Close-up view near the top of the slope at location A-1.

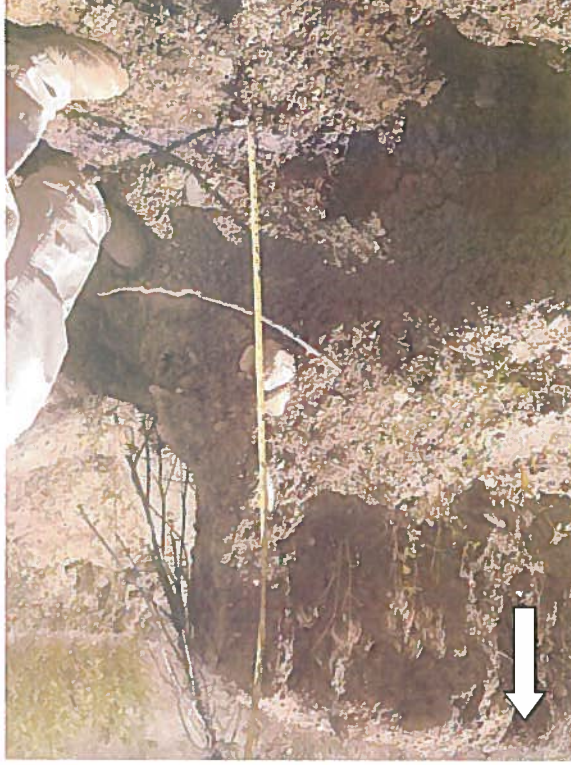
Photo 4 Close up view midway down the slope at location A-1.

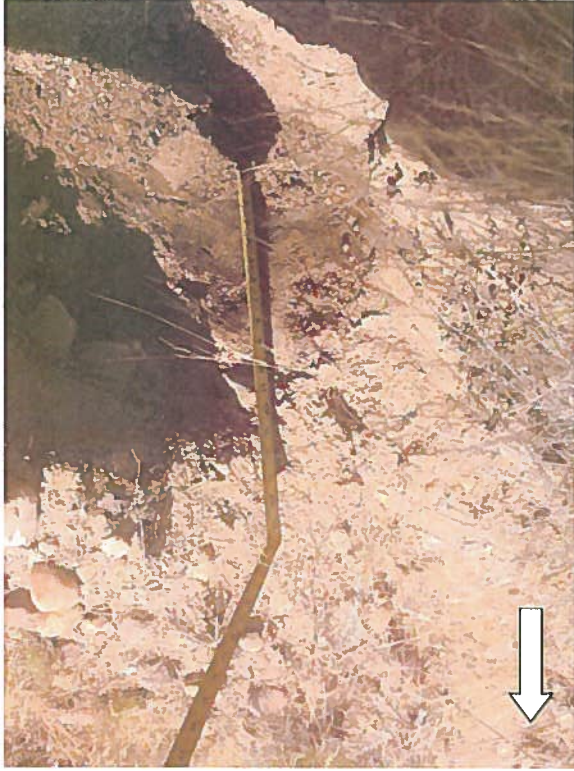
Photo 5 Close-up view near the bottom of the slope at location A-1.

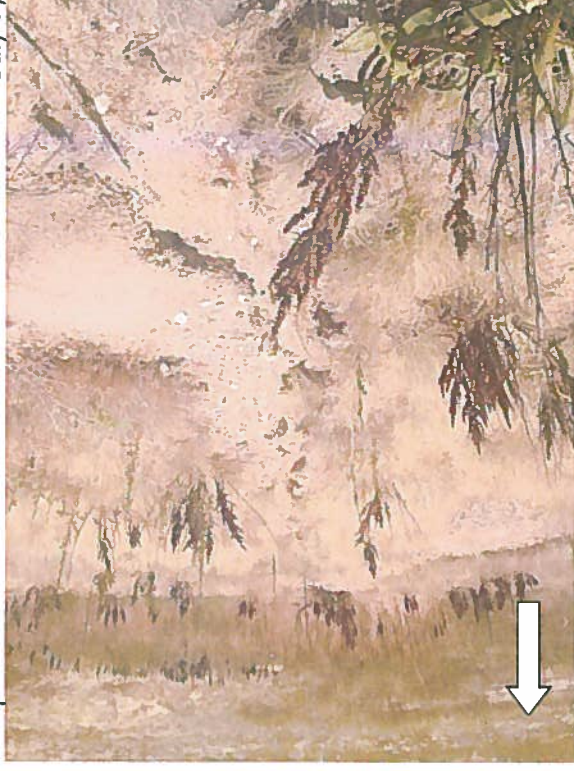
Photo 6 General view of location A-2.

Location A-2 was the second area of Lake 2 studied, which was about 1,000 feet east of A-1 at Sta 11+00, according to Tetra Tech's drawing. Photo 6 shows a general view of the damage. At the top of the slope there was 2 feet 7 inches of Zone 1-b exposed, with 1 foot 6 inches of Zone 1a exposed. This is shown in Photos 7 and 8. Midway down the slope there was 1 foot 6 inches of Zone 1b exposed, with the bottom 5 inches being of Zone 1a. This is shown in Photo 9. Near the bottom of the slope there was 15 inches of Zone 1b exposed. Zone 1a encountered several inches deeper than the exposed soil. This is shown in Photos 10 and 11. Here Zone 1b was classified as a well graded sand with silt, clay, and gravel (SW-SC), with a liquid limit of 19, and a plasticity index of 7. Zone 1a was classified as a sandy lean clay (CL), with a liquid limit of 43, and a plasticity index of 25.

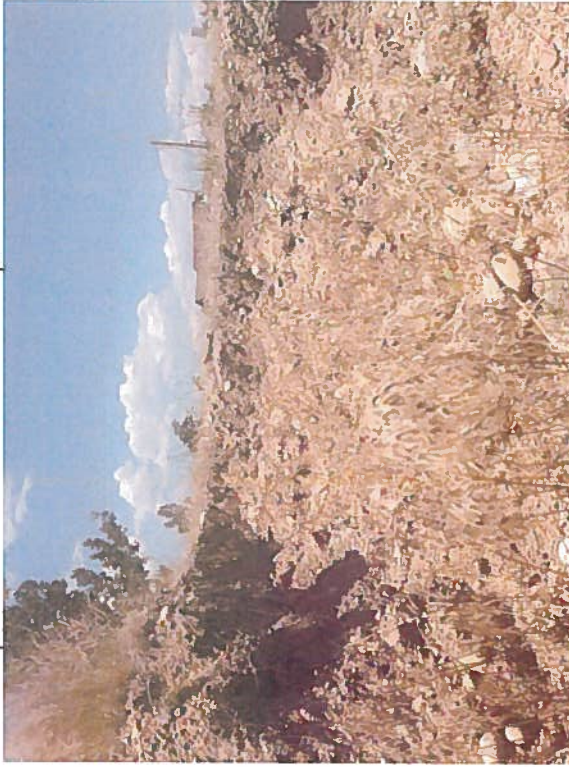
Photo 7 Additional view of the top section at location A-2.

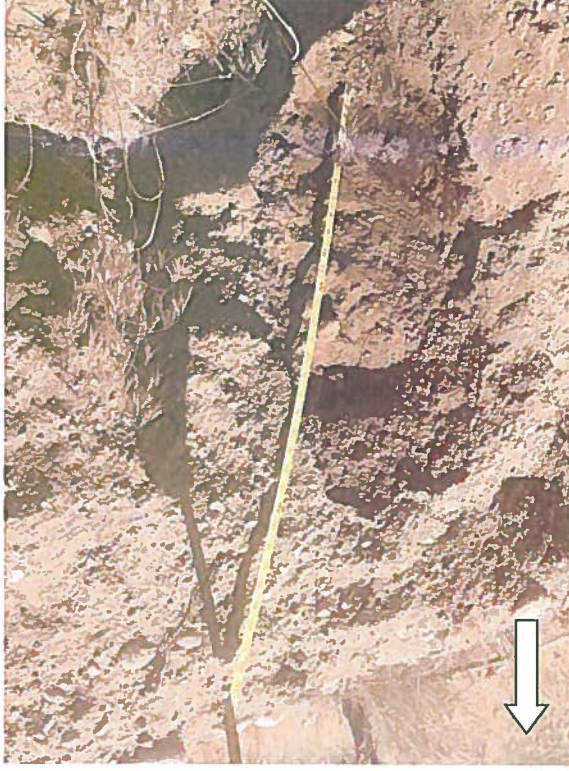
Photo 8 Close-up view near the top of the slope at location A-2.

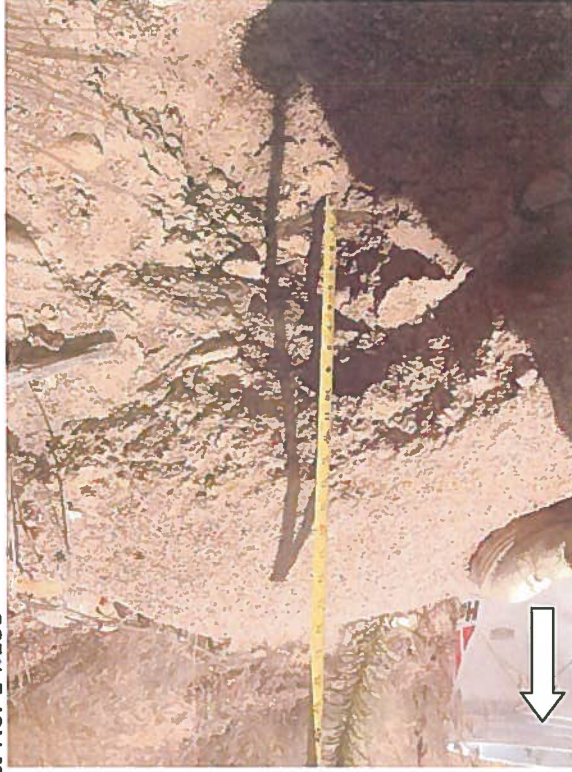
Photo 9 Close-up view midway down the slope at location A-2.

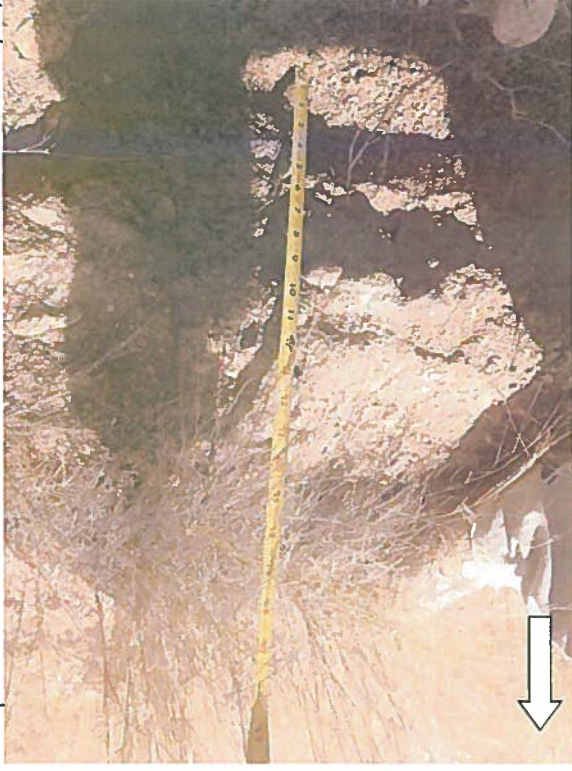
Photo 10 Close-up view near the bottom of the slope at location A-2.

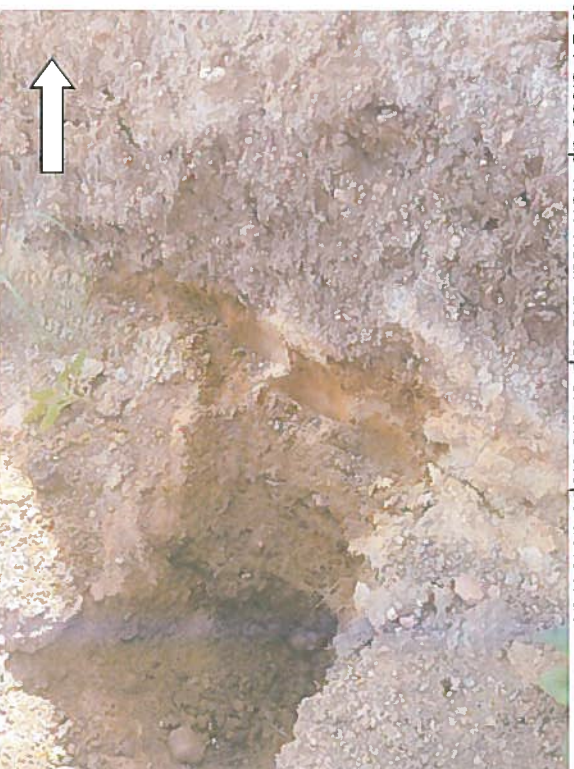
Photo 16 Close-up view of the siltstone intrusion midway down the slope at location A-3.

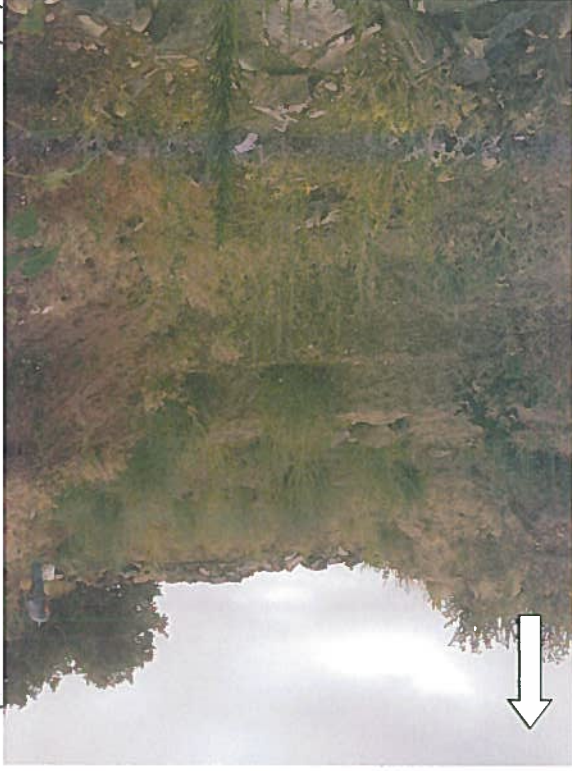
Photo 18 General view of the step downs at location A-4.

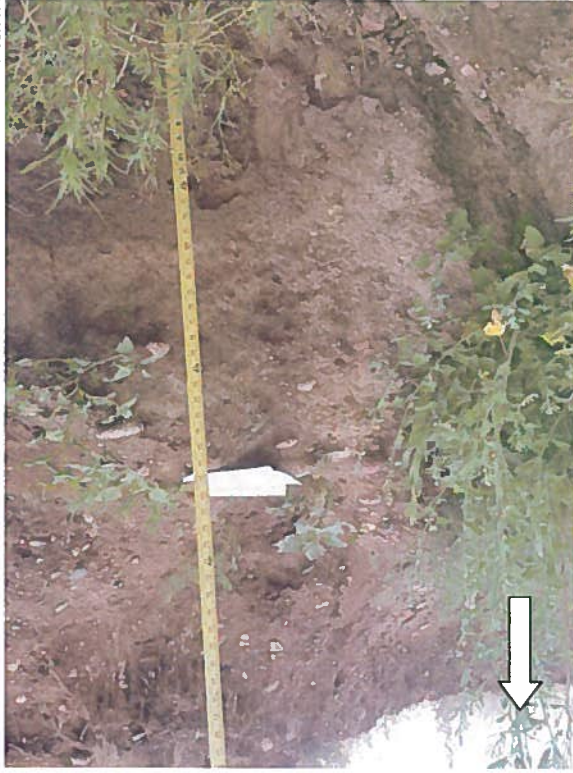
Photo 21 Close-up view near the top of the slope with the step down at location A-4.

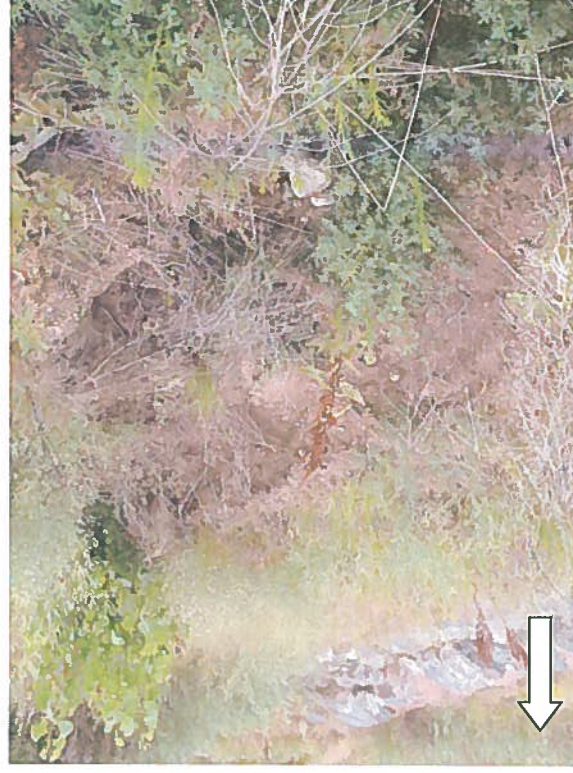
Photo 24 General view of the erosion between Lake 1 and Lake 3.

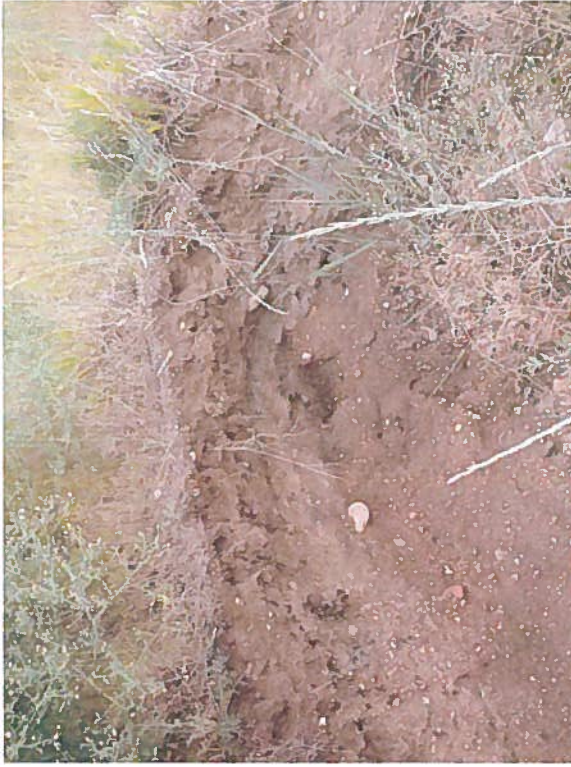
Photo 25 General view of the erosion 150 feet east of inlet between Lake 3 and Lake 1.

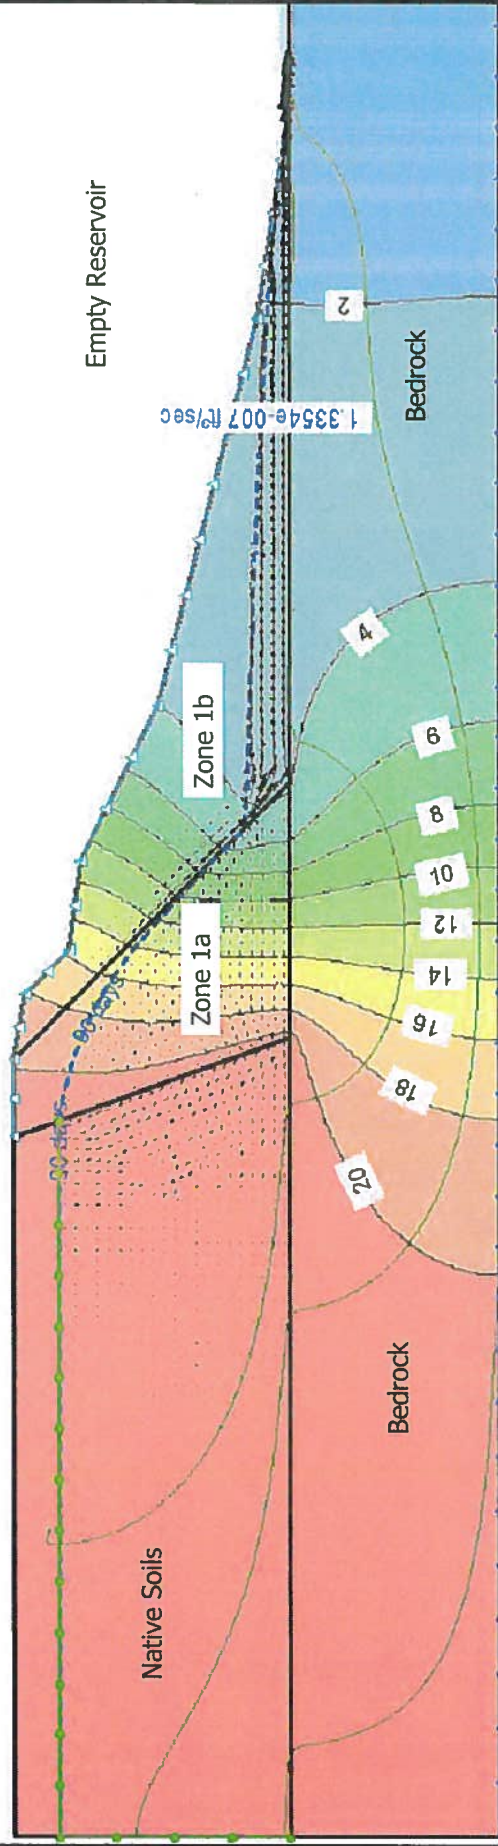
FIGURE 1
Seepage for the Eroded Liner at a
High Water Table

The seepage analyses were performed for a 90 day time period which corresponds with the time needed for a leak test. Figures 1 through 4 in Appendix B show each condition with the total head contours, vector arrows, and flux across the toe of the slope where water would enter the reservoir. The flux in Figure 1 and 2 of the eroded condition was measured where the original toe of the slope would have been. The fan of sand and rock that extended past the toe would have a

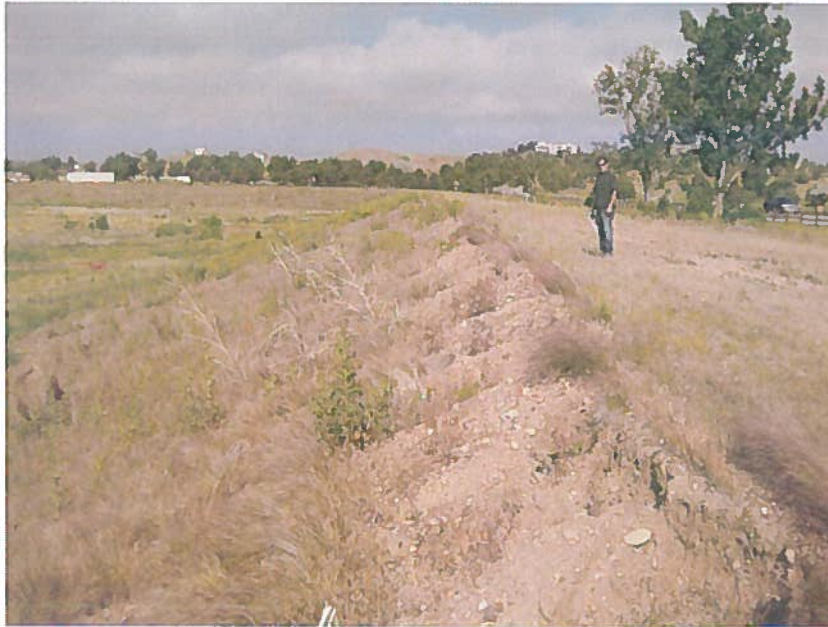
Photo 3 – Damage Area A-2 Facing West

Damage Area A2 is located at the northern edge of Lake 2 and is approximately 1,000 feet east of A-1. At the upper portion of Area A-2, the scarp is approximately 4 feet high. The lower 1.5 feet of the scarp is in Zone 1A liner and the upper 2.5 feet is Zone 1B liner. Midway down the slope, the scarp is approximately 2 feet high and the erosion extends approximately 0.5 feet into the Zone 1A liner. At the bottom of the slope the scarp is approximately 1.5 feet high and the Zone 1A liner was encountered in a boring several inches below the surface. At Area 2, Zone 1b was classified as well graded sand with silt, clay, and gravel (SW-SC) with a liquid limit of 19 and a plasticity index of 7. Zone 1A soil was classified as sandy lean clay (CL), with a liquid limit of 43, and a plasticity index of 25.

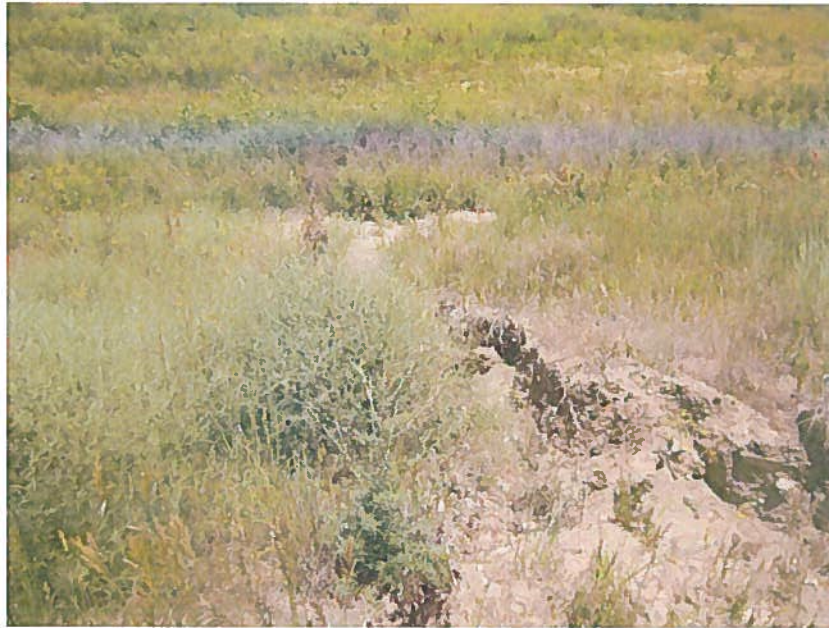
Photo 9 – Damage Area A-6 Facing Northwest

The erosion observed at damage locations A-6 and A-7 was generally less severe than other locations. A detailed subsurface investigation was not conducted at these locations. Damage at location A-6 is a narrow gully, approximately 6 feet wide and four feet deep and occurred as a result of concentrated surface flow from the stockpile area. Damage at Location A-7 was limited to the lower portion of the slope, below the existing wave protection riprap band. Zone 1A material was not observed in either of these locations.

90 mph and a fetch distance of 0.5 mile (USBR, 2014). Due to concentrated flow conditions at Damage Area A6, a riprap rundown was included at this location.
