Inspection

COLORADO DIVISION OF RECLAMATION, MINING AND SAFETY
MINERALS PROGRAM INSPECTION REPORT
PHONE: (303) 866-3567

MINE NAME: Granby Airport Pit	MINE/PROSPECTING ID#: M-1977-254	MINERAL: Sand and gravel	COUNTY: Grand
INSPECTION TYPE: Monitoring	INSPECTOR(S): Peter S. Hays	INSP. DATE: November 5, 2014	INSP. TIME: 09:00
OPERATOR: Grand County	OPERATOR REPRESENTATIVE: Bill Clark	TYPE OF OPERATION: 110c - Construction Limited Impact

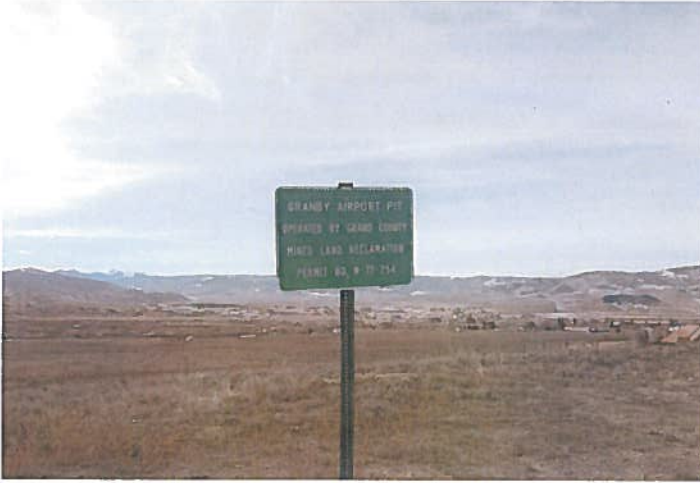
An entrance sign was posted and permit boundary markers were observed as required by Rule 3.1.12.

Granby Airport Pit sign

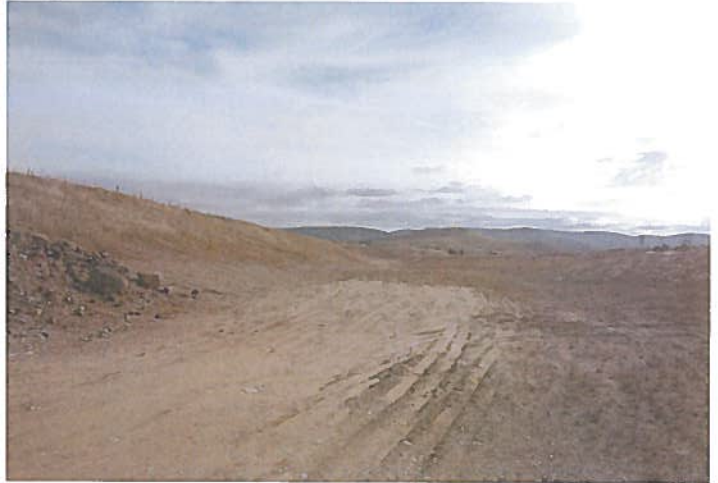
Looking east from west end of site

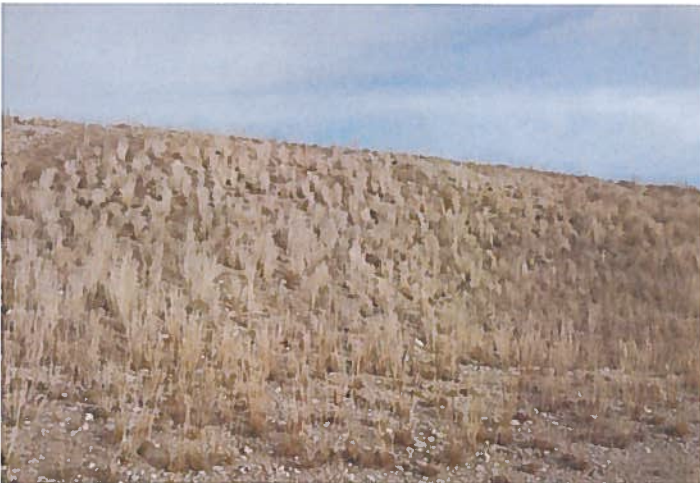
Portions of the east and west slopes were well vegetated with wheatgrass, however additional vegetation will be required prior to any future release requests by the Division. Overall, the final site reclamation is progressing well.

Well vegetated section of north slope

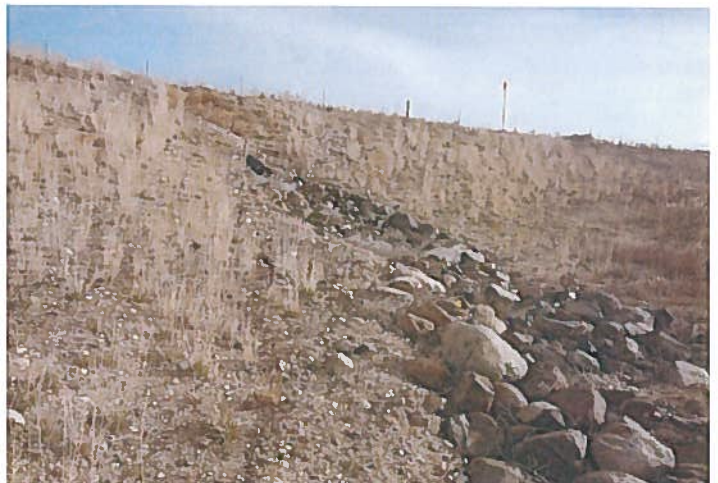
Northeast corner stormwater pipe and erosion control

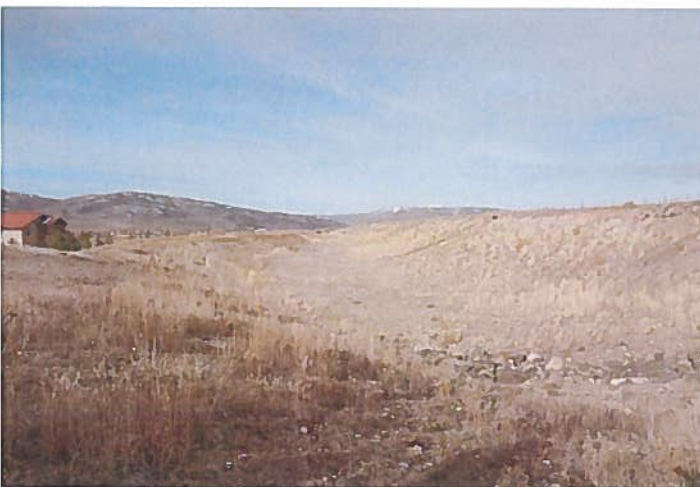
Looking west from east end of site

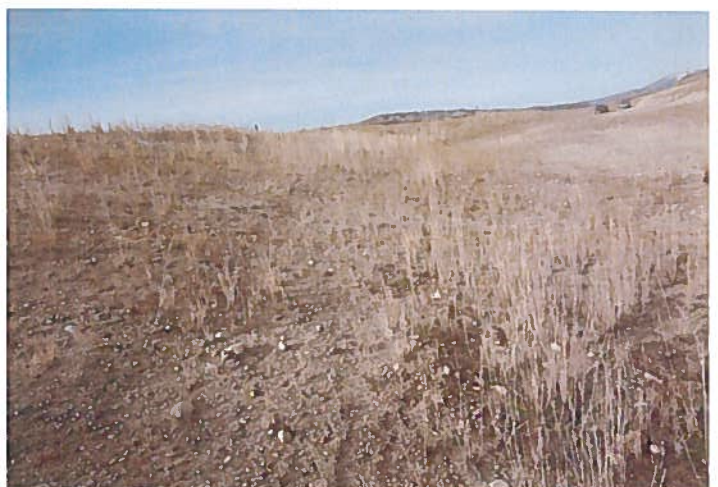
Looking at bare section of south slope
