**COLORADO DIVISION OF RECLAMATION, MINING AND SAFETY**  
**MINERALS PROGRAM INSPECTION REPORT**  
**PHONE: (303) 866-3567**

<b>MINE NAME:</b> Cresson Project	<b>MINE/PROSPECTING ID#:</b> M-1980-244	<b>MINERAL:</b> Gold	<b>COUNTY:</b> Teller
<b>INSPECTION TYPE:</b> Aerial Inspection	<b>INSPECTOR(S):</b> Timothy A. Cazier	<b>INSP. DATE:</b> May 14, 2014	<b>INSP. TIME:</b> 08:20
<b>OPERATOR:</b> Cripple Creek & Victor Gold Mining Company	<b>OPERATOR REPRESENTATIVE:</b> None	<b>TYPE OF OPERATION:</b> 112d-3 - Designated Mining Operation

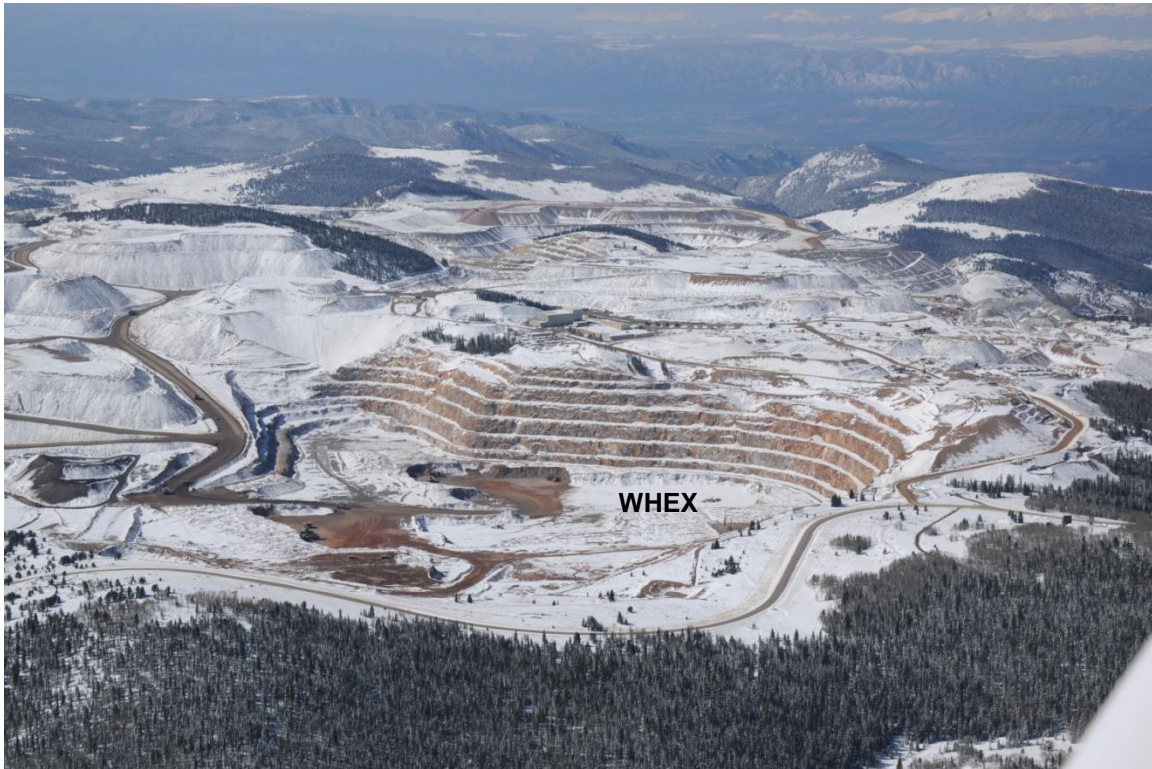
Photo 1. Wildhorse Extension Pit (Looking SW).

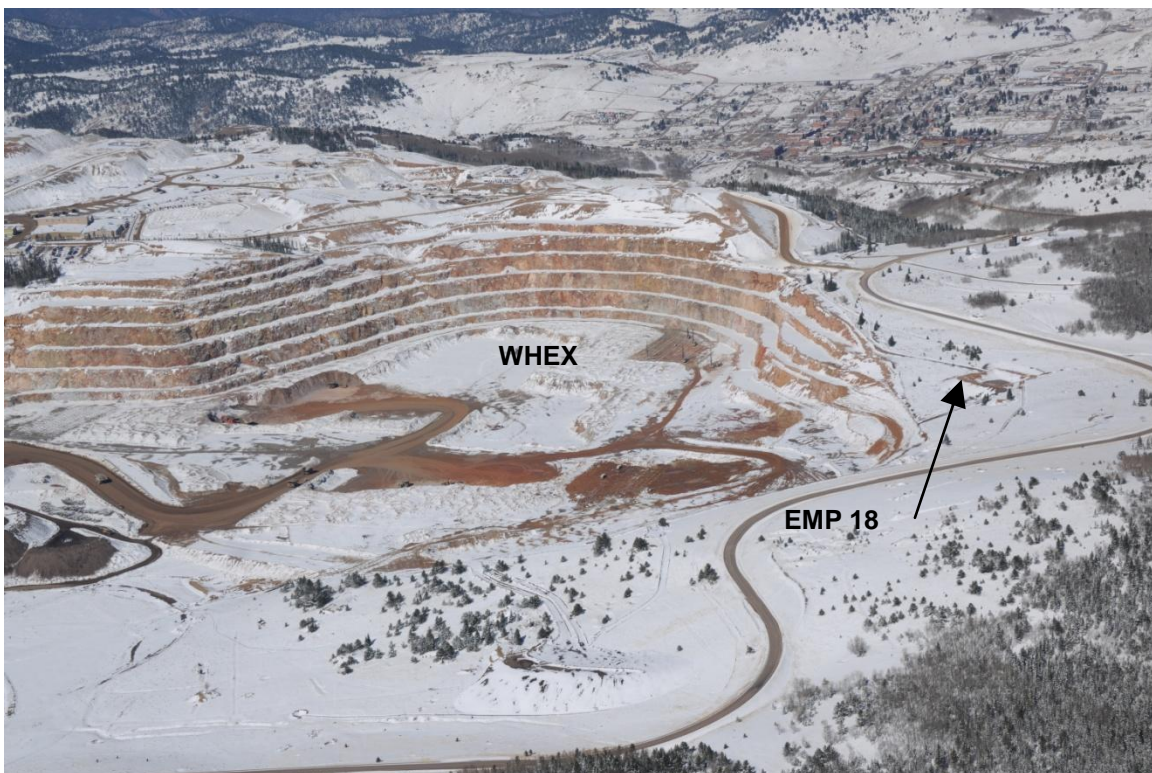
Photo 2. Wildhorse Extension Pit (Looking NW).

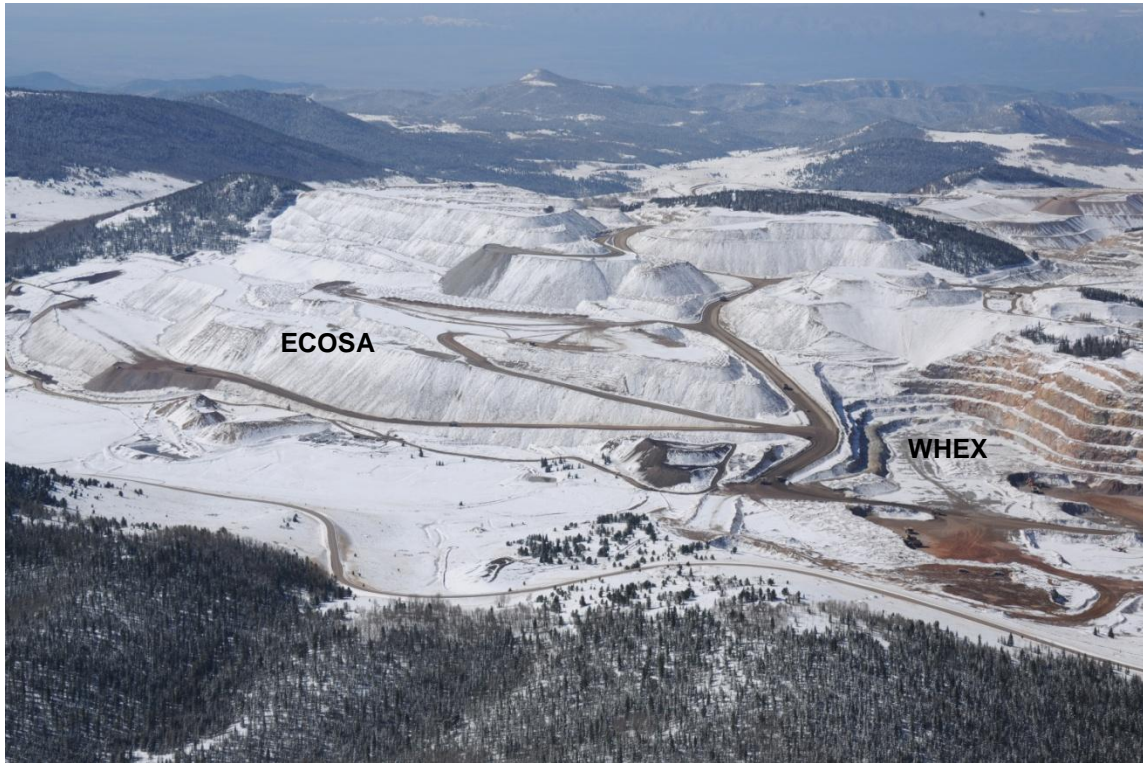
Photo 3. East Cresson OSA (looking SW).

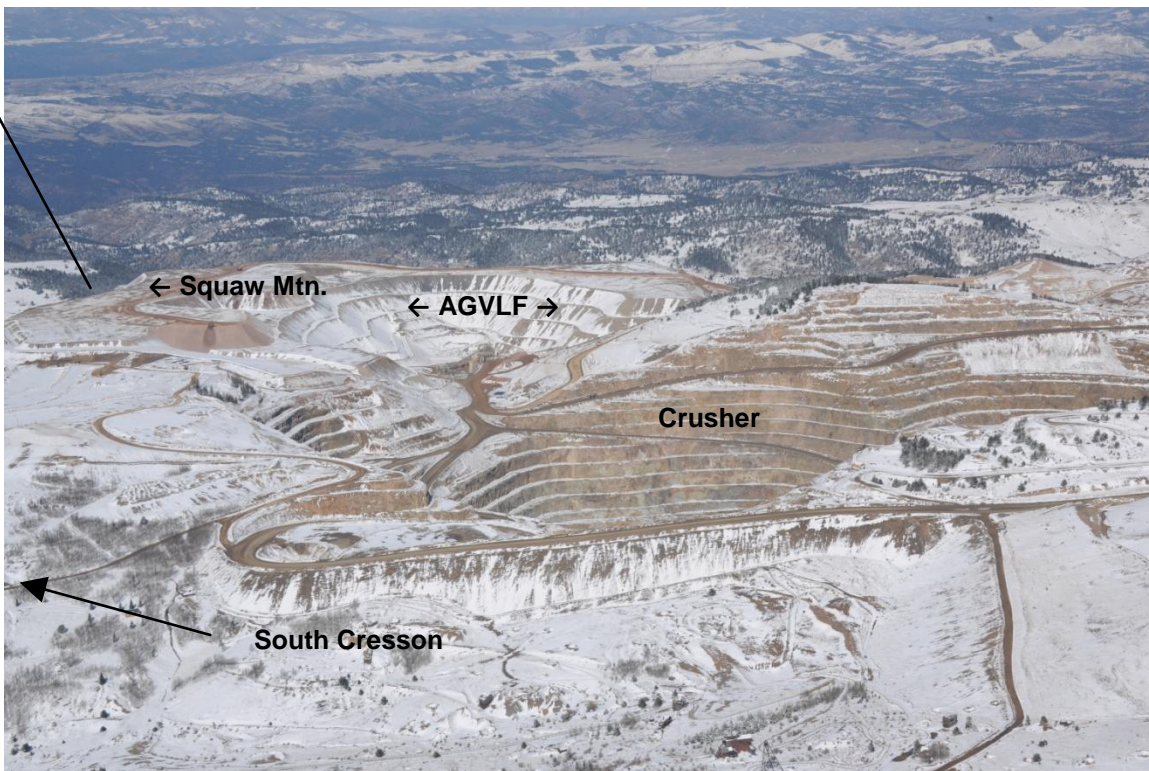
Photo 4. South Cresson (looking west).

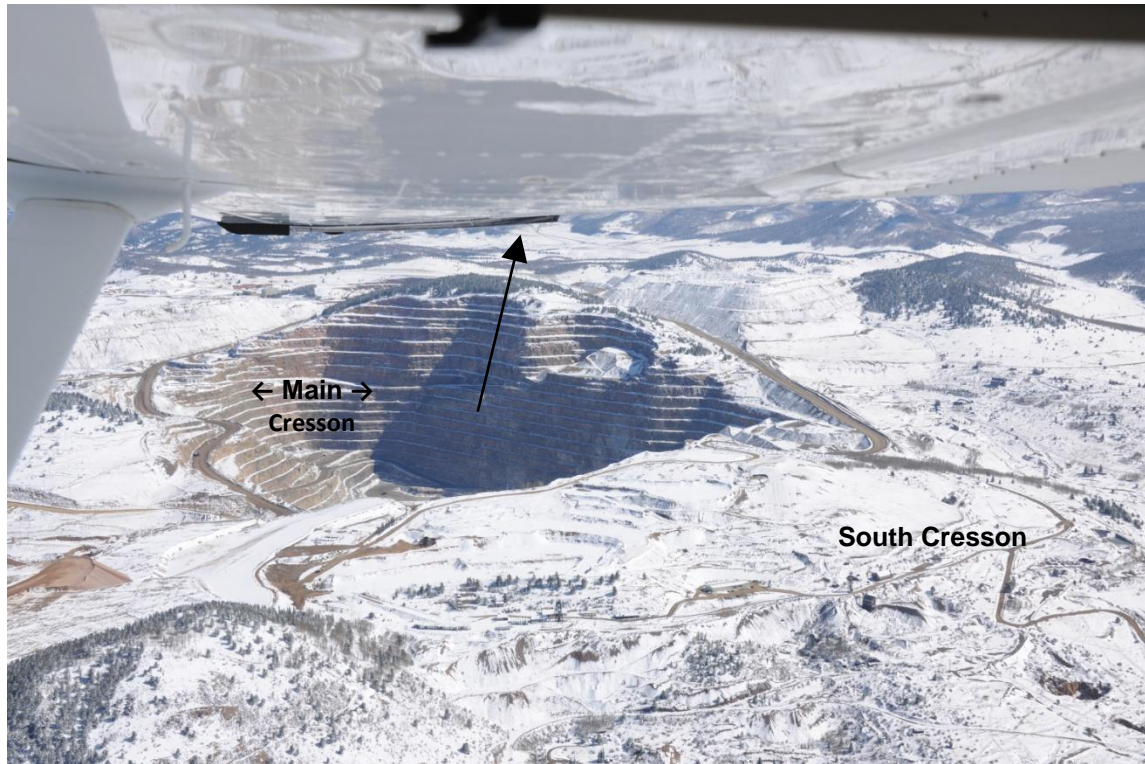
Photo 5. Main Cresson Pit (looking NE).

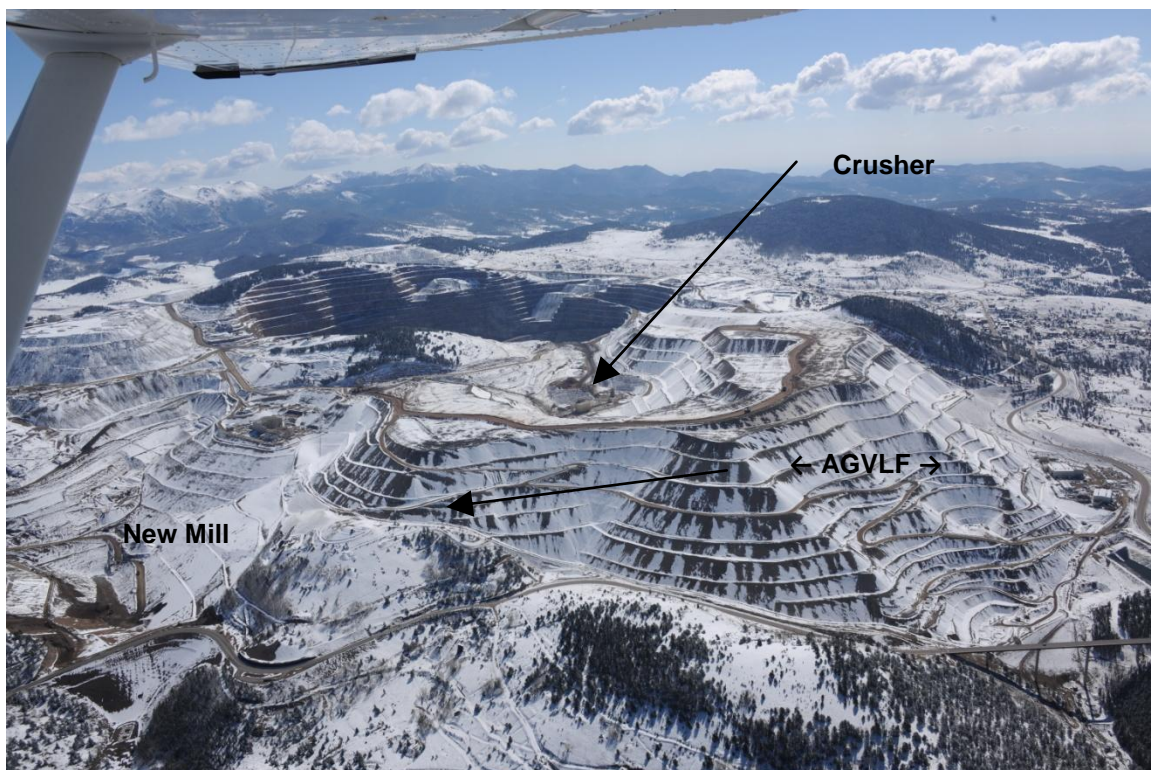
Photo 6. Arequa Gulch VLF (looking SE).

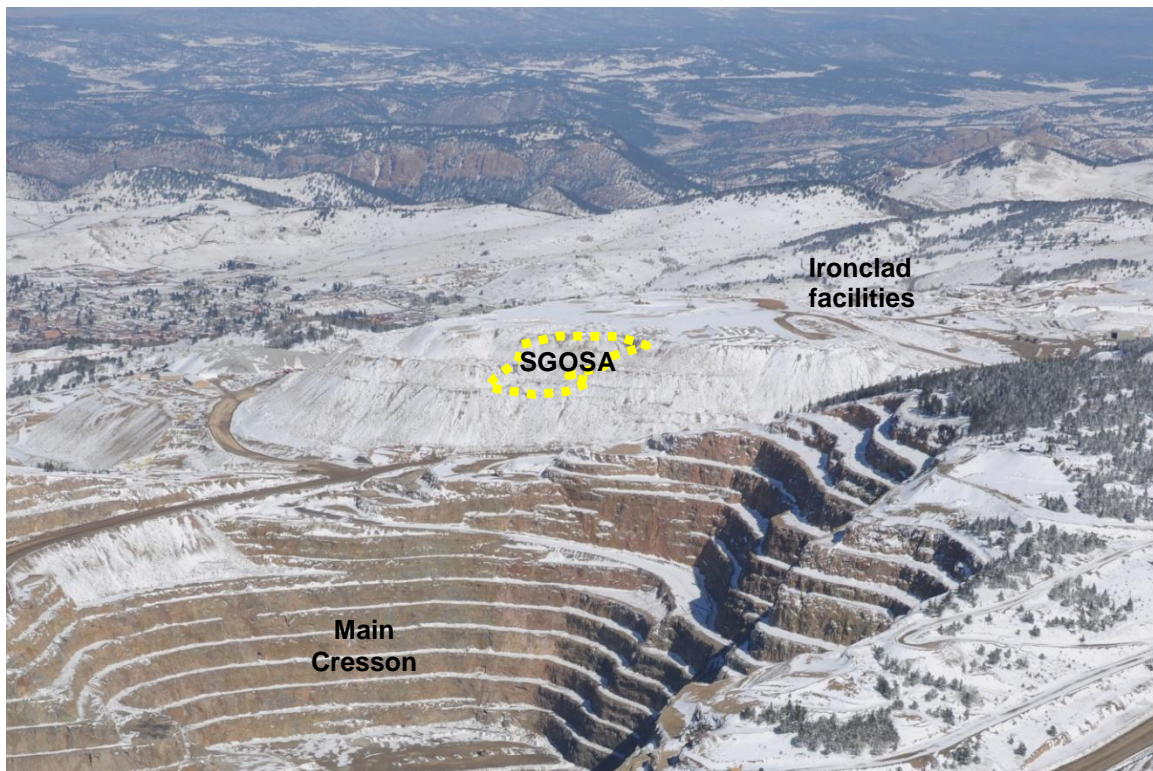
Photo 8. Squaw Gulch OSA (Looking NW).

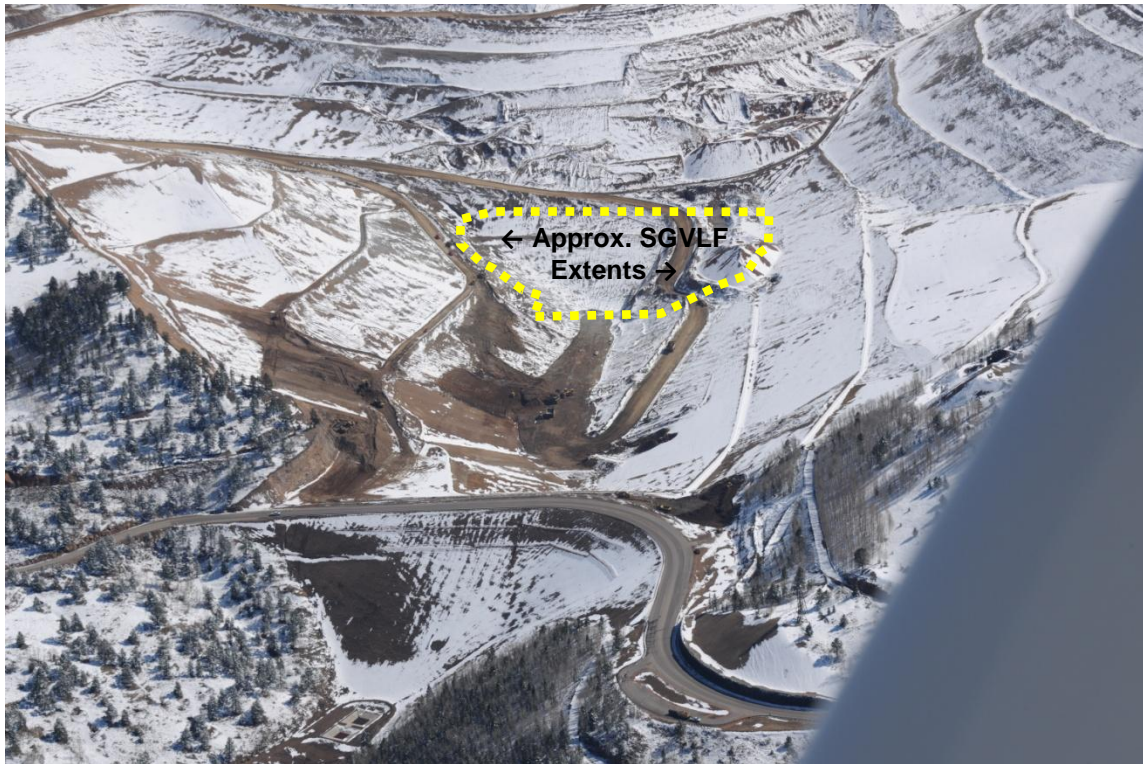
Photo 9. Squaw Gulch VLF (Looking NE).

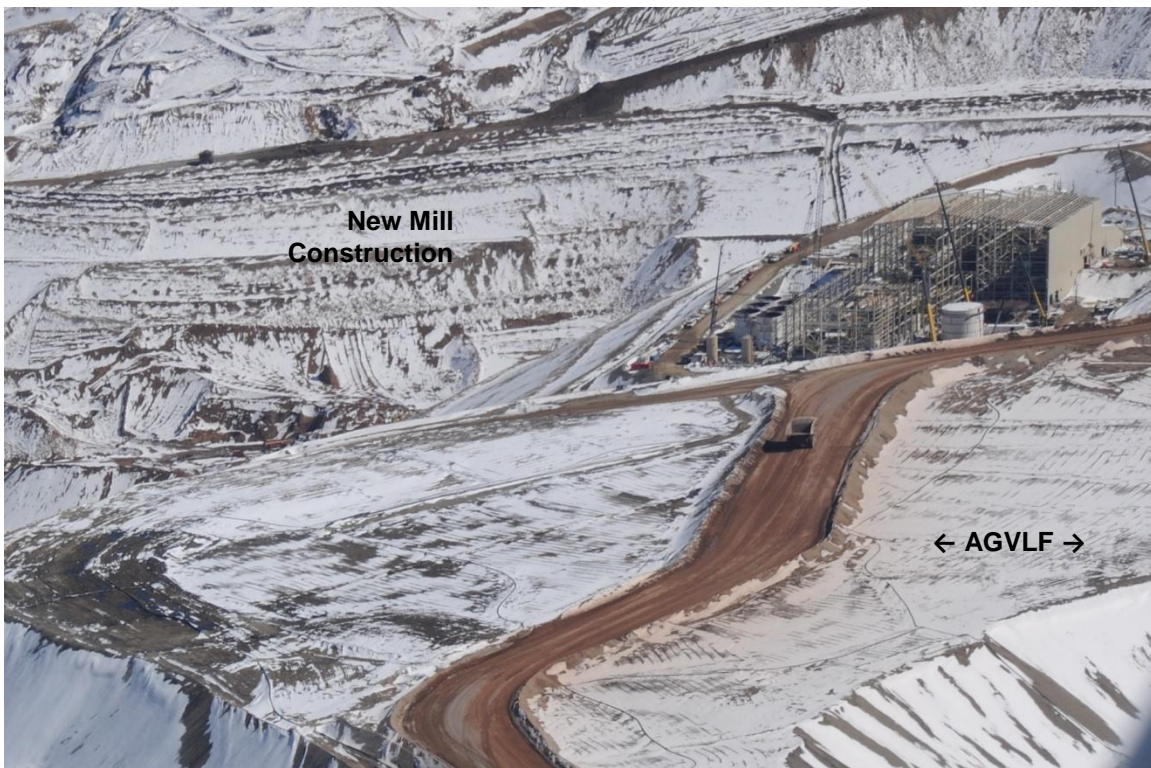
Photo 10. New High Grade Mill Platform (Looking north).
