COLORADO DIVISION OF RECLAMATION, MINING AND SAFETY
MINERALS PROGRAM INSPECTION REPORT
PHONE: (303) 866-3567

| MINE NAME: Cresson Project | MINE/PROSPECTING ID#: M-1980-244 | MINERAL: Gold | COUNTY: Teller |
| INSPECTION TYPE: Aerial Inspection | INSPECTOR(S): Timothy A. Cazier | INSP. DATE: August 29, 2014 | INSP. TIME: 12:40 |

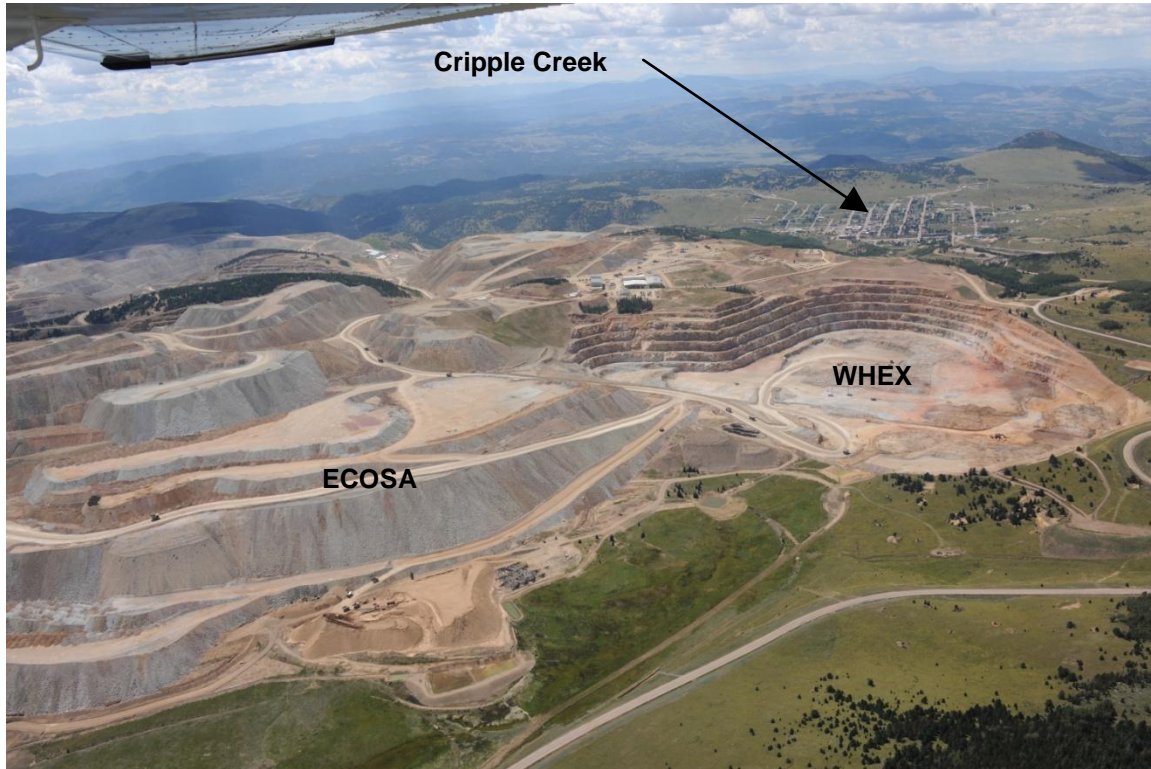
Photo 1. Wildhorse Extension Pit (Looking west).

| Photo ID | Mine Facility | Perspective | Notes |
|---|---|---|---|
| Photo 1 | Wildhorse Extension Pit (WHEX) | Looking west | 6 benches and pit floor |

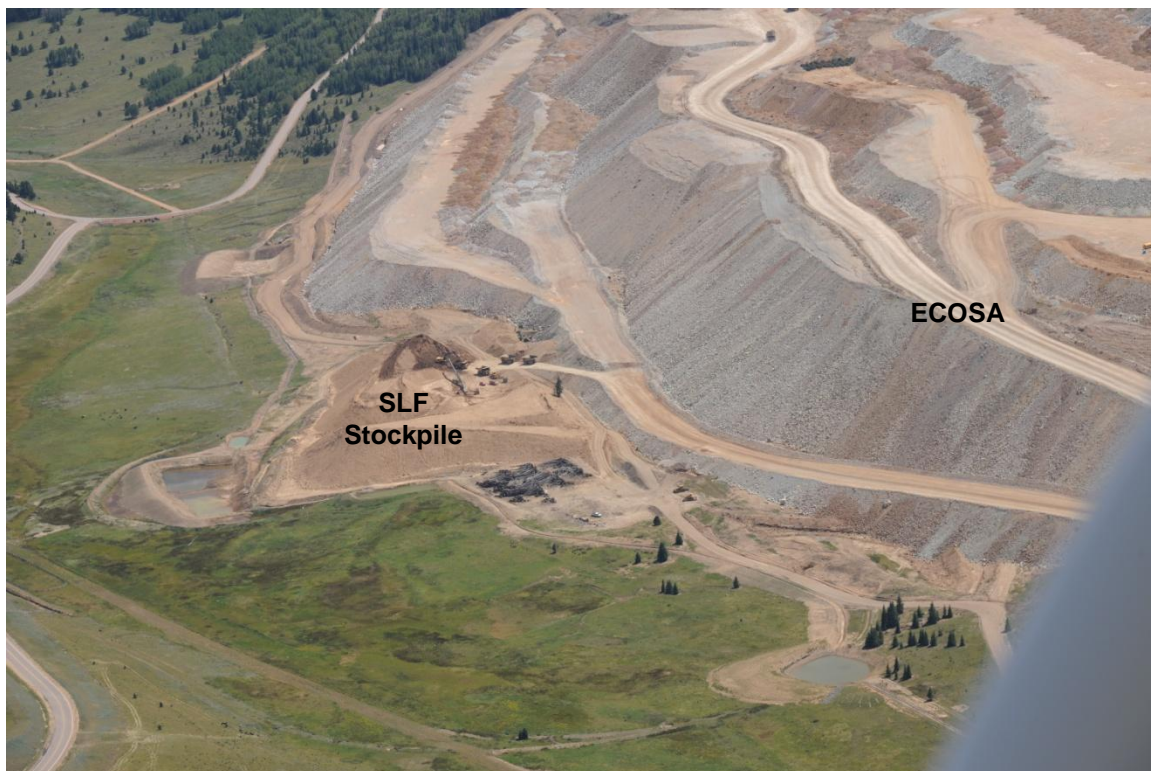
Photo 2. Soil Liner Fill stockpile at Cameron site (Looking SE).

| Photo ID | Mine Facility | Perspective | Notes |
|---|---|---|---|
| Photo 2 | Soil Liner Fill stockpile (Cameron) | Looking SE | Stockpiling SLF for SGVLF near Cameron area |

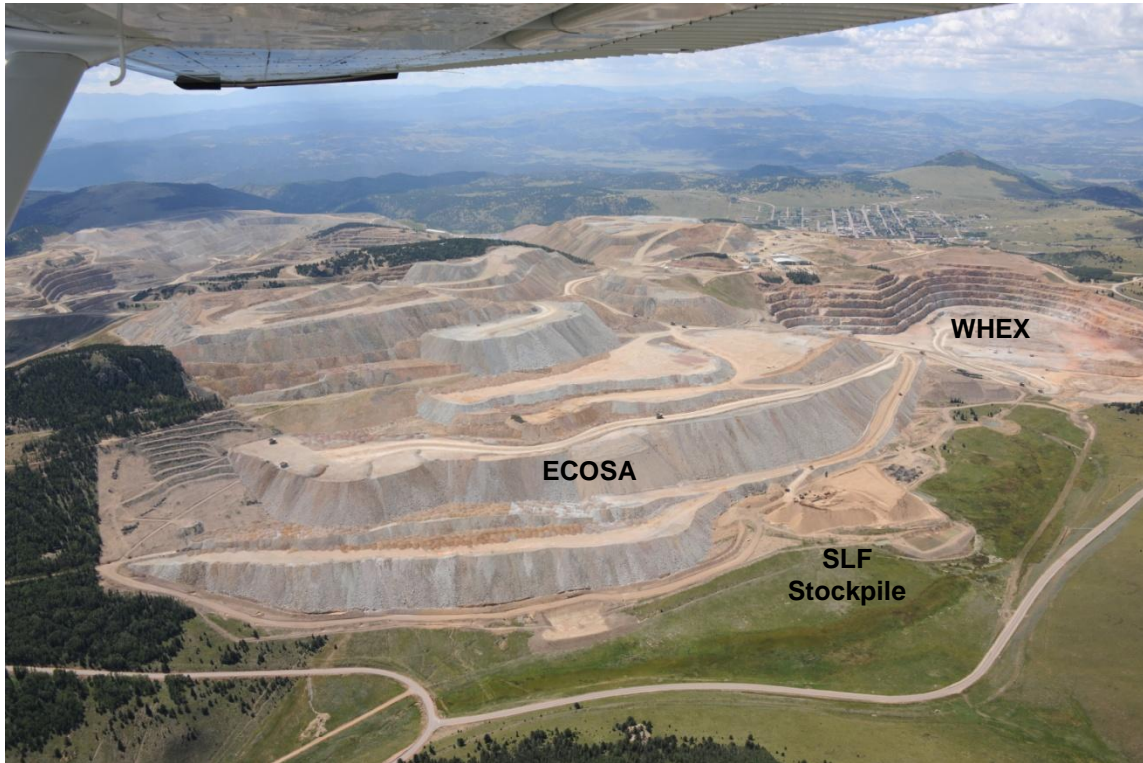
Photo 3. East Cresson OSA (looking west).

| Photo ID | Mine Facility | Perspective | Notes |
|---|---|---|---|
| Photo 3 | East Cresson OSA | Looking west | WHEX to right |

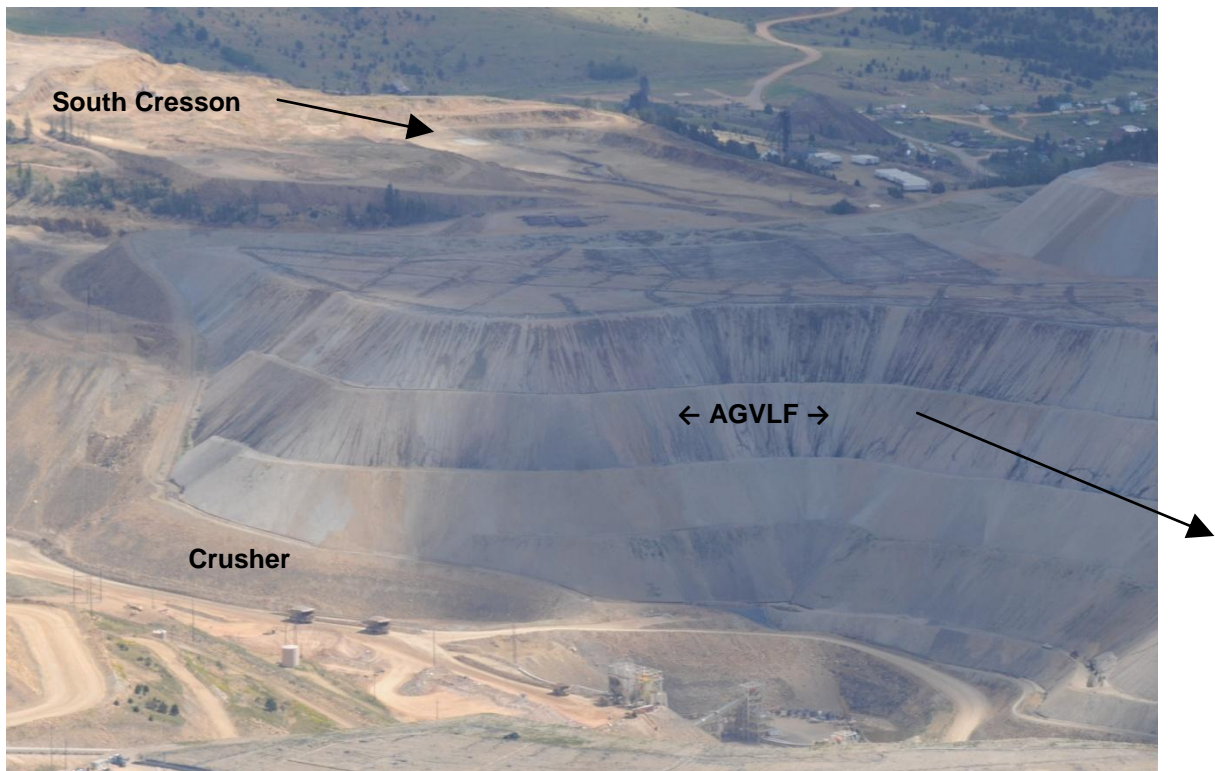
Photo 4. South Cresson (looking SE).

| Photo ID | Mine Facility | Perspective | Notes |
|---|---|---|---|
| Photo 4 | South Cresson | Looking SE | Arequa Gulch VLF and Crusher in foreground |

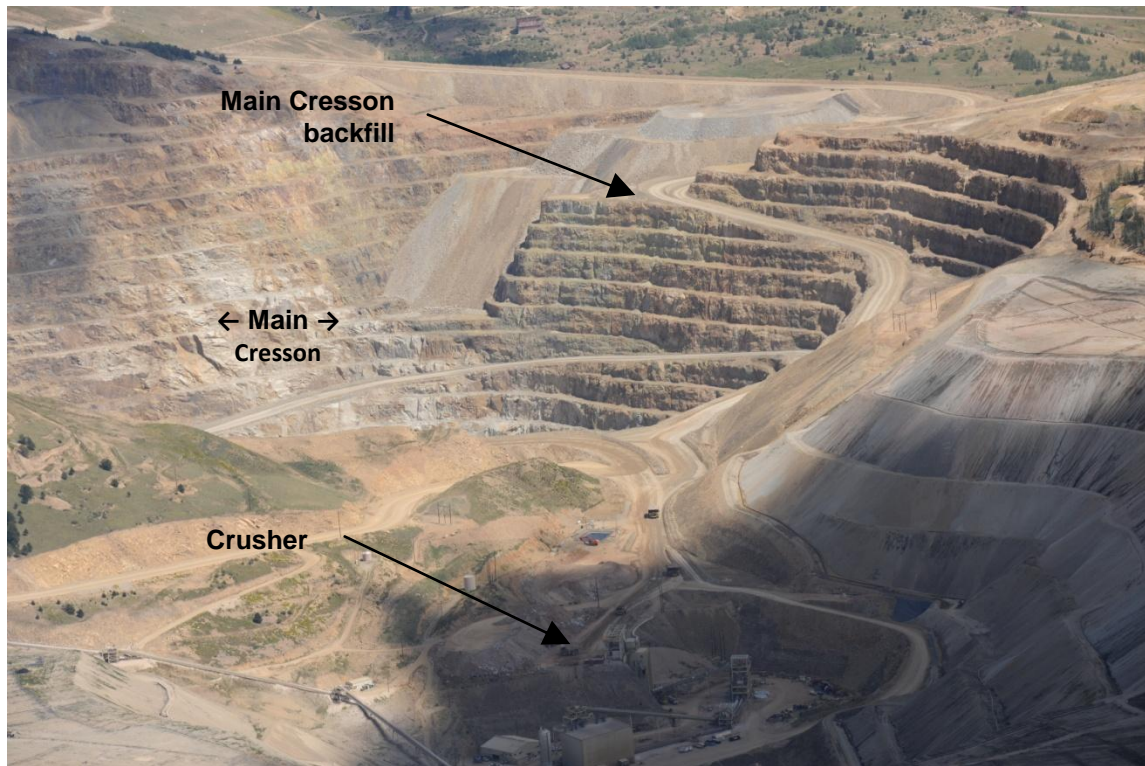
Photo 5. Main Cresson Pit (looking SE).

| Photo ID | Mine Facility | Perspective | Notes |
|---|---|---|---|
| Photo 5 | Main Cresson Pit | Looking SE | Shows backfill in SE corner |

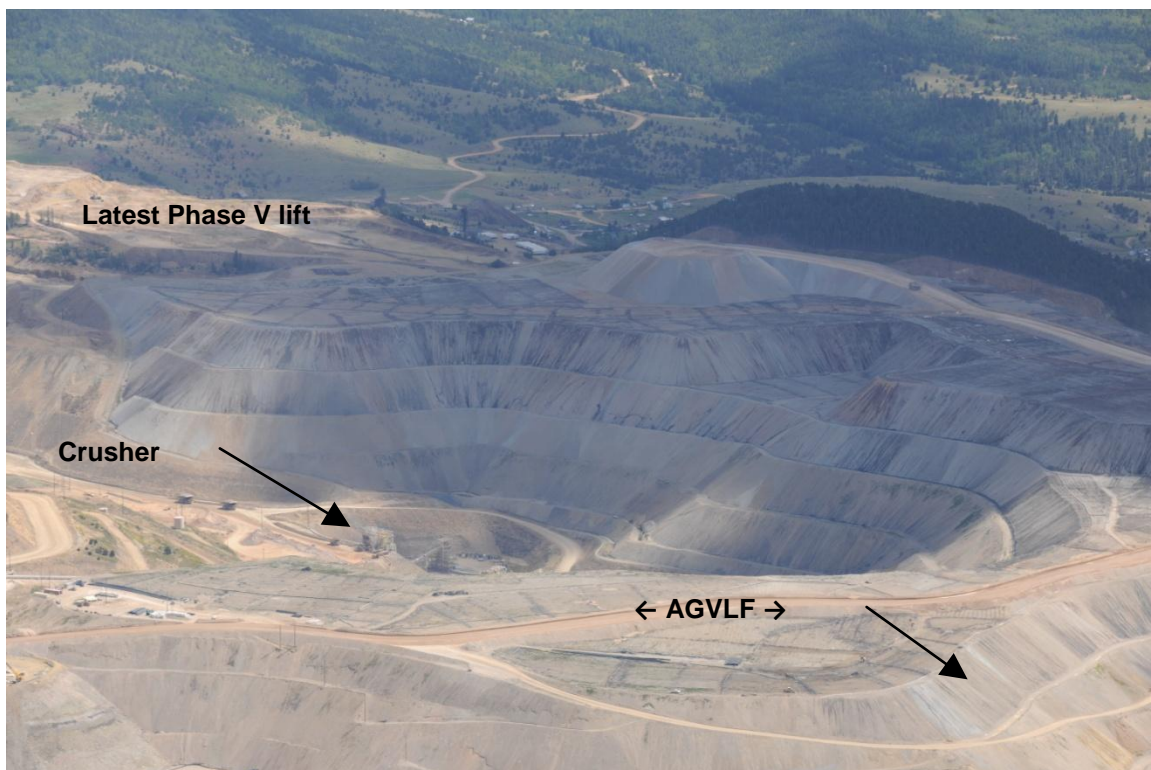
Photo 6. Arequa Gulch VLF (looking SE).

| Photo ID | Mine Facility | Perspective | Notes |
|---|---|---|---|
| Photo 6 | Arequa Gulch VLF | Looking SE | New Phase V lift, Crusher in center |

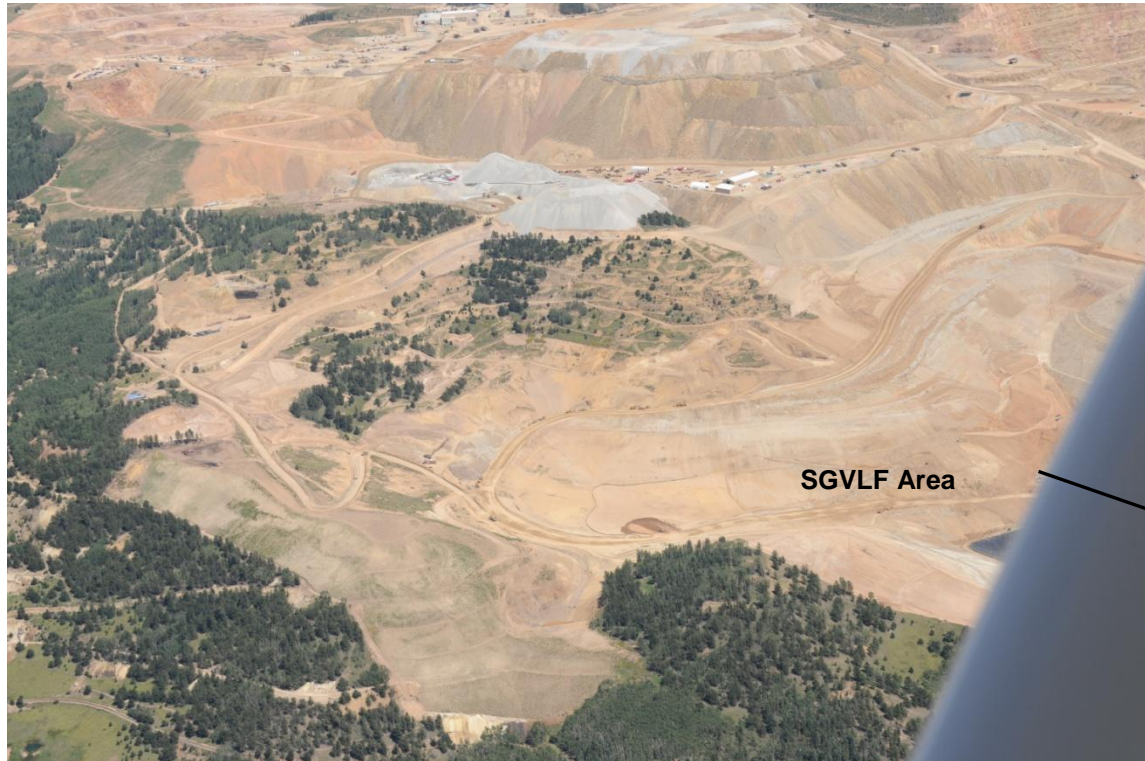
Photo 7. New growth medium stockpile #34 (looking east).

| Photo ID | Mine Facility | Perspective | Notes |
|---|---|---|---|
| Photo 7 | New growth medium stockpile #34 | Looking east | North end of SGVLF on right, vegetation getting established |

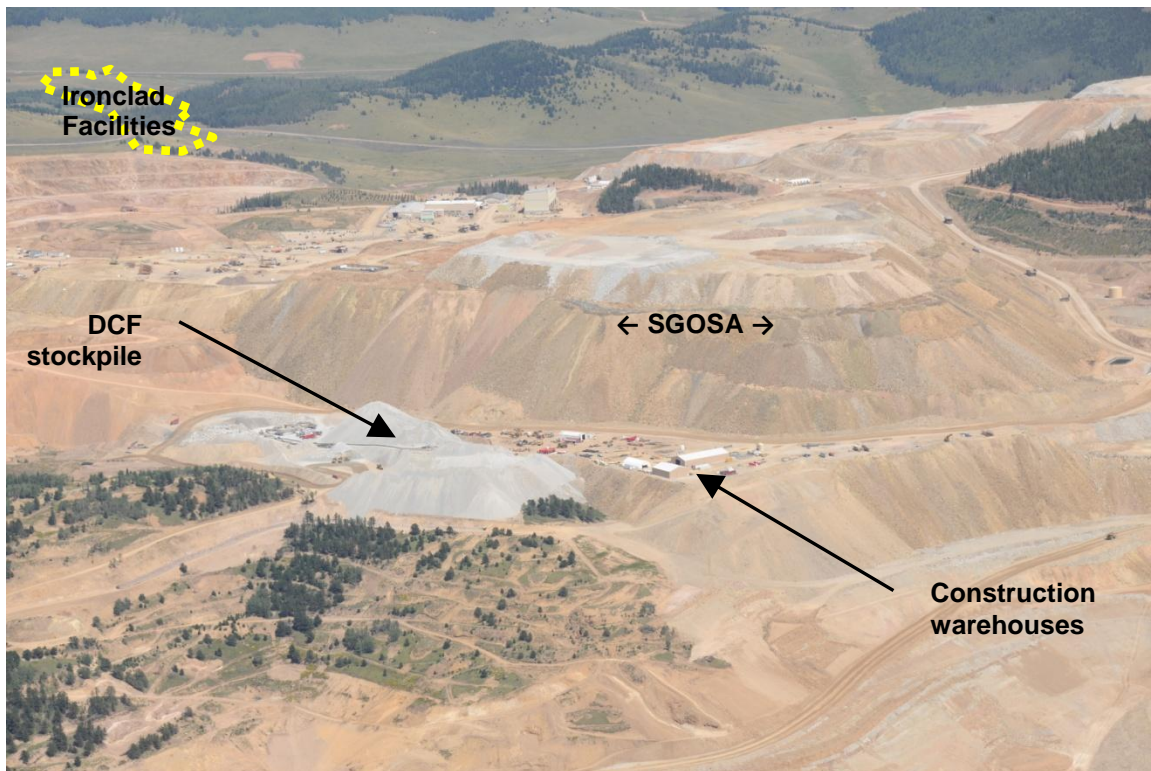
Photo 8. Squaw Gulch OSA (Looking east).

| Photo ID | Mine Facility | Perspective | Notes |
|---|---|---|---|
| Photo 8 | Squaw Gulch OSA | Looking east | DCF stockpile in foreground, Ironclad Facility beyond |

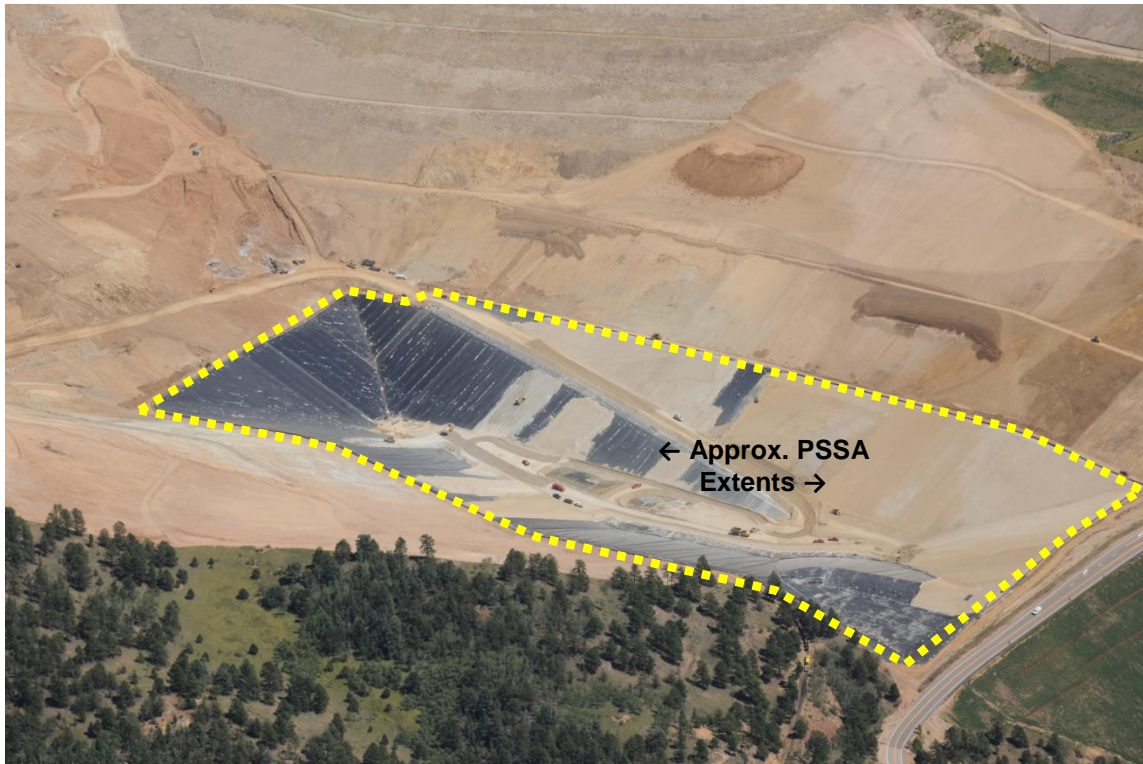
Photo 9. Squaw Gulch VLF Pregnant Solution Storage Area (Looking east).

| Photo ID | Mine Facility | Perspective | Notes |
|---|---|---|---|
| Photo 9 | Squaw Gulch VLF (SGVLF) | Looking east | Installing liner |

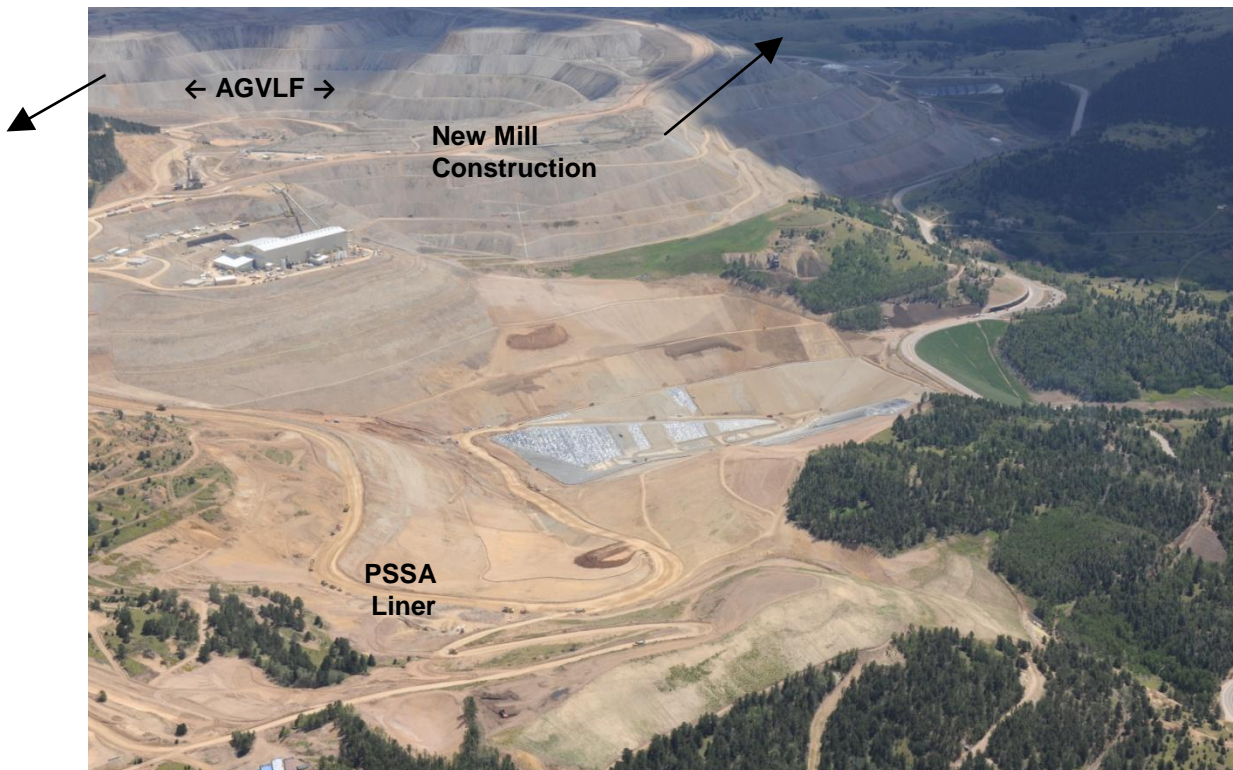
Photo 10. New High Grade Mill Platform (Looking south).

| Photo ID | Mine Facility | Perspective | Notes |
|---|---|---|---|
| Photo 10 | New High Grade Mill & SGVLF | Looking south | AGVLF in background |
