COLORADO DIVISION OF RECLAMATION, MINING AND SAFETY
MINERALS PROGRAM INSPECTION REPORT
PHONE: (303) 866-3567

MINE NAME: Cresson Project	MINE/PROSPECTING ID#: M-1980-244	MINERAL: Gold	COUNTY: Teller
INSPECTION TYPE: Monitoring	INSPECTOR(S): Timothy A. Cazier	INSP. DATE: April 9, 2014	INSP. TIME: 09:35
OPERATOR: Cripple Creek & Victor Gold Mining Company	OPERATOR REPRESENTATIVE: Chris Hanks, Scott Redabaugh	TYPE OF OPERATION: 112d-3 - Designated Mining Operation

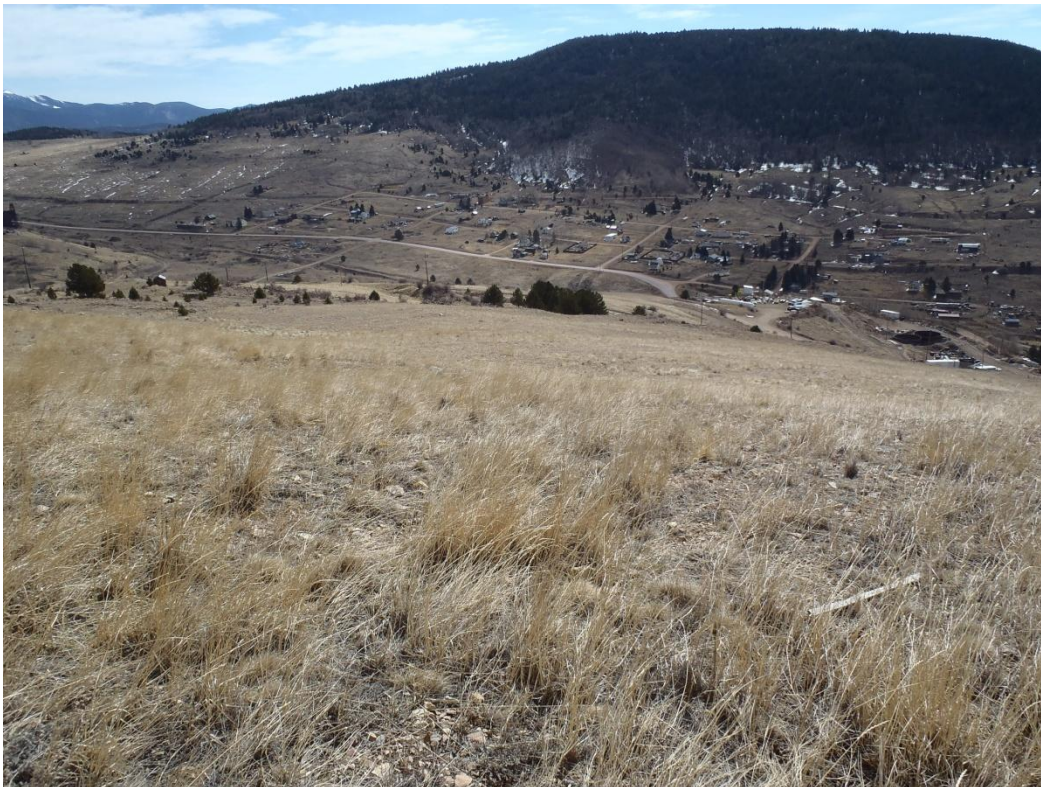
Acreage release: The Division observed the proposed acreage release area southeast of the existing radio tower (see **Photo 1**). The area appeared acceptable for release.

Photo 1. Proposed acreage release area southeast of the existing radio tower (looking east).

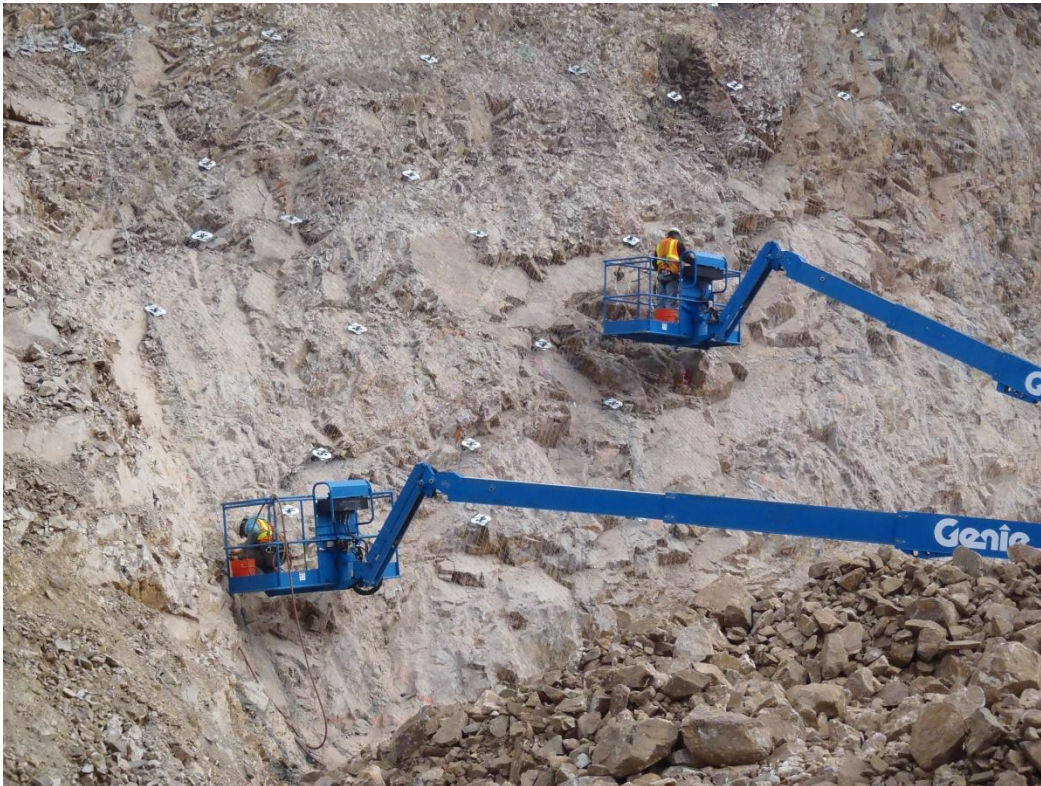
Construction: The Division observed installation of rock bolts designed to stabilize the steep wall on the west side of the proposed ADR (see **Photo 2**).

Photo 2. Installation of rock bolts in the steep wall on the west side of proposed ADR.

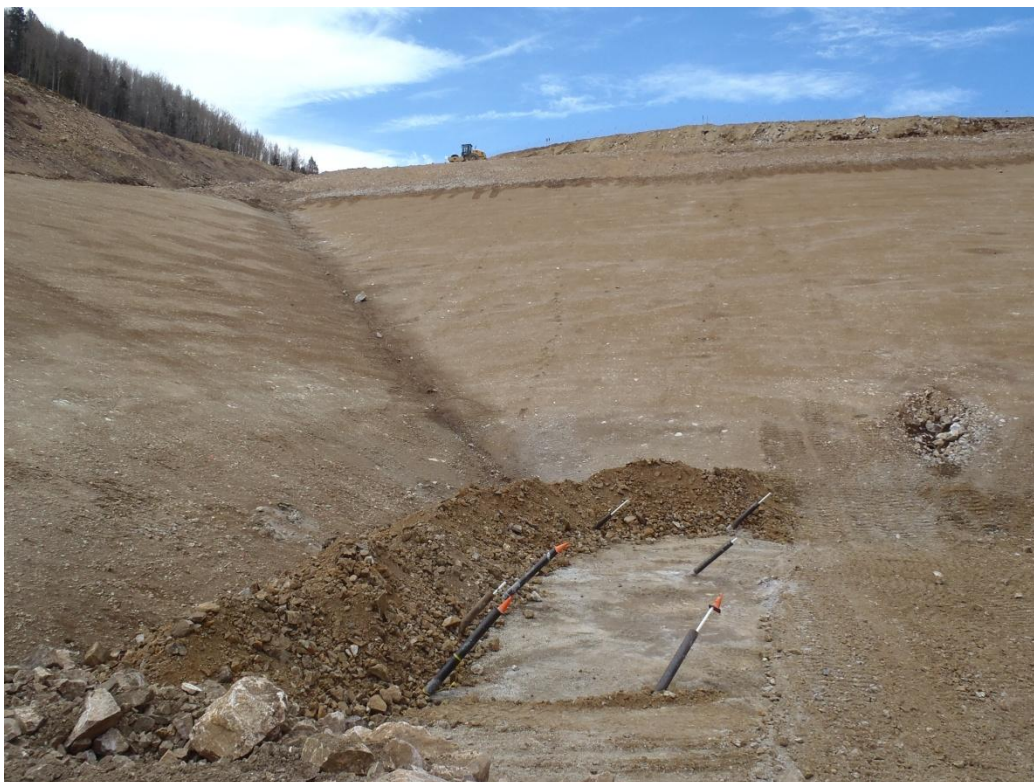
Scott Redabaugh and Ron DiDonato, representing CC&V provided oversight and answered the Division's questions regarding construction activity in the PSSA area. The Division observed the completed PSSA closure drains (see **Photo 3**) and secondary underdrain construction (see **Photo 4**). Mr. Redabaugh explained CC&V used geophysics to check for voids under the PSSA.

Photo 3. PSSA closure drains (looking south).

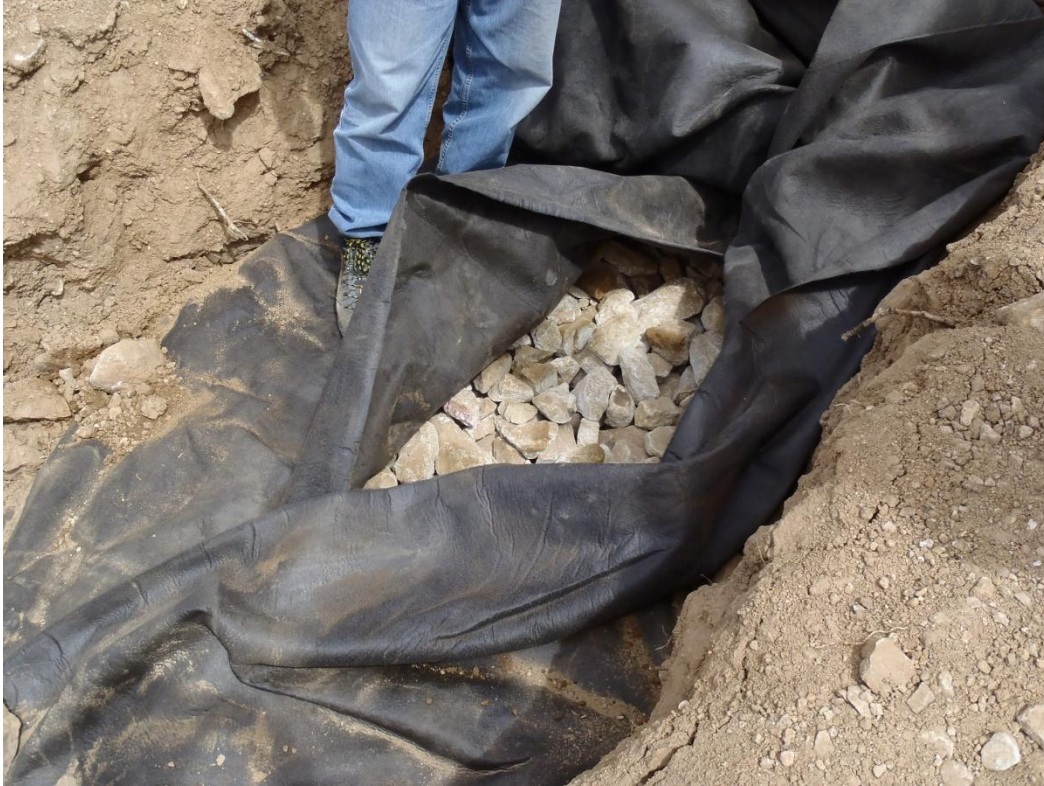
Photo 4. Secondary underdrain construction.

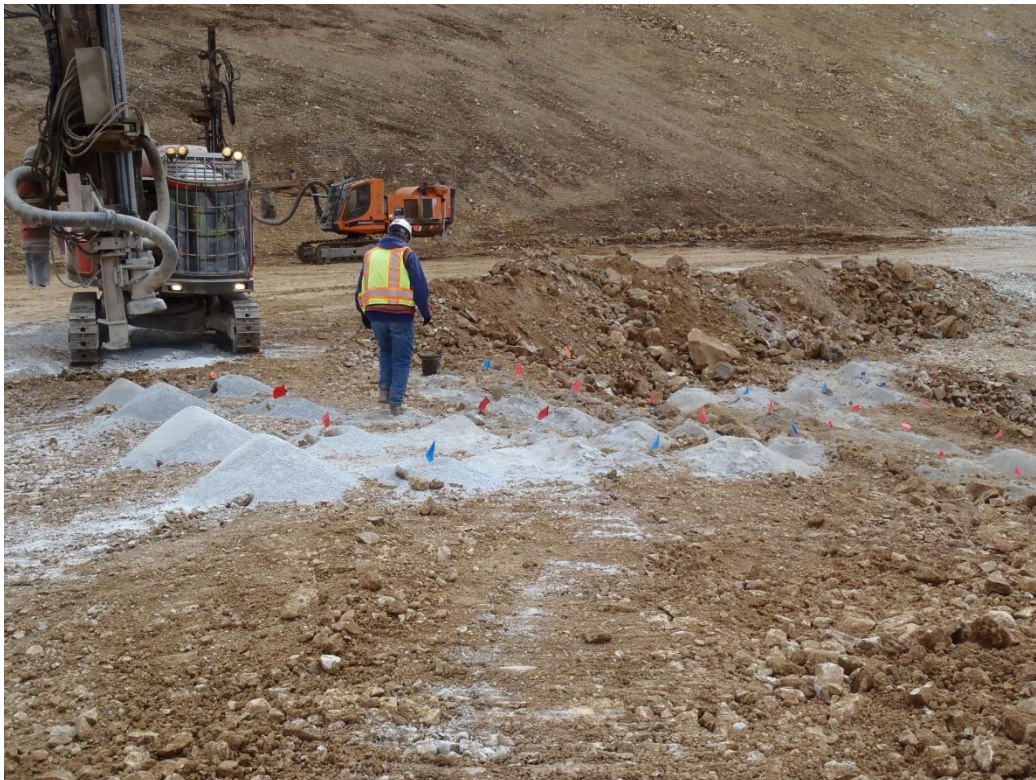
remediation approach used to ensure existing mine workings are stabilized prior to PSSA/VLF liner construction. A drilling program is used to confirm the extent of identified underground workings. Holes are drilled in a grid pattern (see **Photo 5**) to delineate the horizontal and vertical extents of underground workings within 50 feet of the surface. Red flags (see **Photo 6a**) confirm the existence of a void and are labeled with: underground working ID #, borehole #, void depth, and drilling date. Blue flags (see **Photo 6b**) indicate no void found and are labeled with: underground working ID #, borehole #, and drilling date. An excavator was observed exposing a drift (see **Photo 7**) for future remediation. Open workings, collapsed workings, shallow surface pits, laterals/drifts, inclines, and adits are all remediated per division approved project specifications. The new mill construction progress was observed from the AGVLF (see **Photo 8**).

Photo 5. Drill pattern to delineate extents of underground working (NE of PSSA).

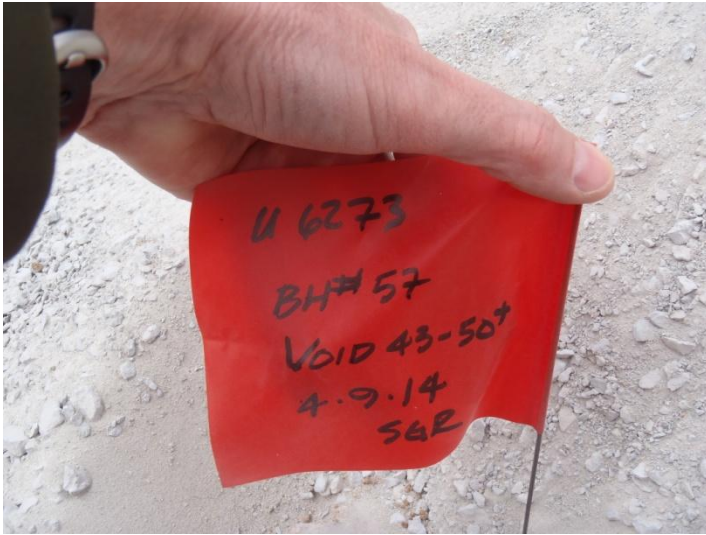
Photo 6a. Red Flag – confirming void.

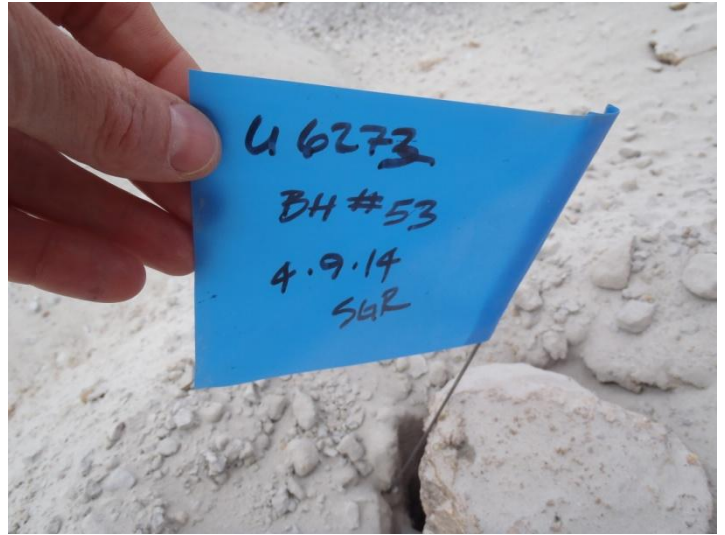
Photo 6b. Blue Flag – no void found.

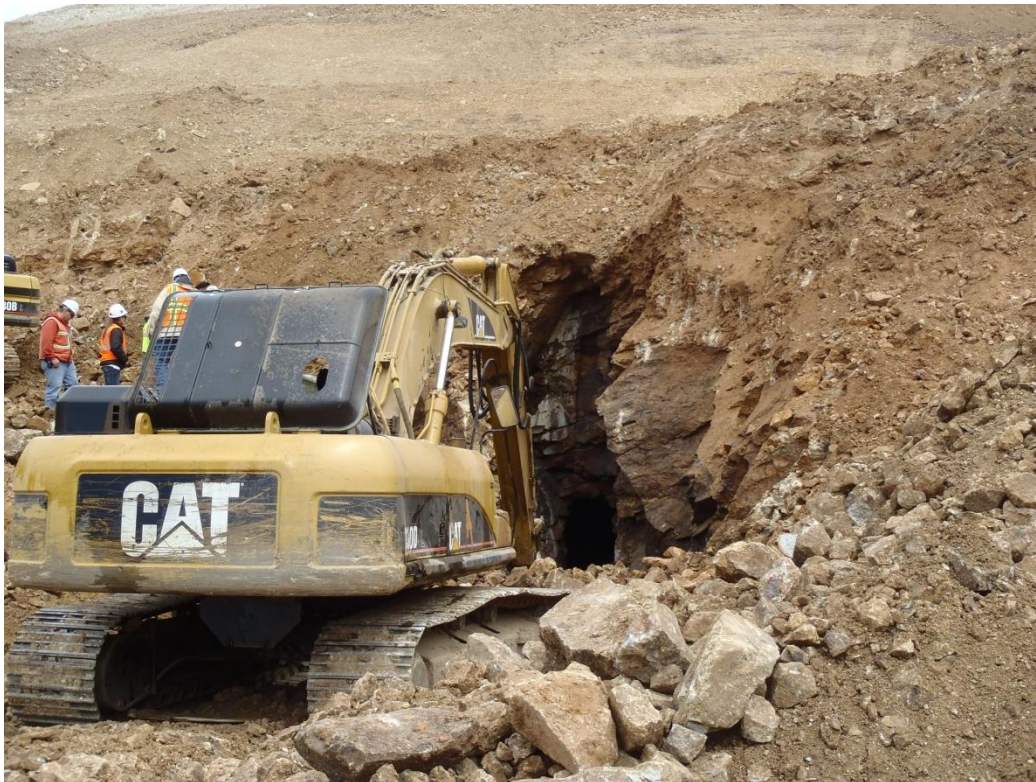
Photo 7. Excavator exposing a drift for future remediation (NE of PSSA).

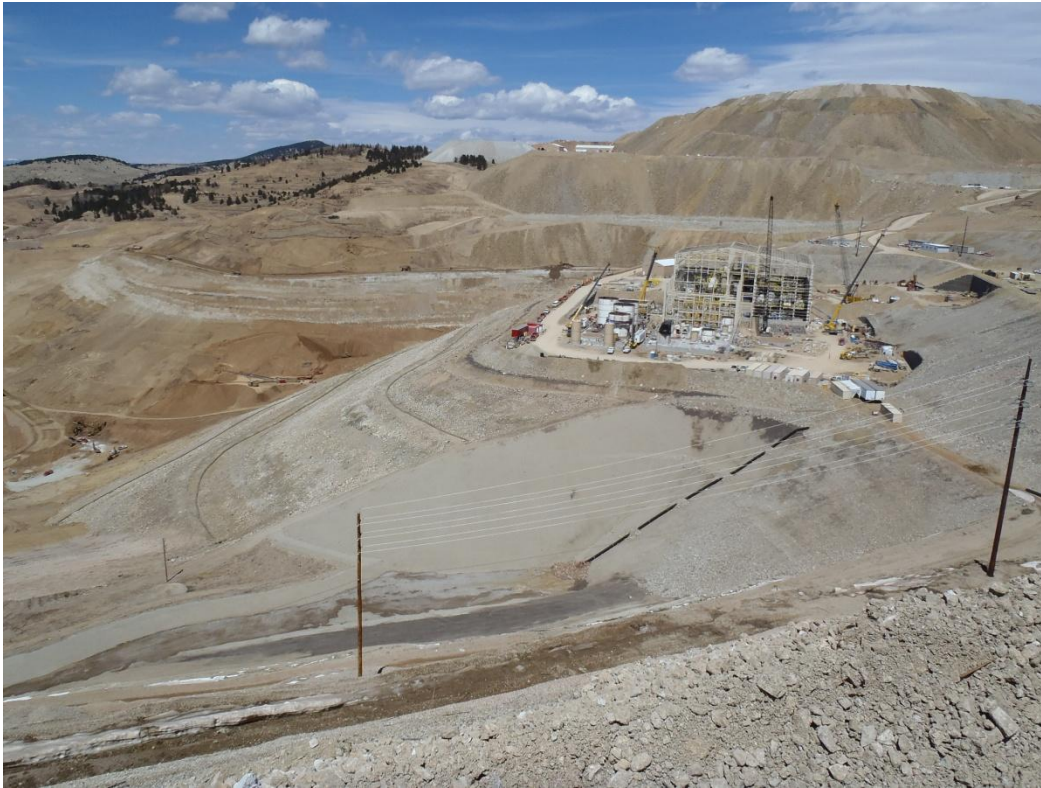
Photo 8. New mill construction progress (looking north).
