COLORADO DIVISION OF RECLAMATION, MINING AND SAFETY
MINERALS PROGRAM INSPECTION REPORT
PHONE: (303) 866-3567

MINE NAME: Cresson Project	MINE/PROSPECTING ID#: M-1980-244	MINERAL: Gold	COUNTY: Teller
INSPECTION TYPE: Monitoring	INSPECTOR(S): Timothy A. Cazier	INSP. DATE: June 3, 2014	INSP. TIME: 11:00
OPERATOR: Cripple Creek & Victor Gold Mining Company	OPERATOR REPRESENTATIVE: Chris Hanks	TYPE OF OPERATION: 112d-3 - Designated Mining Operation

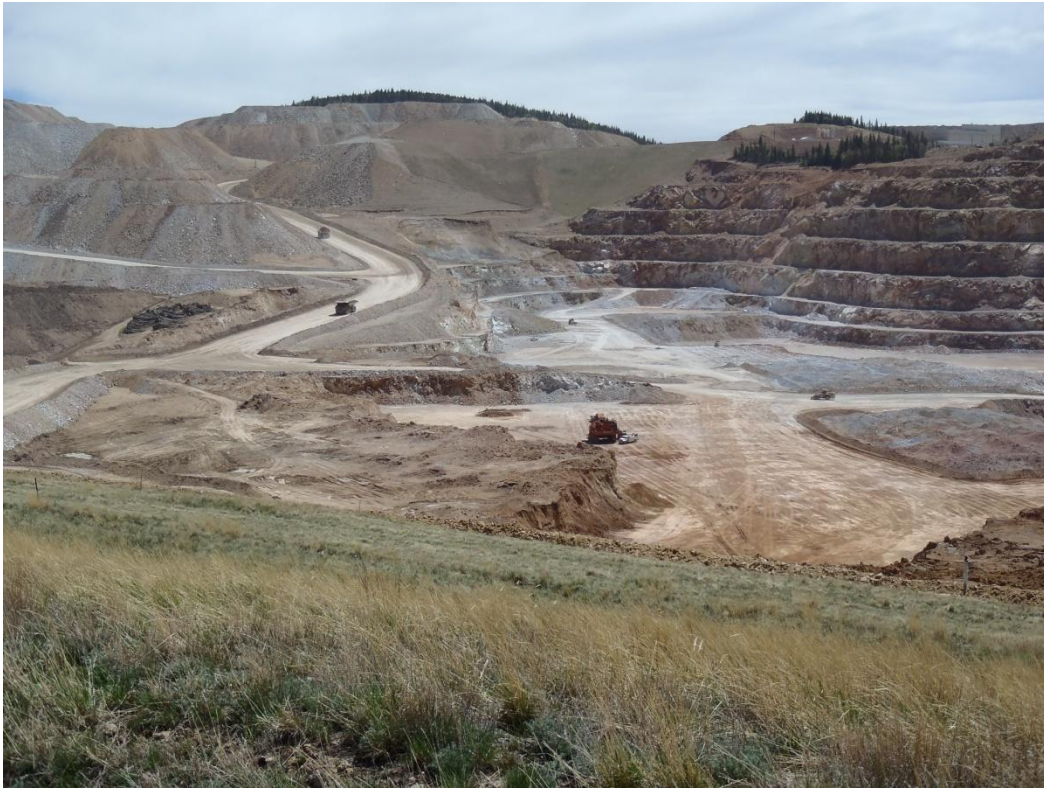
Mine plan: Active mining was focused primarily in the Wildhorse Extension (WHEX) area (see **Photo 1**). Mr. Hanks pointed out a typical permit boundary sign for the Cresson project (see **Photo 2**).

Photo 1. Active mining in the WHEX area (looking south).

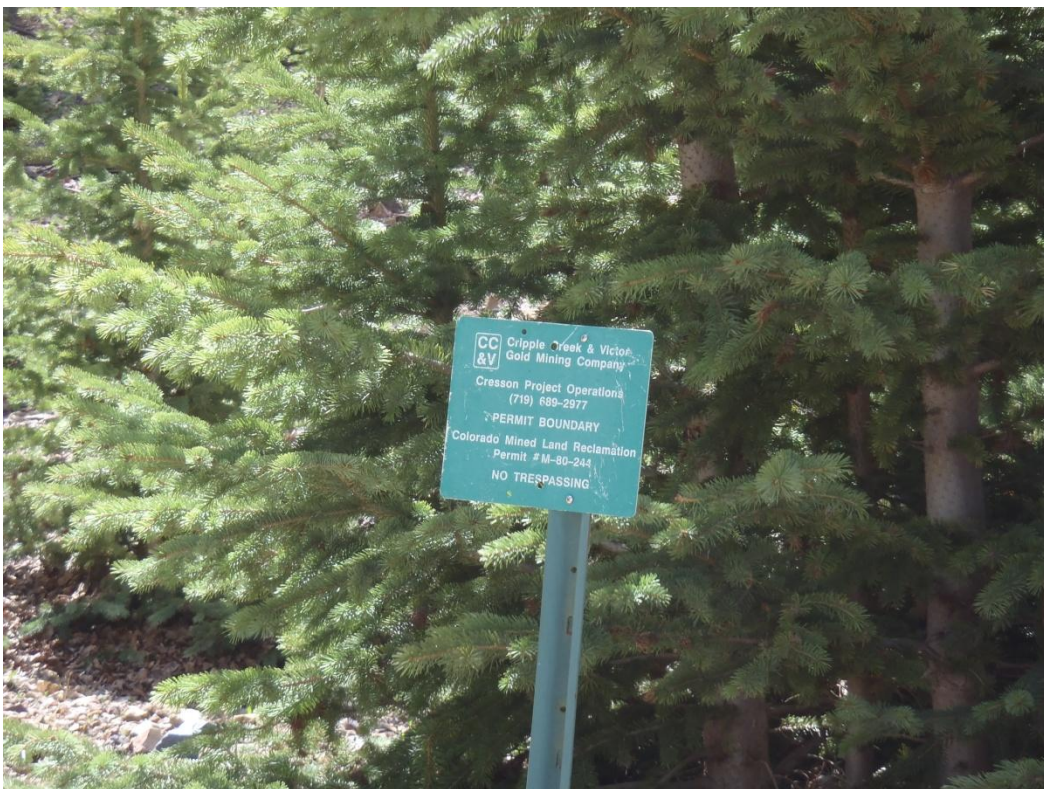
Photo 2. Typical permit boundary sign for the Cresson project.

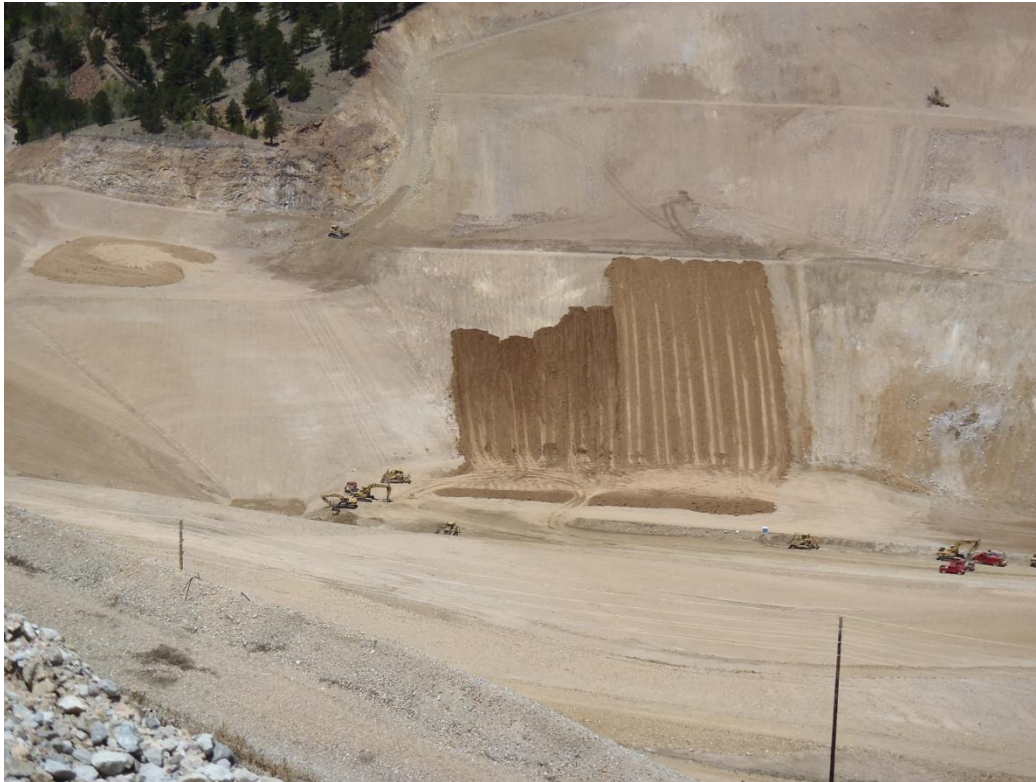
Construction: The Division observed placement of soil liner fill (SLF) in the PSSA (see **Photo 3**). A SLF stockpile (see **Photo 4**) was observed near the East Cresson Overburden Storage Area (ECOSA). The base of the new radio tower is in place on Squaw Mountain (see **Photo 5**).

Photo 3. Placement of soil liner fill (SLF) in the PSSA (looking NW).

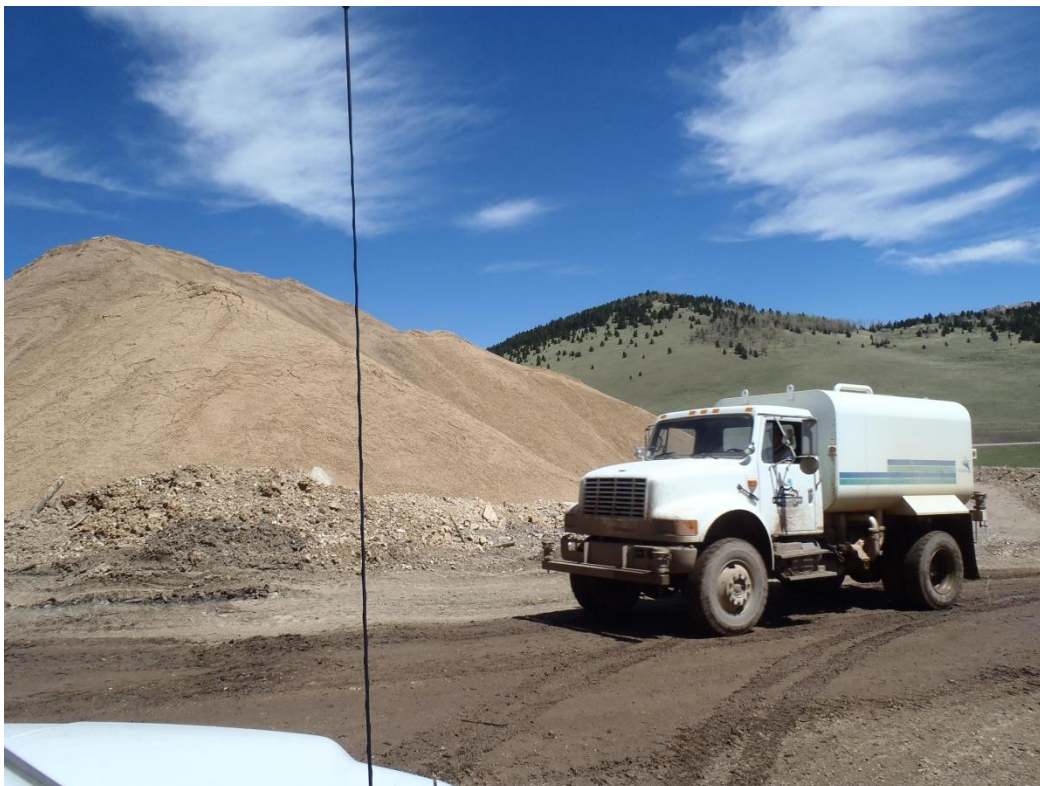
Photo 4. SLF stockpile.

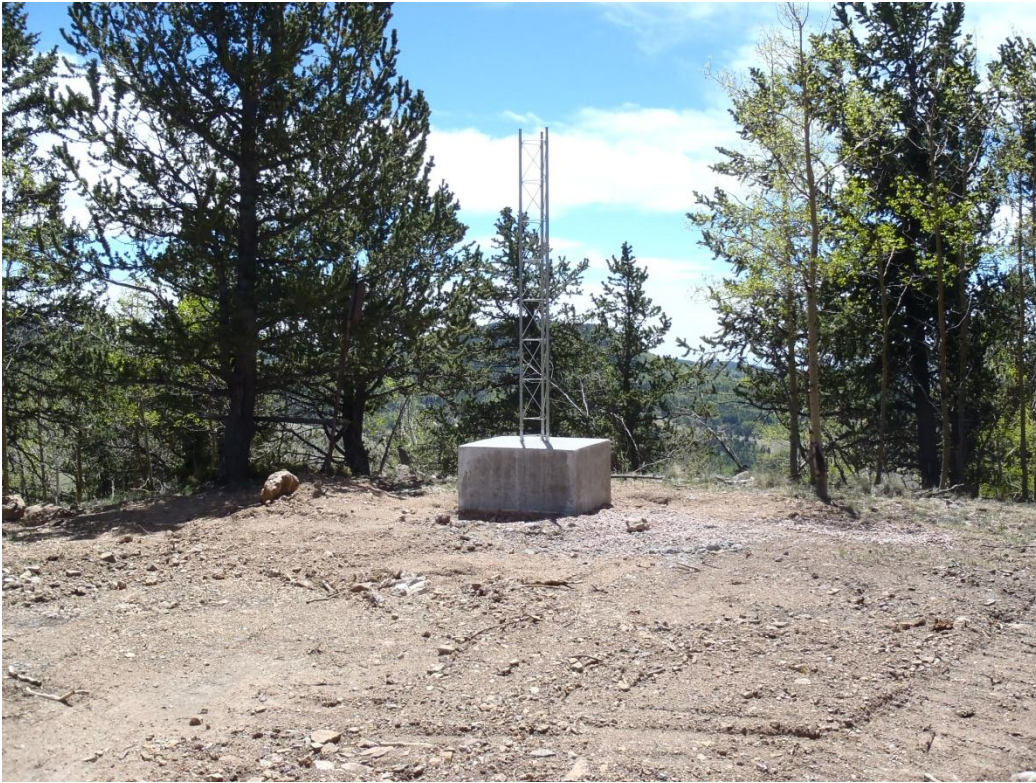
Photo 5. Base of new radio tower in place on Squaw Mountain (looking south).
