COLORADO DIVISION OF RECLAMATION, MINING AND SAFETY
MINERALS PROGRAM INSPECTION REPORT
PHONE: (303) 866-3567

MINE NAME: Cresson Project	MINE/PROSPECTING ID#: M-1980-244	MINERAL: Gold	COUNTY: Teller
INSPECTION TYPE: Aerial Inspection	INSPECTOR(S): Timothy A. Cazier	INSP. DATE: August 29, 2014	INSP. TIME: 12:40
OPERATOR: Cripple Creek & Victor Gold Mining Company	OPERATOR REPRESENTATIVE: None	TYPE OF OPERATION: 112d-3 - Designated Mining Operation

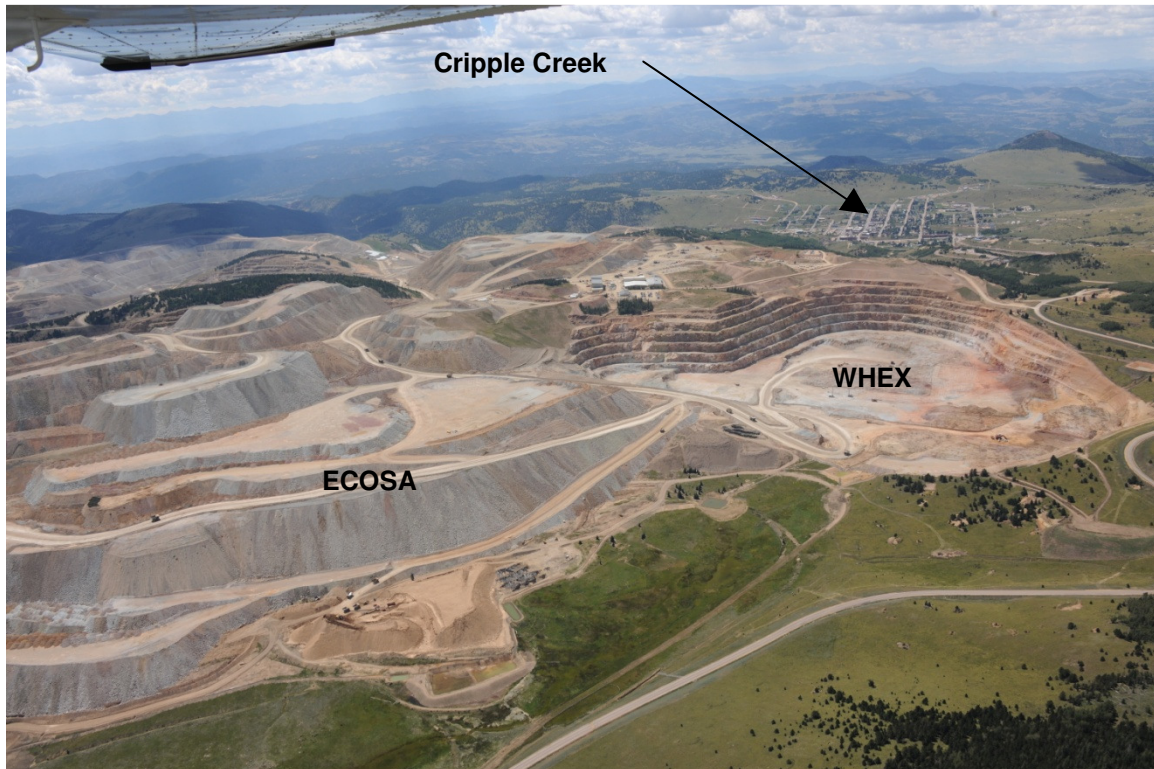
Photo 1. Wildhorse Extension Pit (Looking west).

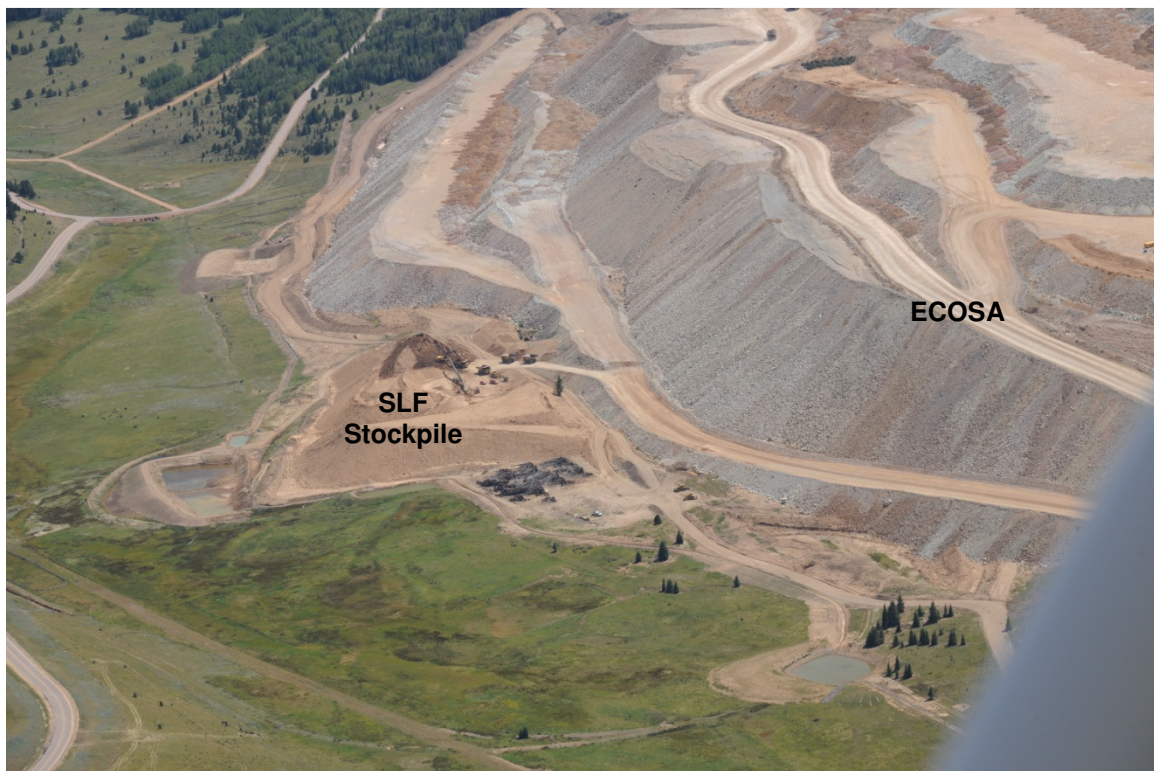
Photo 2. Soil Liner Fill stockpile at Cameron site (Looking SE).

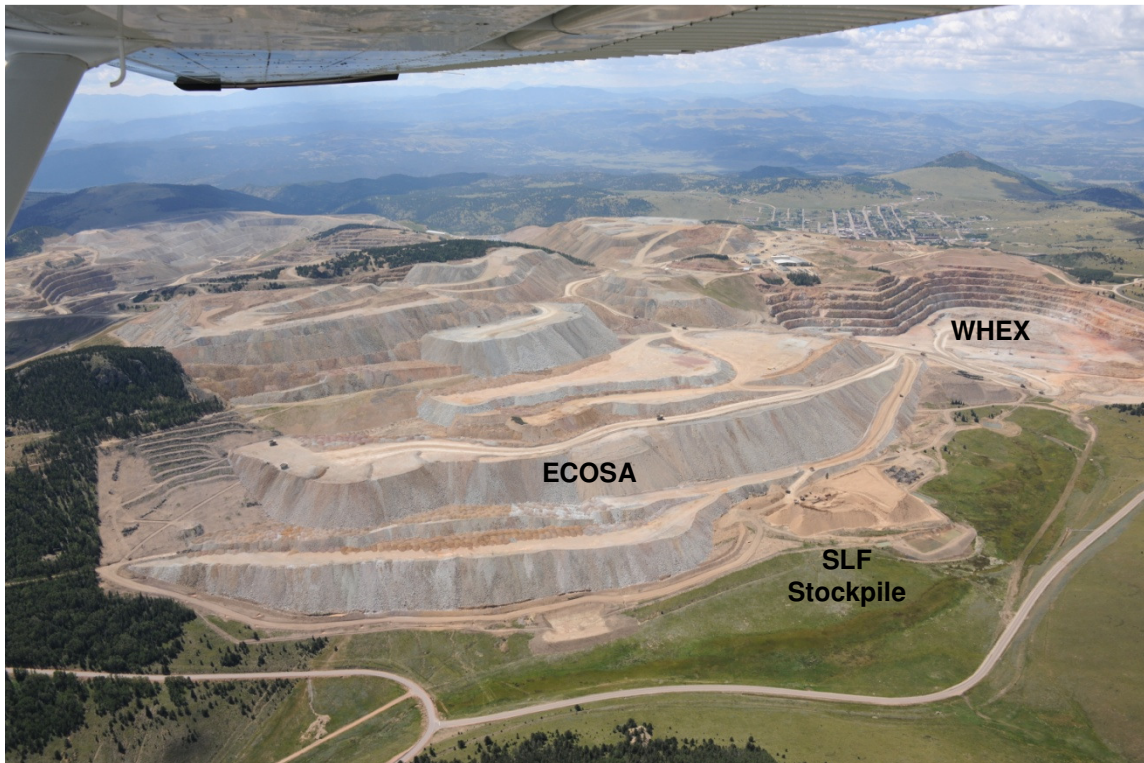
Photo 3. East Cresson OSA (looking west).

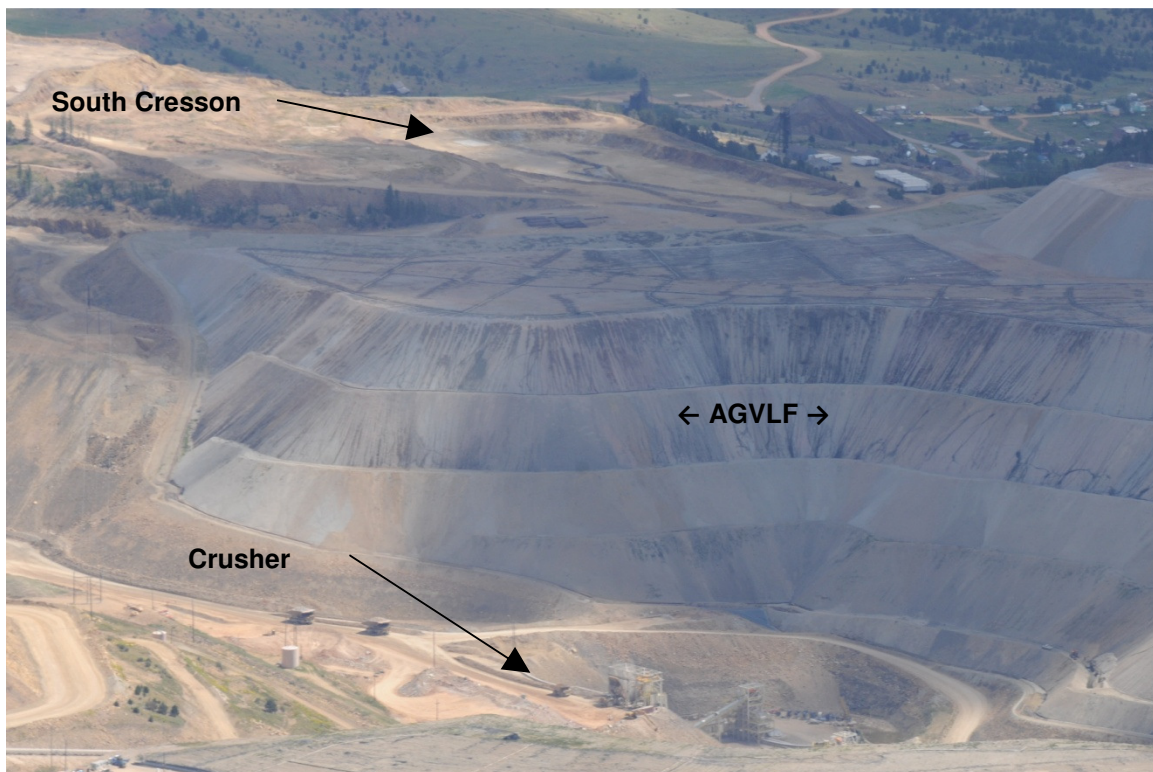
Photo 4. South Cresson (looking SE).

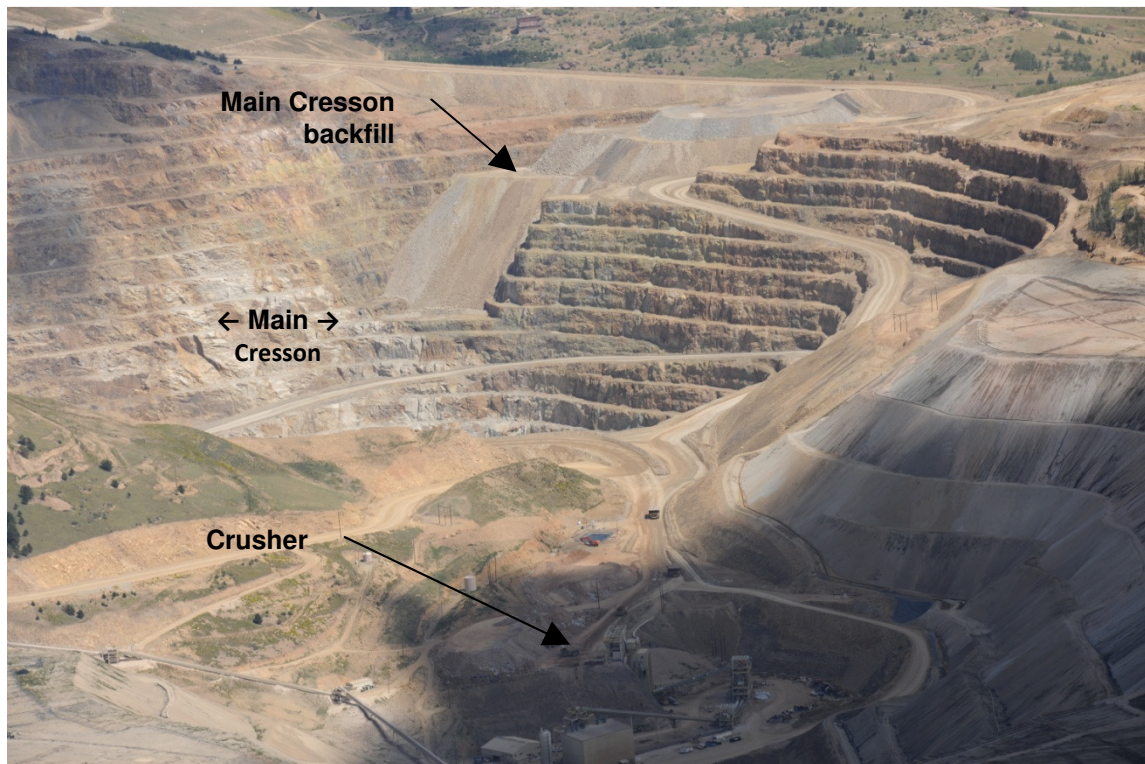
Photo 5. Main Cresson Pit (looking SE).

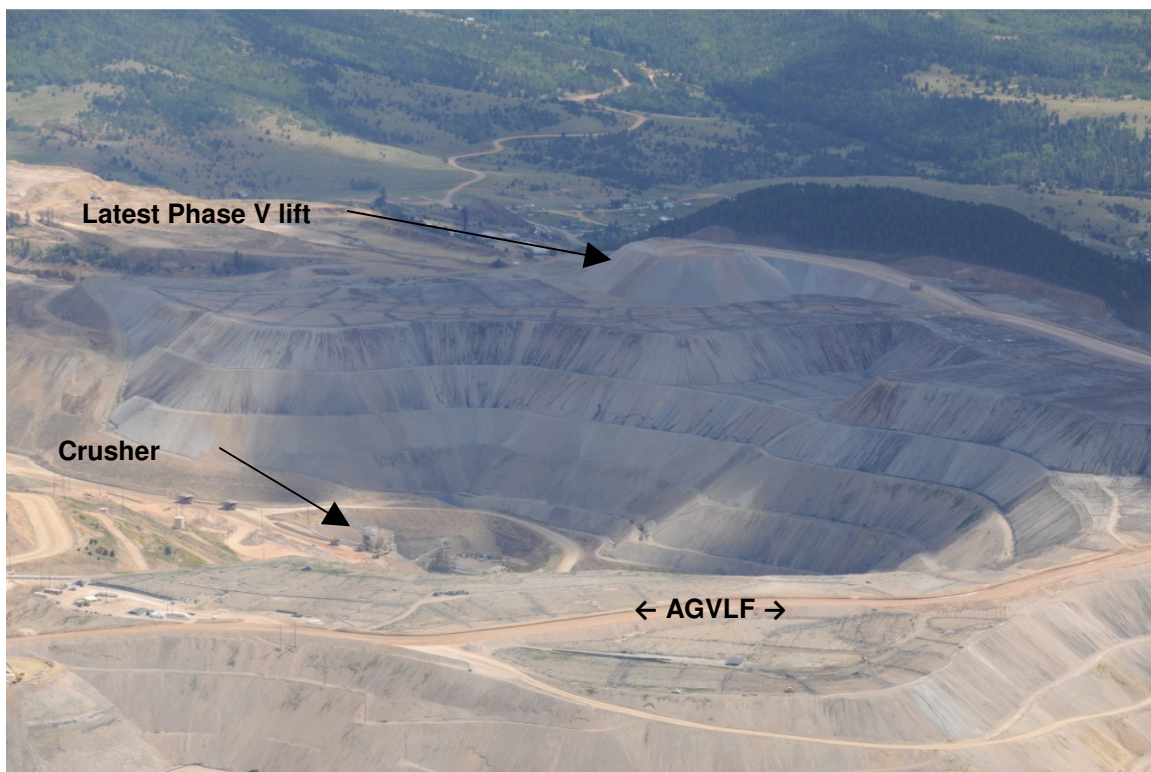
Photo 6. Arequa Gulch VLF (looking SE).

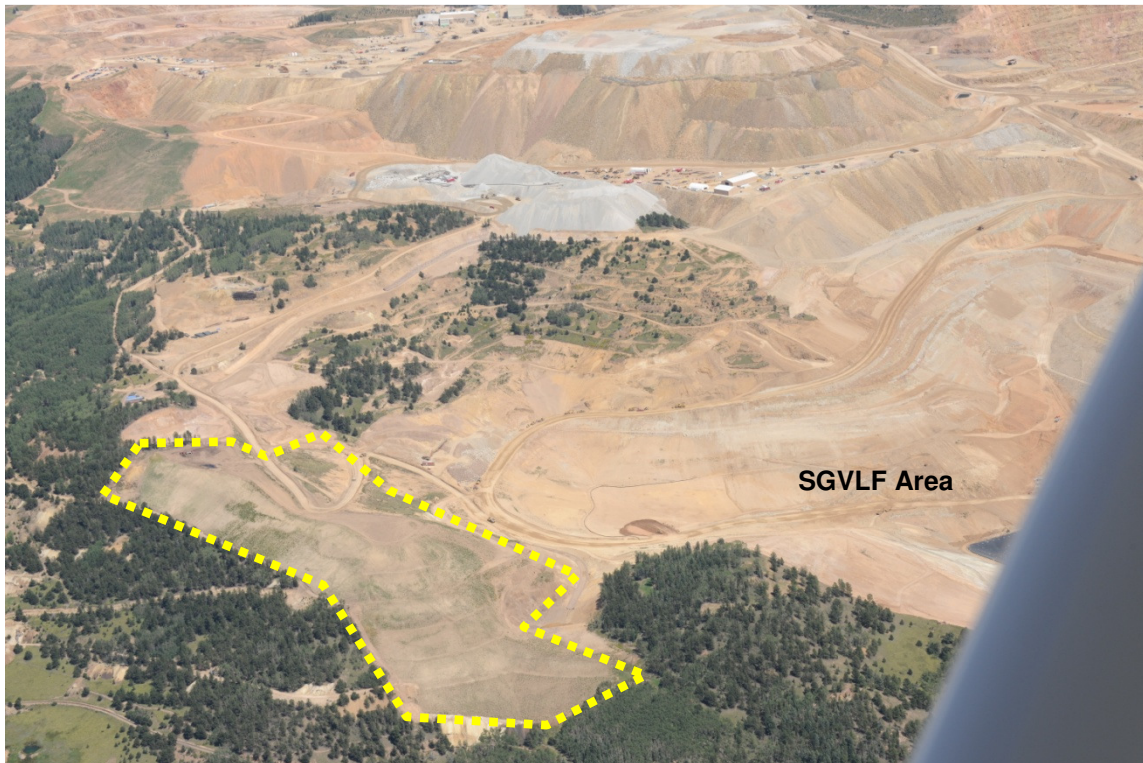
Photo 7. New growth medium stockpile #34 (looking east).

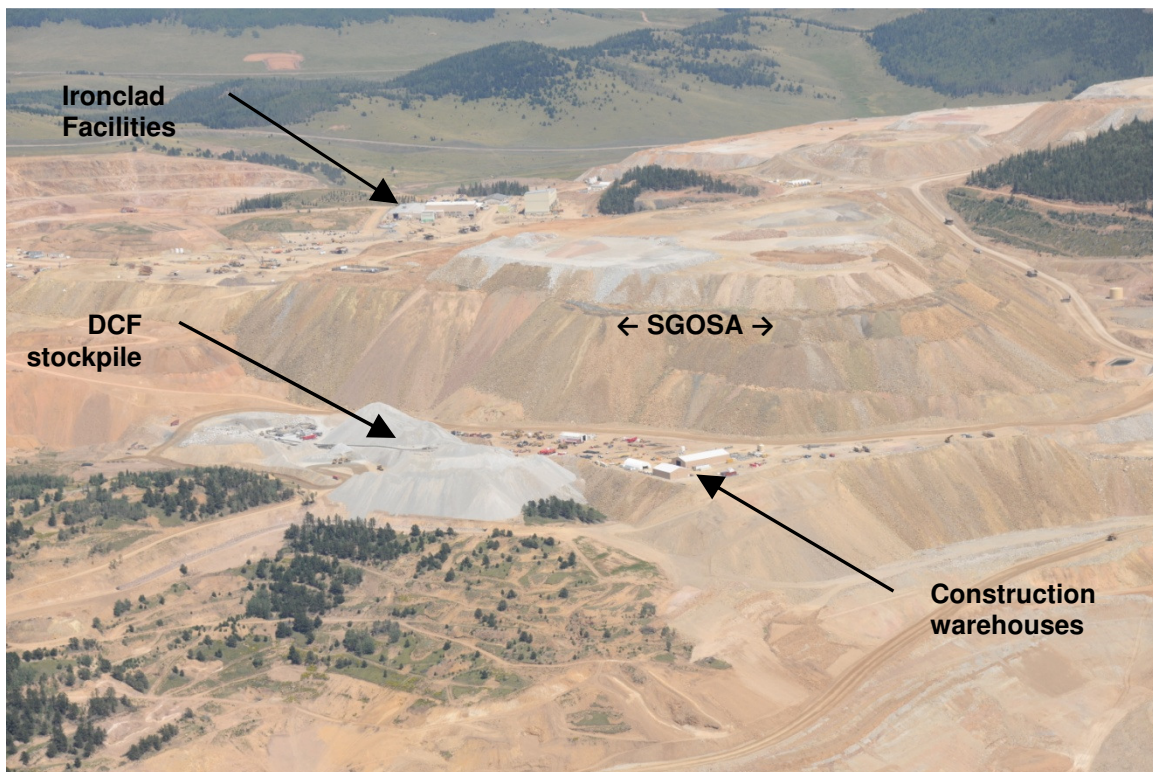
Photo 8. Squaw Gulch OSA (Looking east).

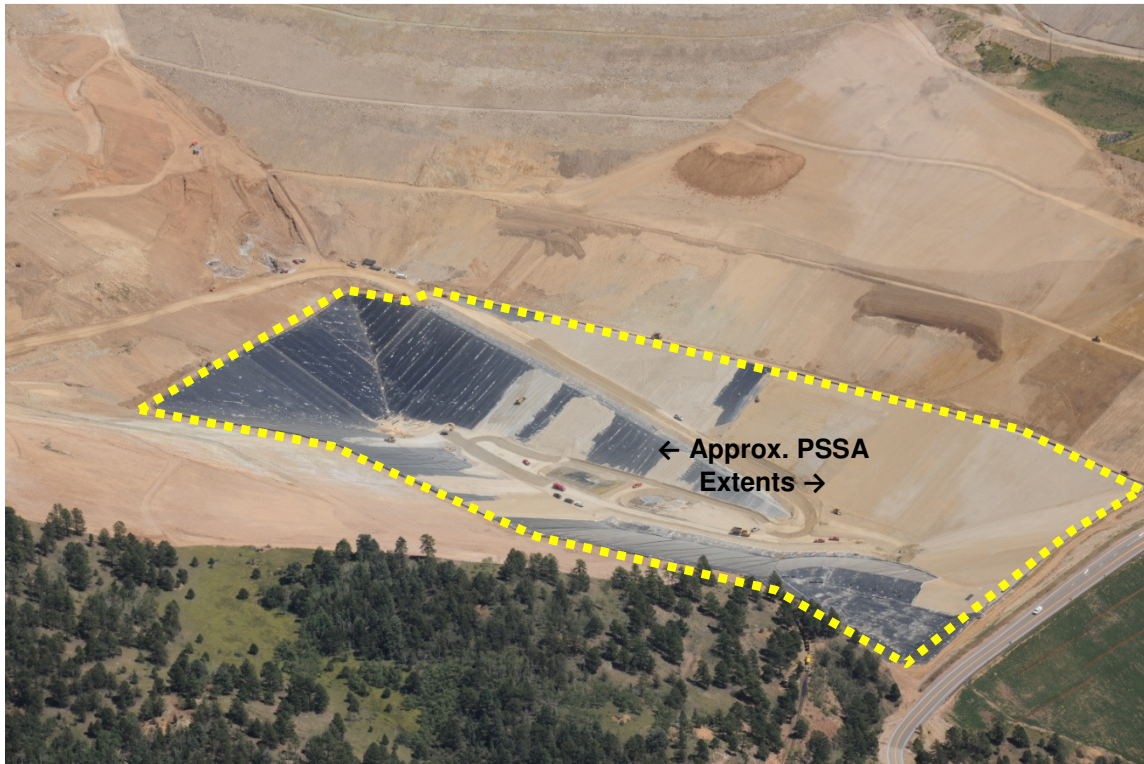
Photo 9. Squaw Gulch VLF Pregnant Solution Storage Area (Looking east).

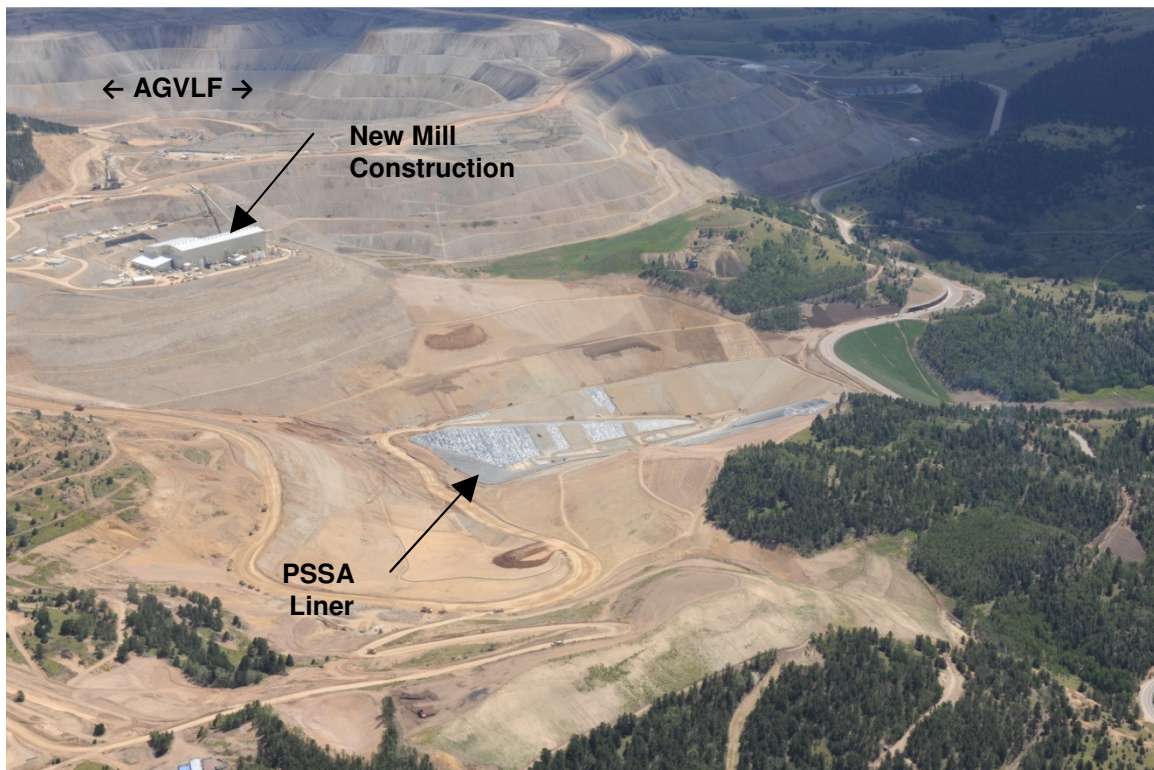
Photo 10. New High Grade Mill Platform (Looking south).
