**COLORADO DIVISION OF RECLAMATION, MINING AND SAFETY**  
**MINERALS PROGRAM INSPECTION REPORT**  
**PHONE: (303) 866-3567**

<b>MINE NAME:</b> Cresson Project	<b>MINE/PROSPECTING ID#:</b> M-1980-244	<b>MINERAL:</b> Gold	<b>COUNTY:</b> Teller
<b>INSPECTION TYPE:</b> Monitoring	<b>INSPECTOR(S):</b> Timothy A. Cazier	<b>INSP. DATE:</b> August 7, 2014	<b>INSP. TIME:</b> 08:25
<b>OPERATOR:</b> Cripple Creek & Victor Gold Mining Company	<b>OPERATOR REPRESENTATIVE:</b> Chris Hanks	<b>TYPE OF OPERATION:</b> 112d-3 - Designated Mining Operation

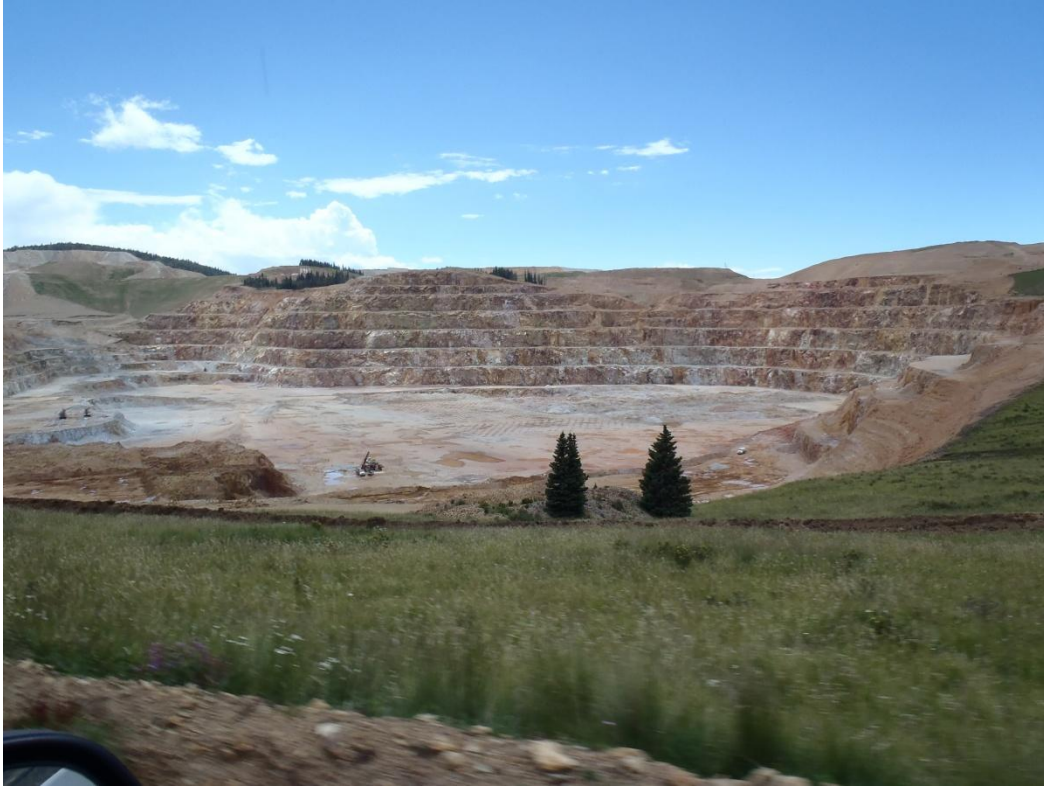
**Mine plan:** Production drilling and blasting continued in the Wildhorse Extension (WHEX) pit (see **Photo 1**). The new power line on the south side of the AGVLF was completed (see **Photos 2** and **3**).

Photo 1. Active mining in the WHEX area (looking south).

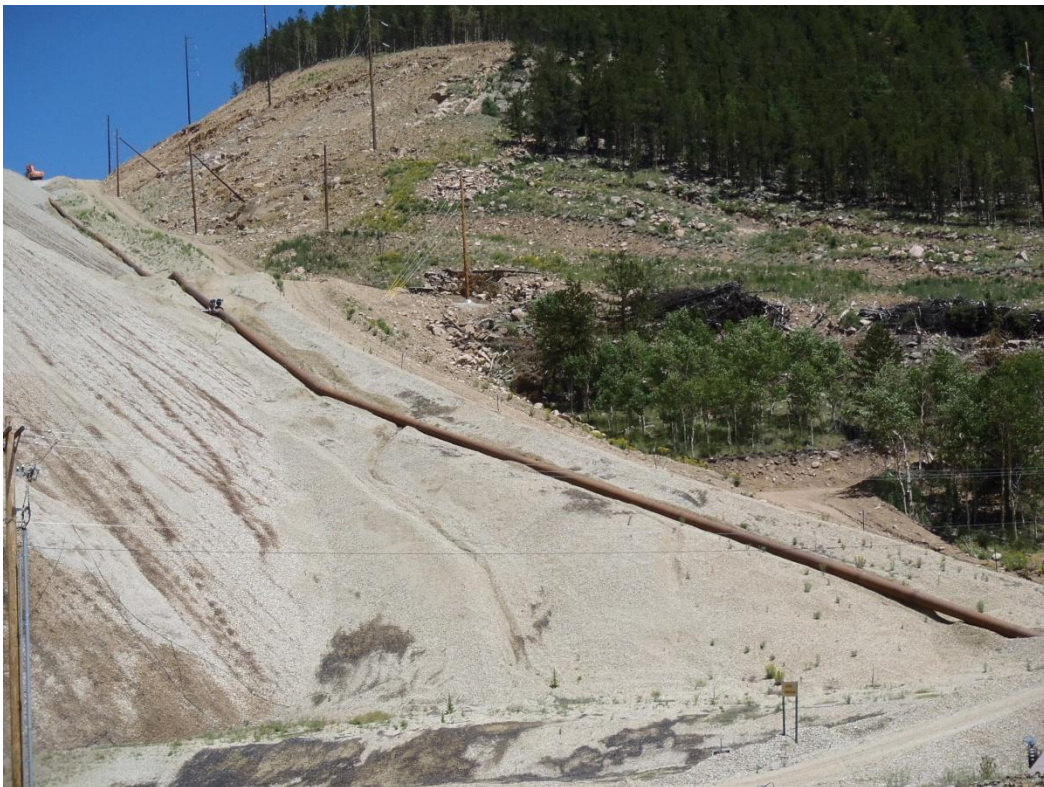
Photo 2. New power line on the south side of the AGVLF (looking NE).

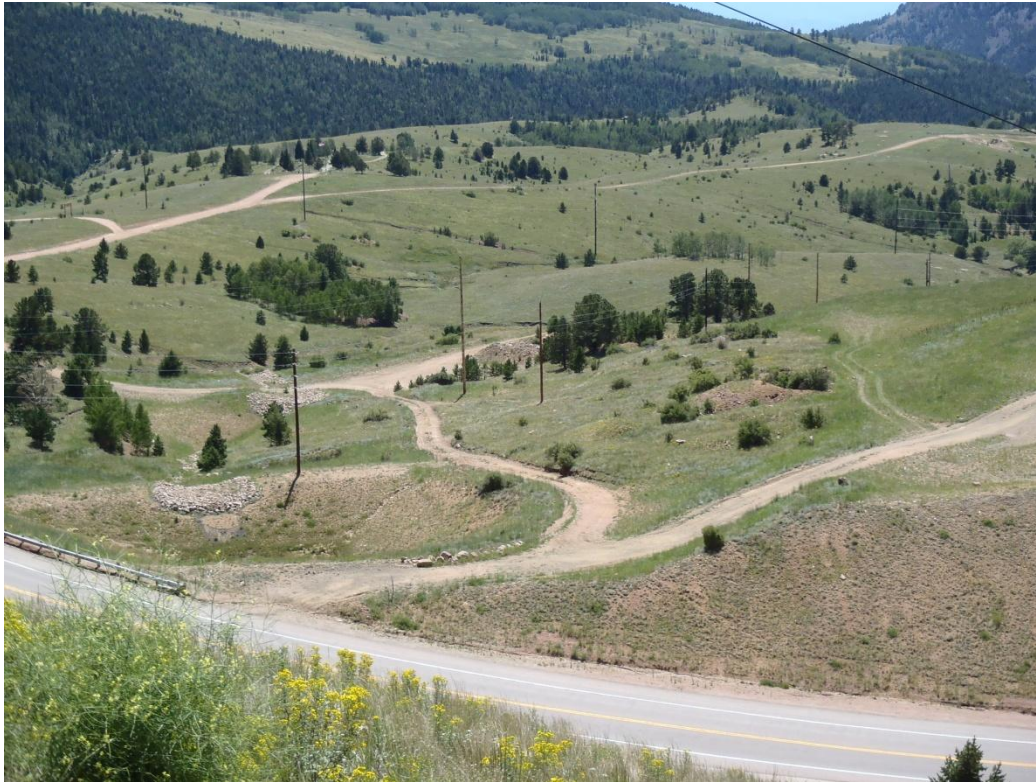
Photo 3. New power line on the south side of the AGVLF (looking SE).

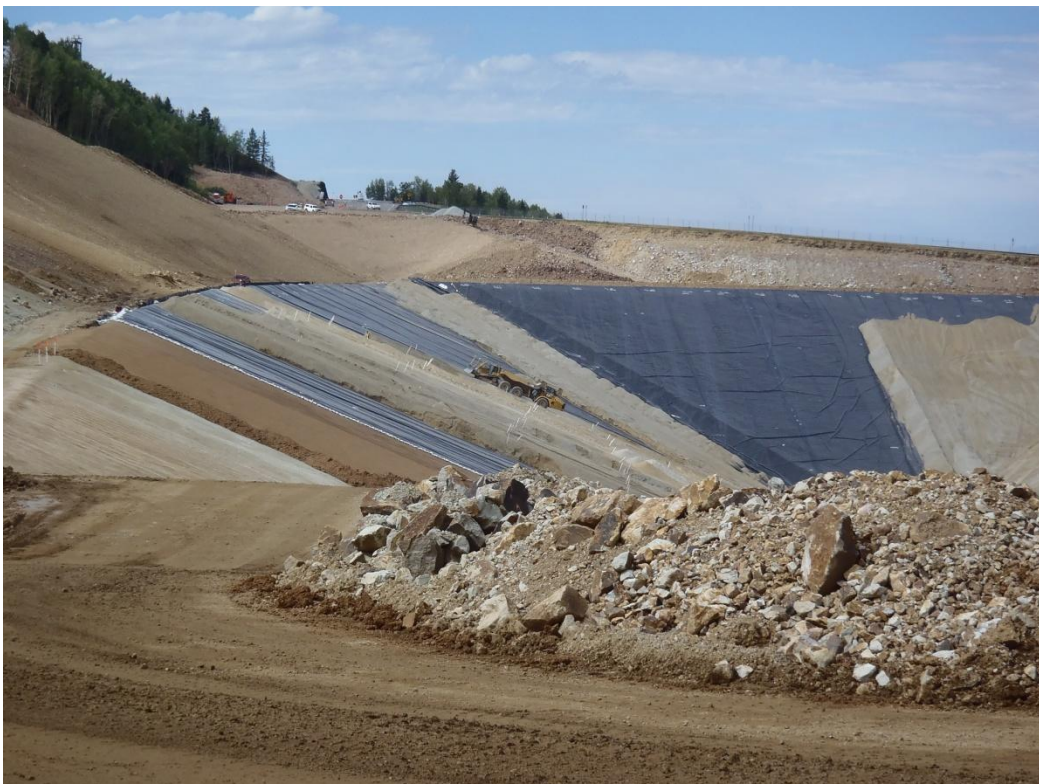
**Construction:** The Division observed concurrent placement of soil liner fill (SLF), 100 mil single-sided textured geomembrane and low volume solution collection fill (LVSCF) in the PSSA (see **Photo 4**). The low volume solution collection (LVSC) riser pipes (see **Photo 5**) were also installed in the south corner of the PSSA. PVC pipe used to determine when the required 3-foot thickness of the LVSCF is achieved was observed (see **Photo 6**).

Photo 4. Placement of SLF, 100 mil single-sided textured geomembrane & LVSCF in PSSA (looking SW).

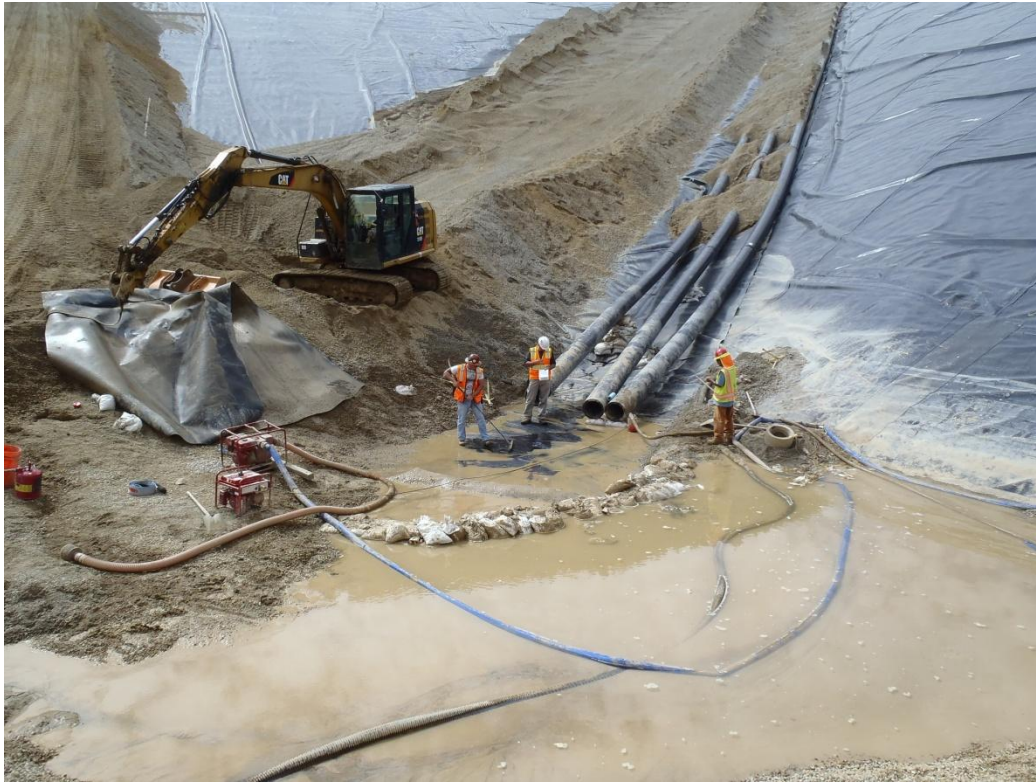
Photo 5. LVSC) riser pipes (looking south).

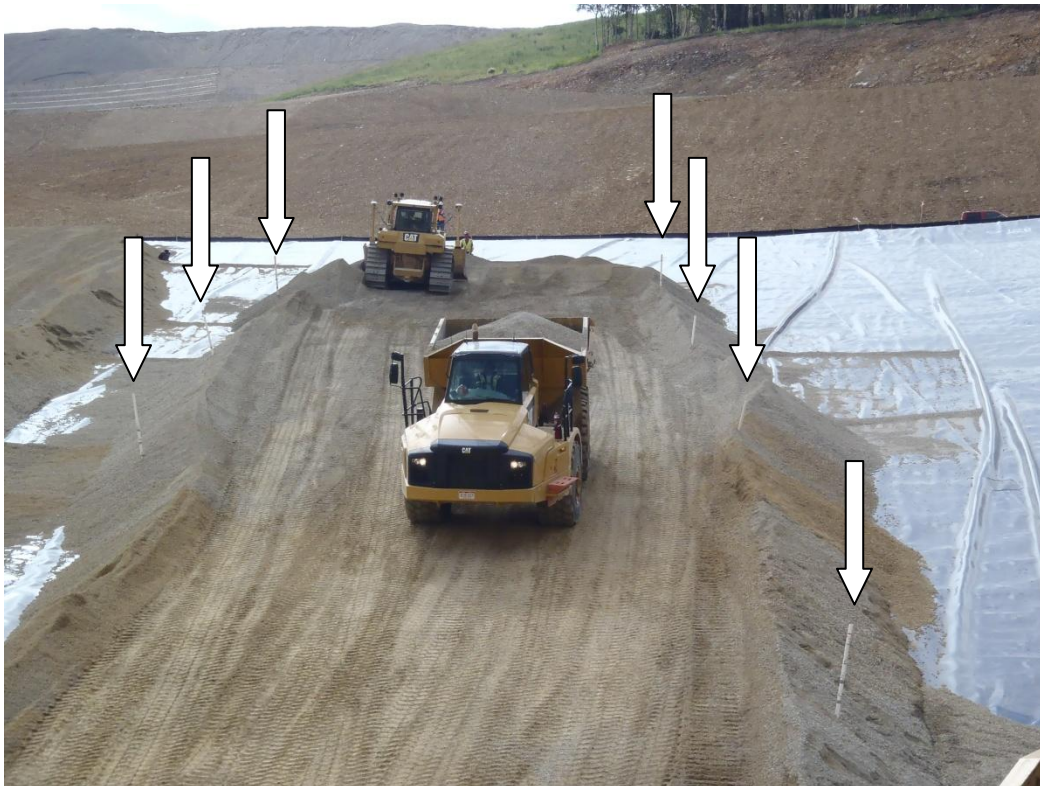
Photo 6. PVC pipes used to determine required 3-foot thickness of the LVSCF in the PSSA.

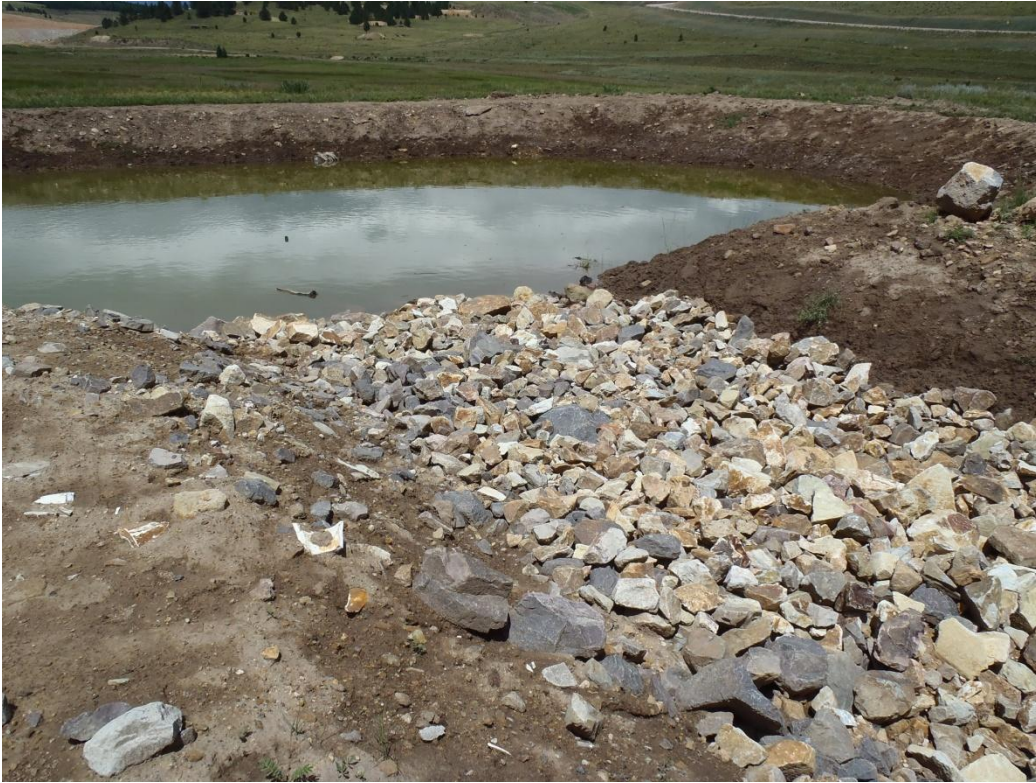
**Grassy Valley Stormwater Ponds:** The Division inspected pond numbers 16, 17, 17N, 18, 19, and 20. All ponds appeared to be functioning properly. Riprap in the spillways (see **Photos 7** and **8**) appeared in good condition and adequate overflow capacity appeared to be available (see **Photos 9** and **10**).

Photo 7. Spillway riprap – Pond #17N (looking north).

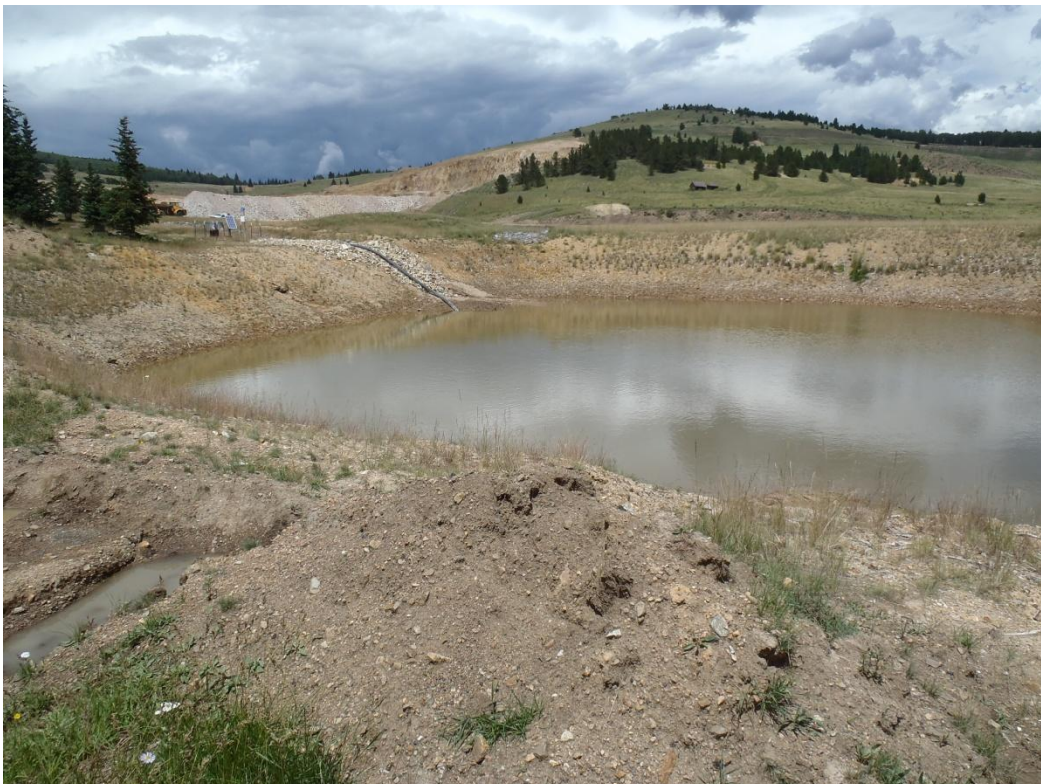
Photo 8. Inlet riprap – Pond #16 (looking north).

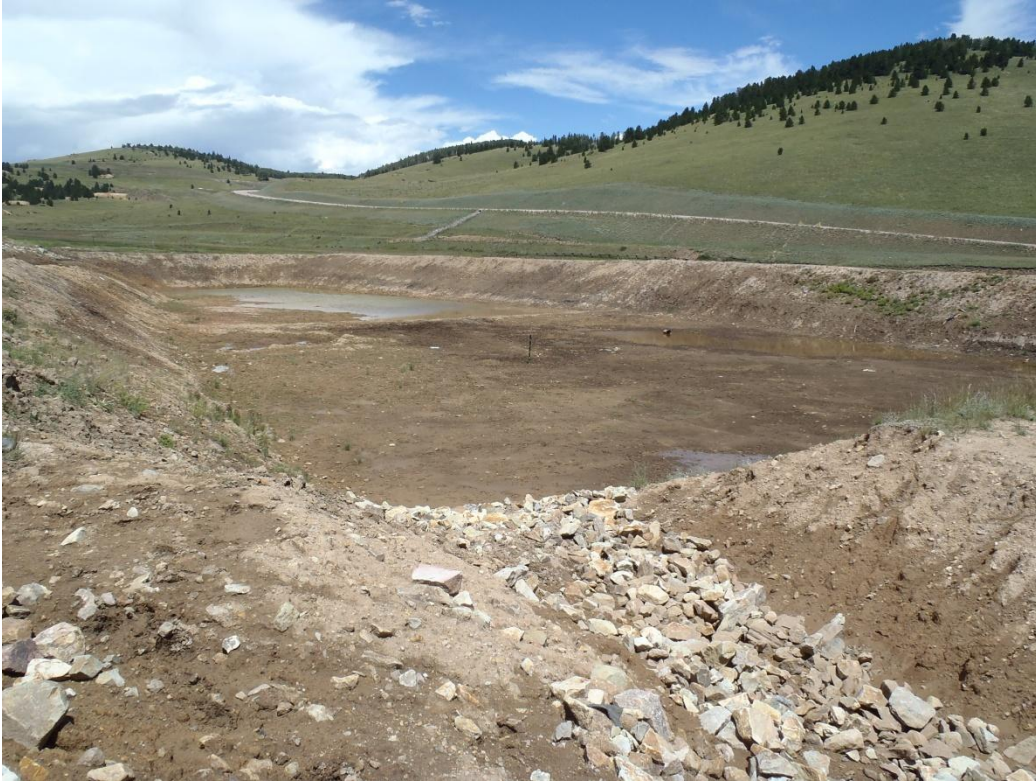
Photo 9. Available capacity in Pond #17 (looking north).

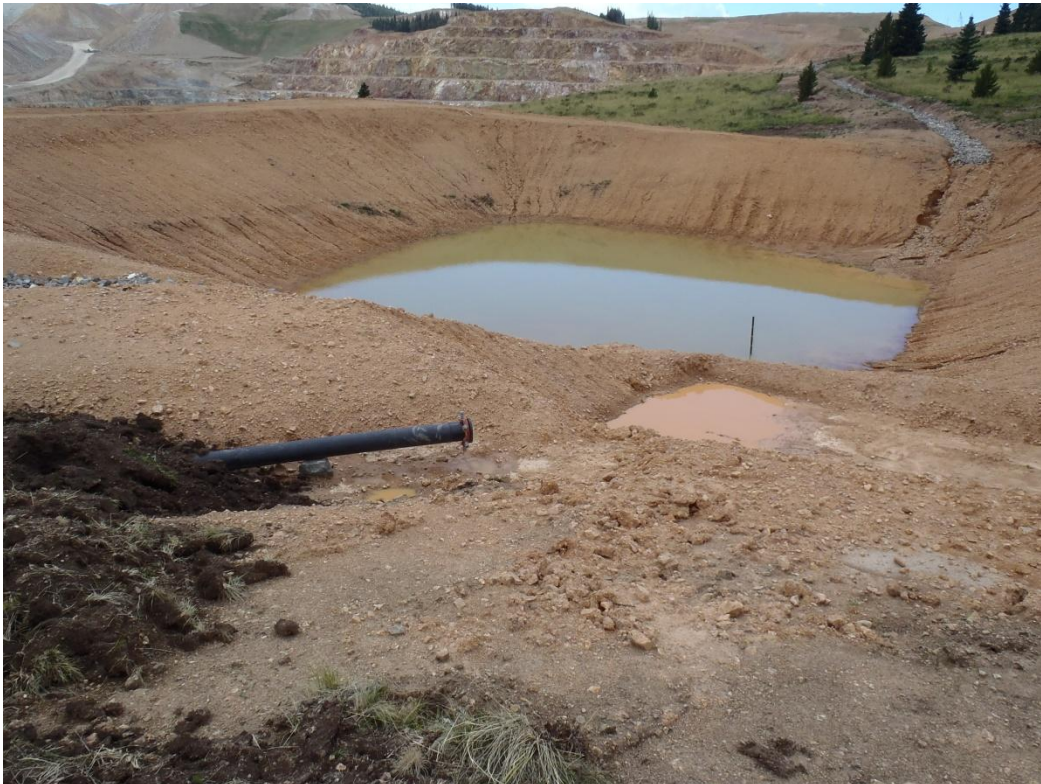
Photo 10. Available capacity in Pond #19 (looking north).
