COLORADO DIVISION OF RECLAMATION, MINING AND SAFETY
MINERALS PROGRAM INSPECTION REPORT
PHONE: (303) 866-3567

MINE NAME: Cresson Project	MINE/PROSPECTING ID#: M-1980-244	MINERAL: Gold	COUNTY: Teller
INSPECTION TYPE: Aerial Inspection	INSPECTOR(S): Timothy A. Cazier	INSP. DATE: March 21, 2014	INSP. TIME: 08:40
OPERATOR: Cripple Creek & Victor Gold Mining Company	OPERATOR REPRESENTATIVE: None	TYPE OF OPERATION: 112d-3 - Designated Mining Operation

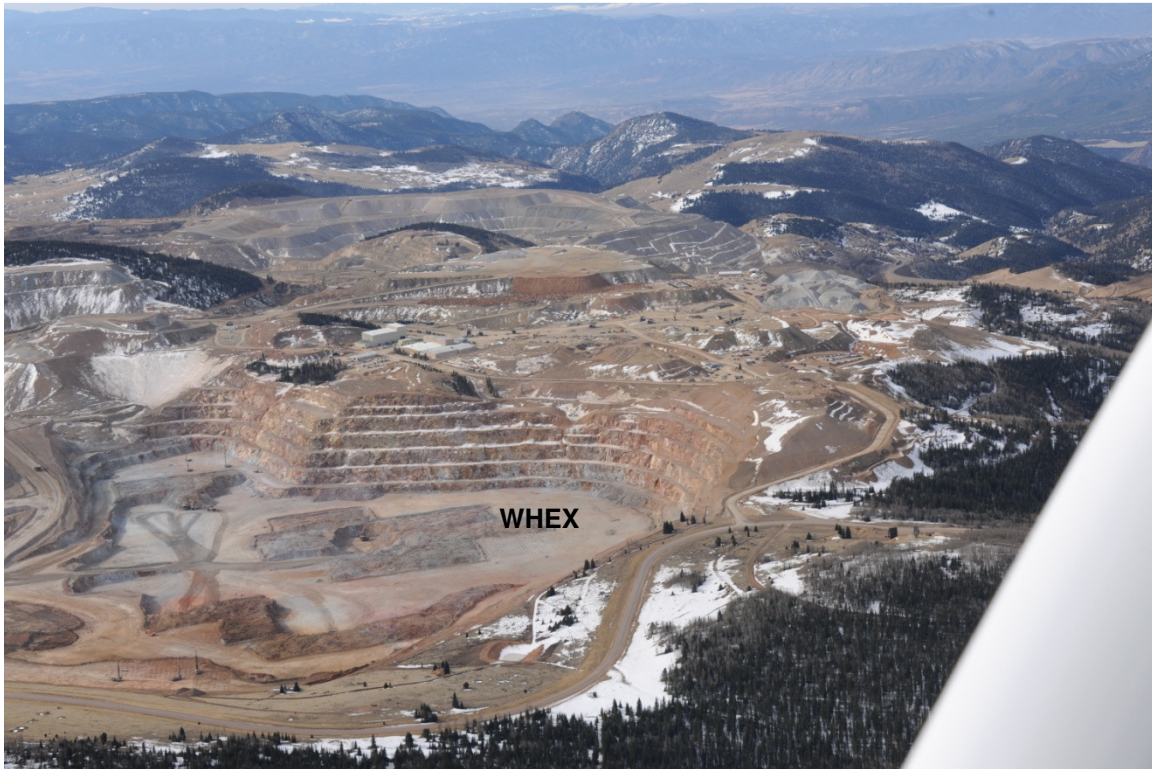
Photo ID	Mine Facility	Perspective	Notes
Photo 1	Wildhorse Extension Pit (WHEX)	Looking SW	6 benches and pit floor
Photo 2	Drain Cover Fill stockpile	Looking NE	Stockpiling for SGVLF
Photo 3	East Cresson OSA	Looking south	WHEX to right
Photo 4	South Cresson	Looking west	East side of Arequa Gulch VLF in background
Photo 5	Main Cresson Pit	Looking NNE	American Eagles above east highwall
Photo 6	Arequa Gulch VLF	Looking west	Phase IV area, new mill on left, crusher on right
Photo 7	New growth medium stockpile #34	Looking NE	North end of SGVLF on right
Photo 8	Squaw Gulch OSA	Looking north	Main Cresson on right, Load Out Bin in lower left
Photo 9	Squaw Gulch VLF (SGVLF)	Looking north	Prepping for liner
Photo 10	New High Grade Mill & SGVLF	Looking NE	AGVLF on right, SGOSA beyond
Acronyms: AG – Arequa Gulch SG – Squaw Gulch OSA – overburden storage area VLF – valley leach facility

Photo 1. Wildhorse Extension Pit (Looking SW).

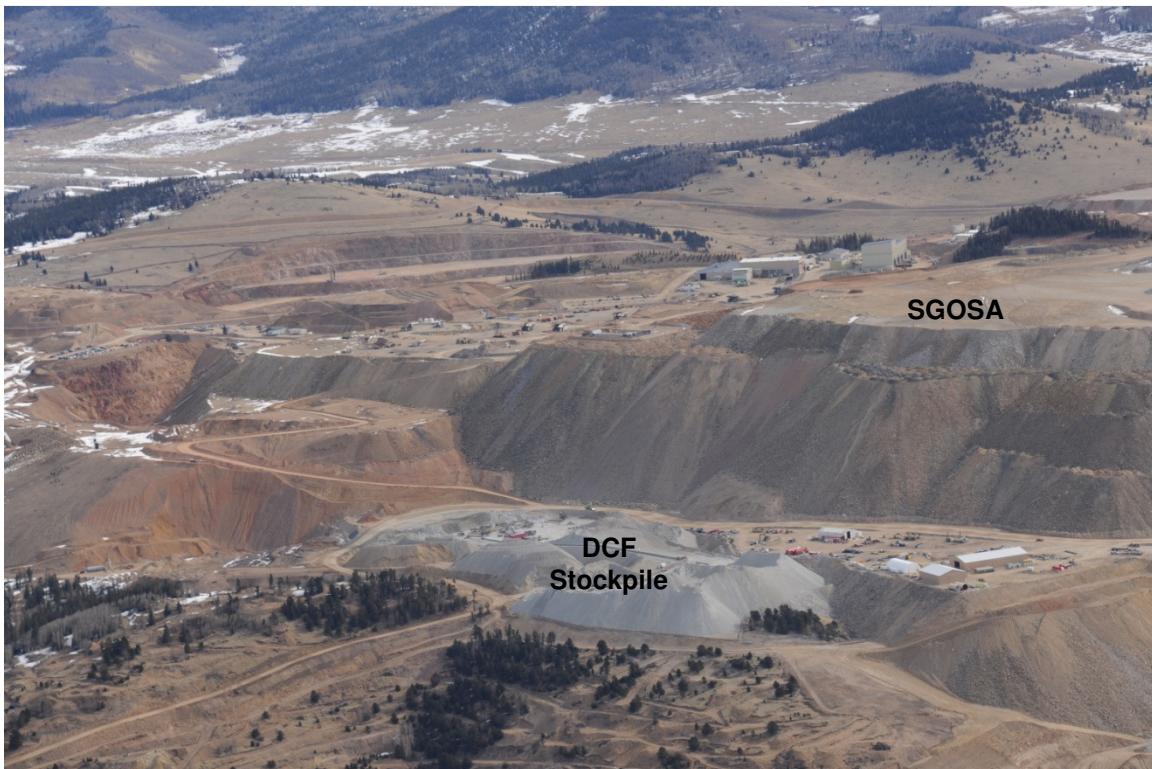
Photo 2. Drain Cover Fill stockpile (Looking NE).

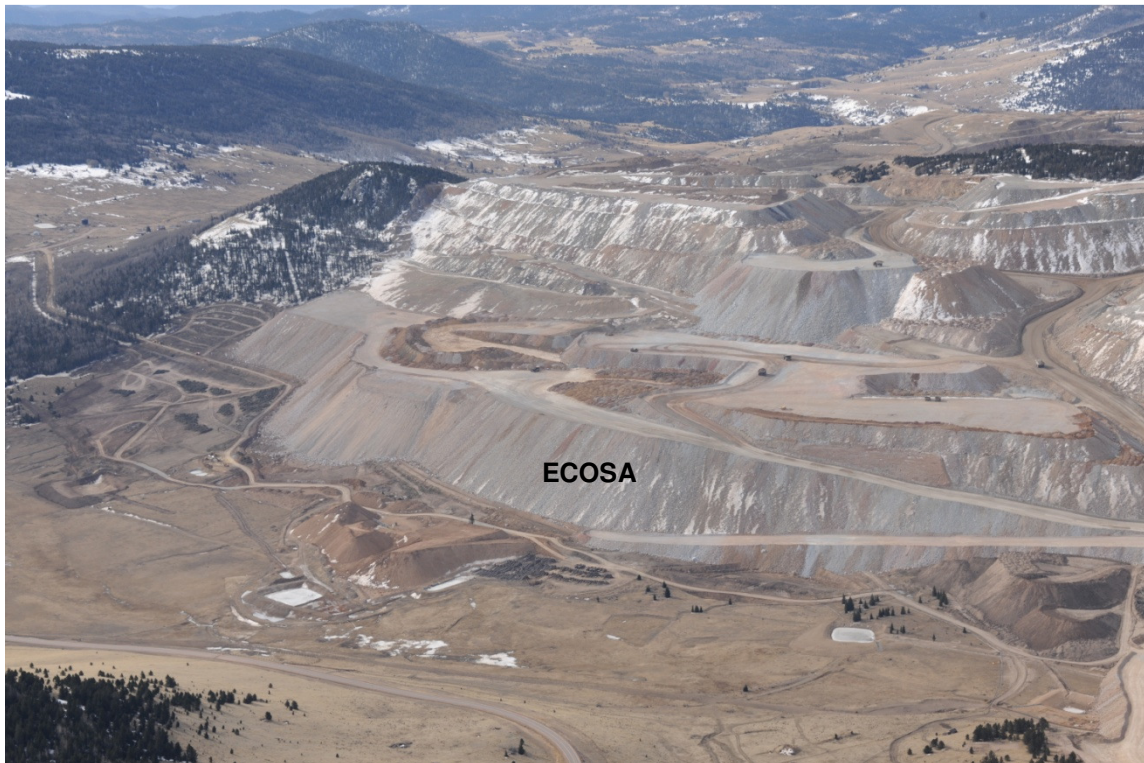
Photo 3. East Cresson OSA (looking south).

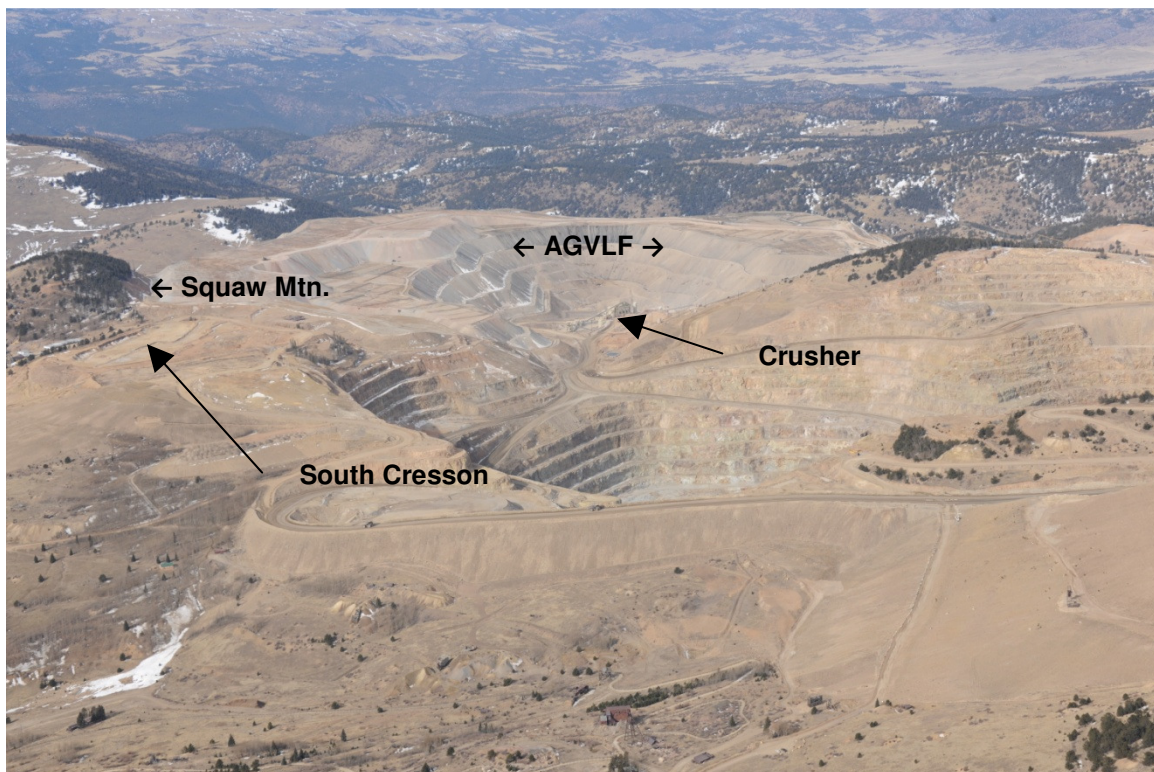
Photo 4. South Cresson (looking west).

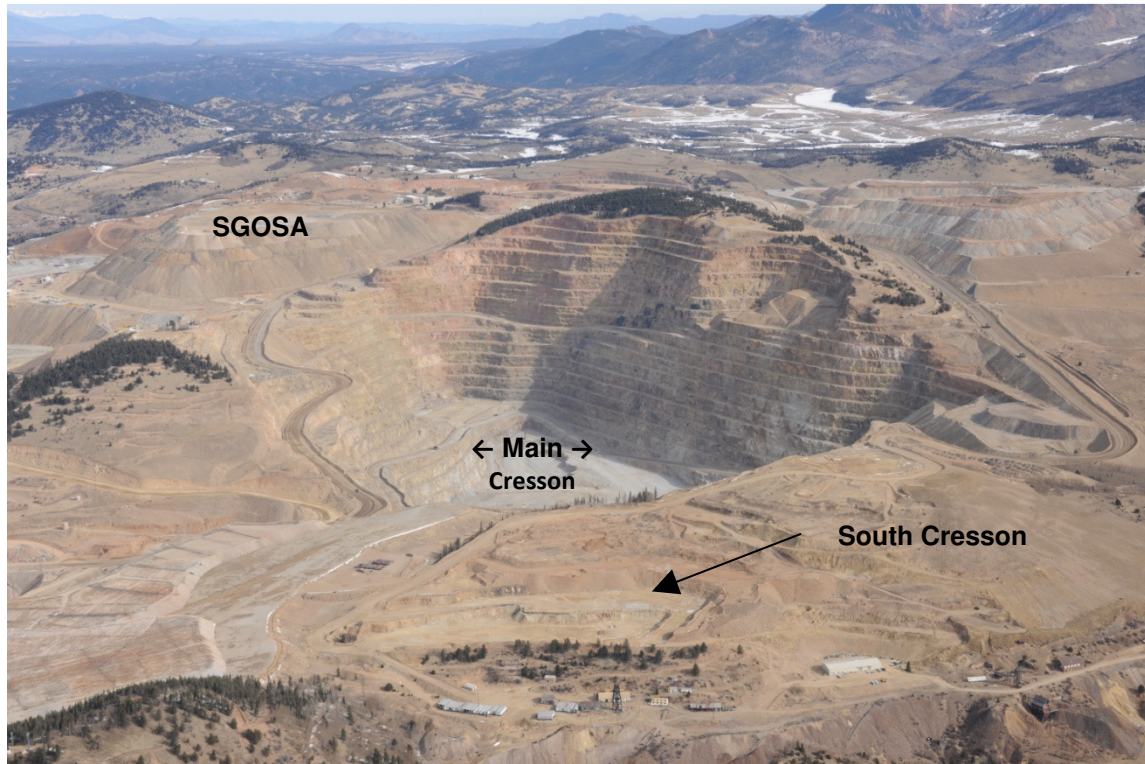
Photo 5. Main Cresson Pit (looking NNE).

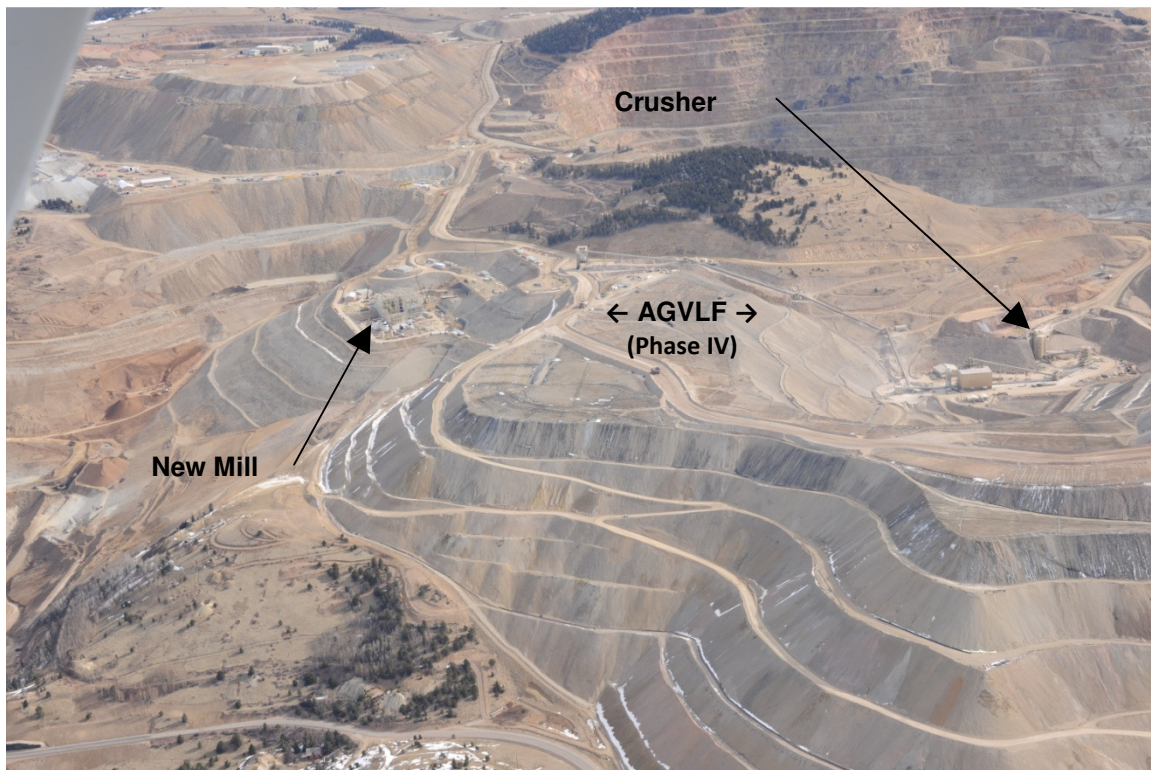
Photo 6. Arequa Gulch VLF (looking west).

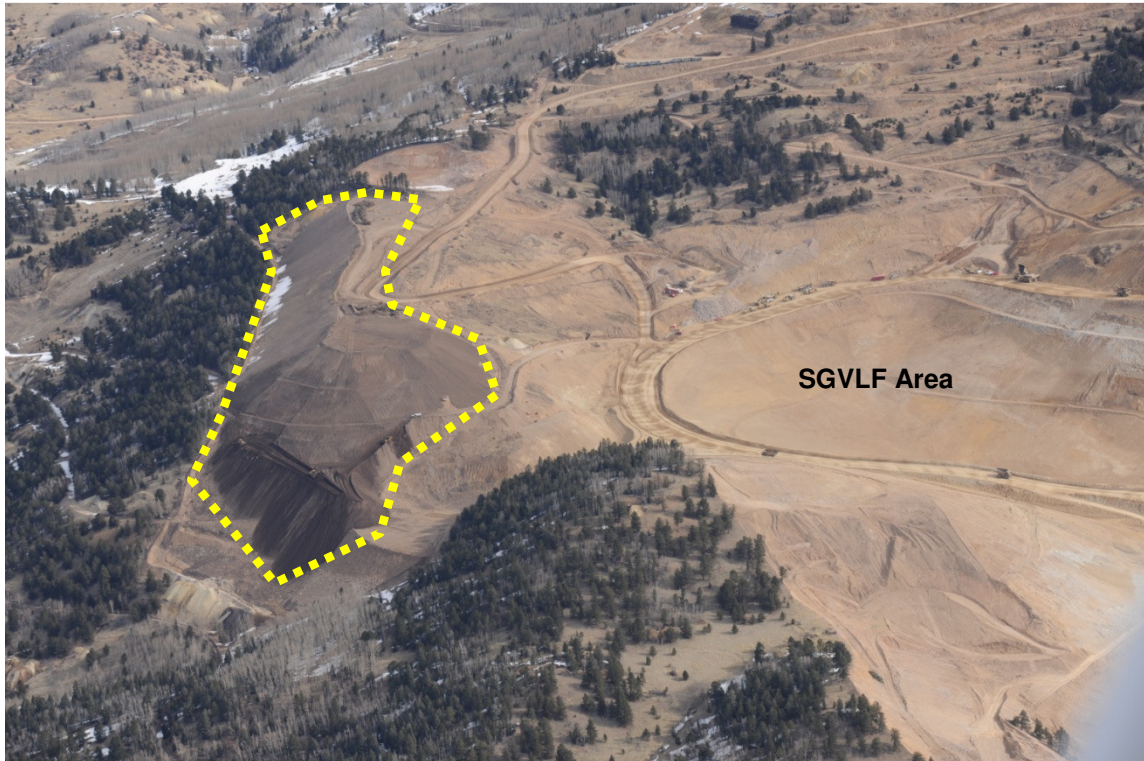
Photo 7. New growth medium stockpile #34 (looking NE).

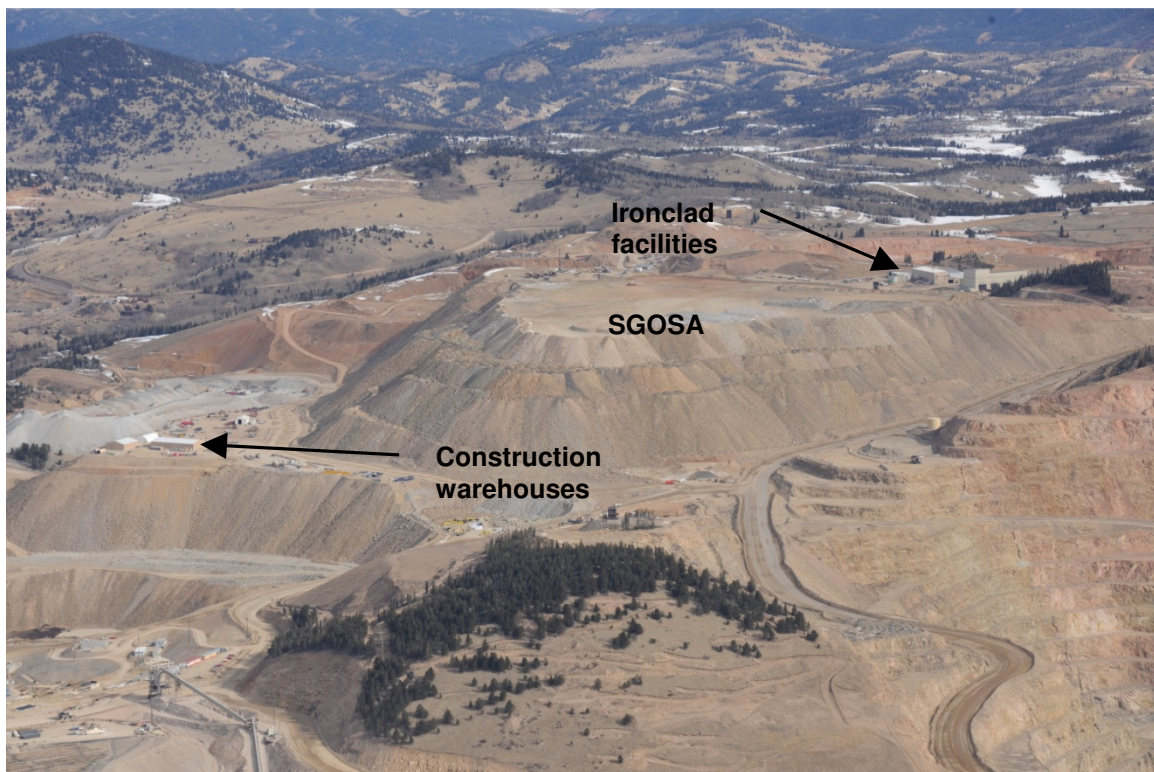
Photo 8. Squaw Gulch OSA (Looking north).

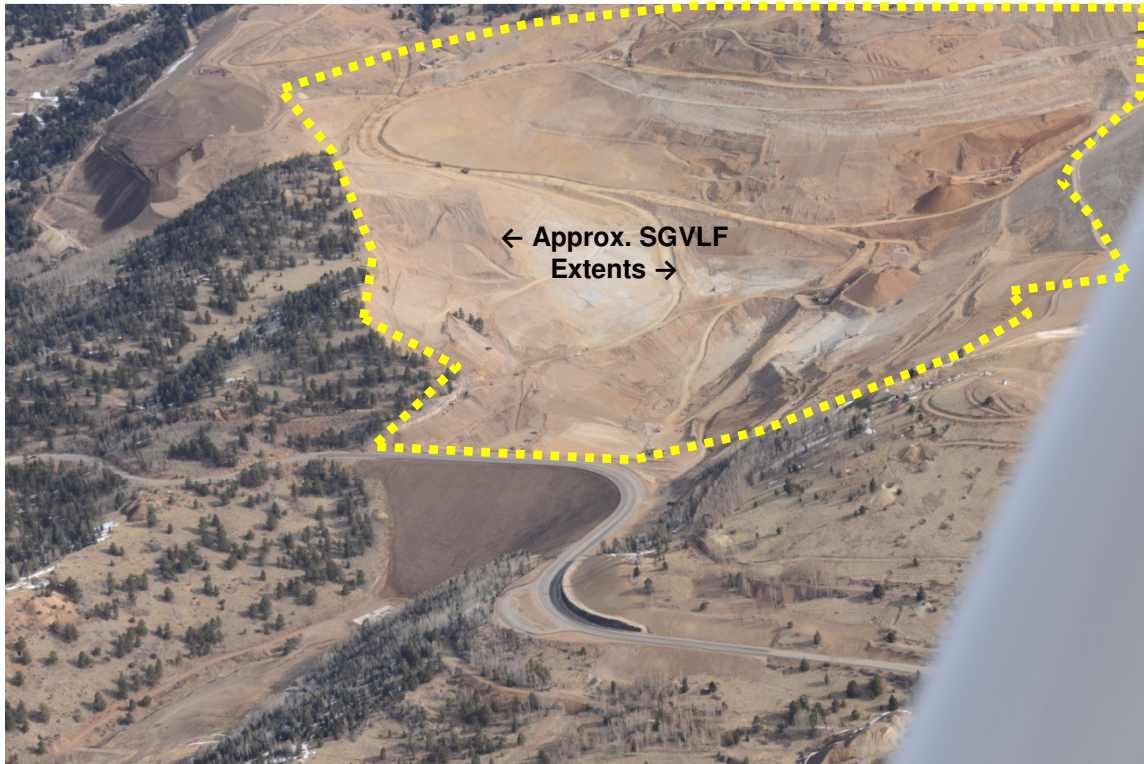
Photo 9. Squaw Gulch VLF (Looking north).

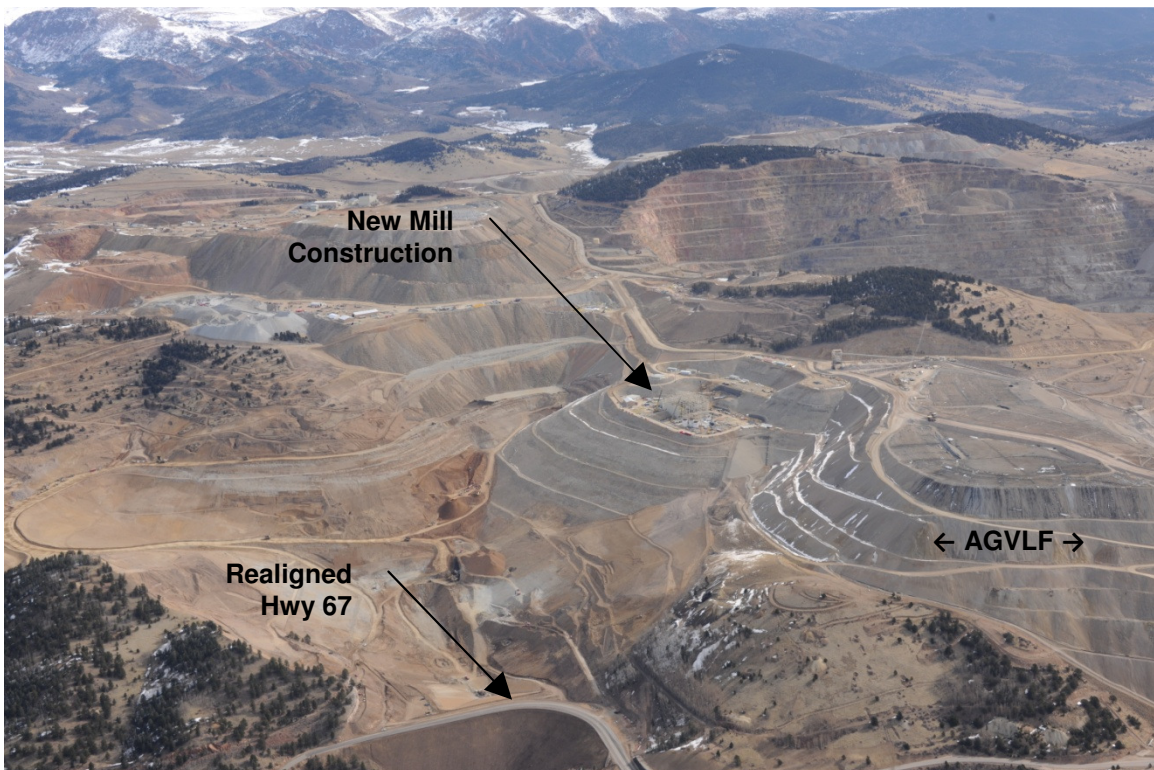
Photo 10. New High Grade Mill Platform (Looking NE).
