COLORADO DIVISION OF RECLAMATION, MINING AND SAFETY
MINERALS PROGRAM INSPECTION REPORT
PHONE: (303) 866-3567

MINE NAME: ZMK Gravel Pit	MINE/PROSPECTING ID#: M-1991-146	MINERAL: Gravel	COUNTY: Ouray
INSPECTION TYPE: Multi Person Inspection	INSPECTOR(S): Wallace H. Erickson, Lucas West	INSP. DATE: August 5, 2014	INSP. TIME: 13:30
OPERATOR: Sako Excavation, LLC	OPERATOR REPRESENTATIVE: Dick Z, Travis Sackman, Tim Pasic, Bob Larson	TYPE OF OPERATION: 110c - Construction Limited Impact	
REASON FOR INSPECTION: Normal I&E Program	BOND CALCULATION TYPE: Partial Bond	BOND AMOUNT: \$8,151.48	
DATE OF COMPLAINT: NA	POST INSP. CONTACTS: None	JOINT INSP. AGENCY: None	
WEATHER: Cloudy	INSPECTOR'S SIGNATURE: <i>Wallace H. Erickson</i>	SIGNATURE DATE: November 20, 2014

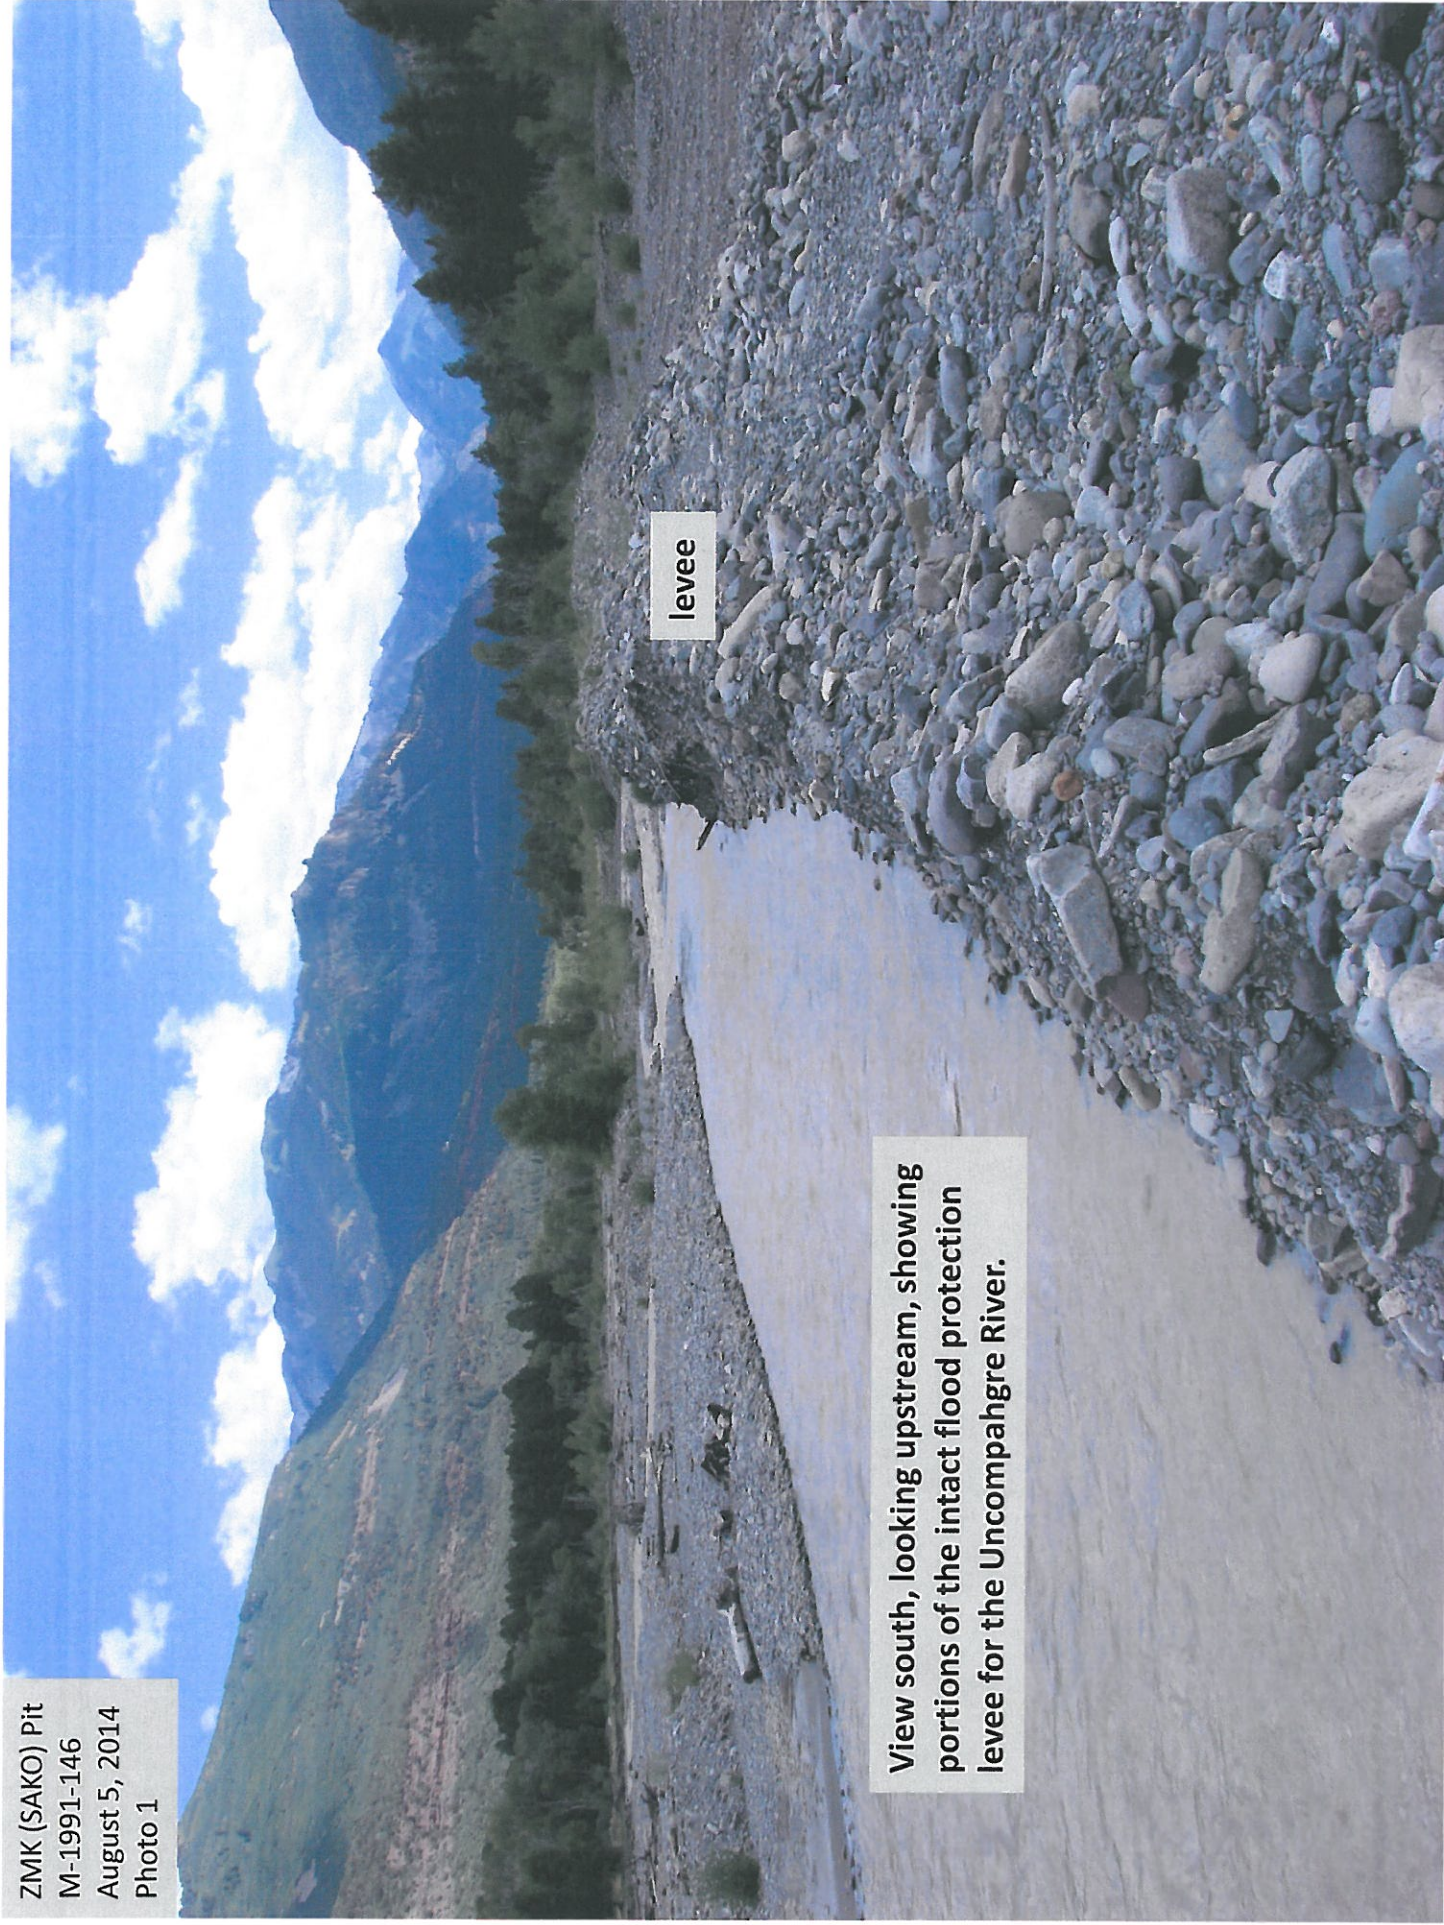
ZMK (SAKO) Pit
M-1991-146
August 5, 2014
Photo 1

View south, looking upstream, showing
portions of the intact flood protection
levee for the Uncompahgre River.

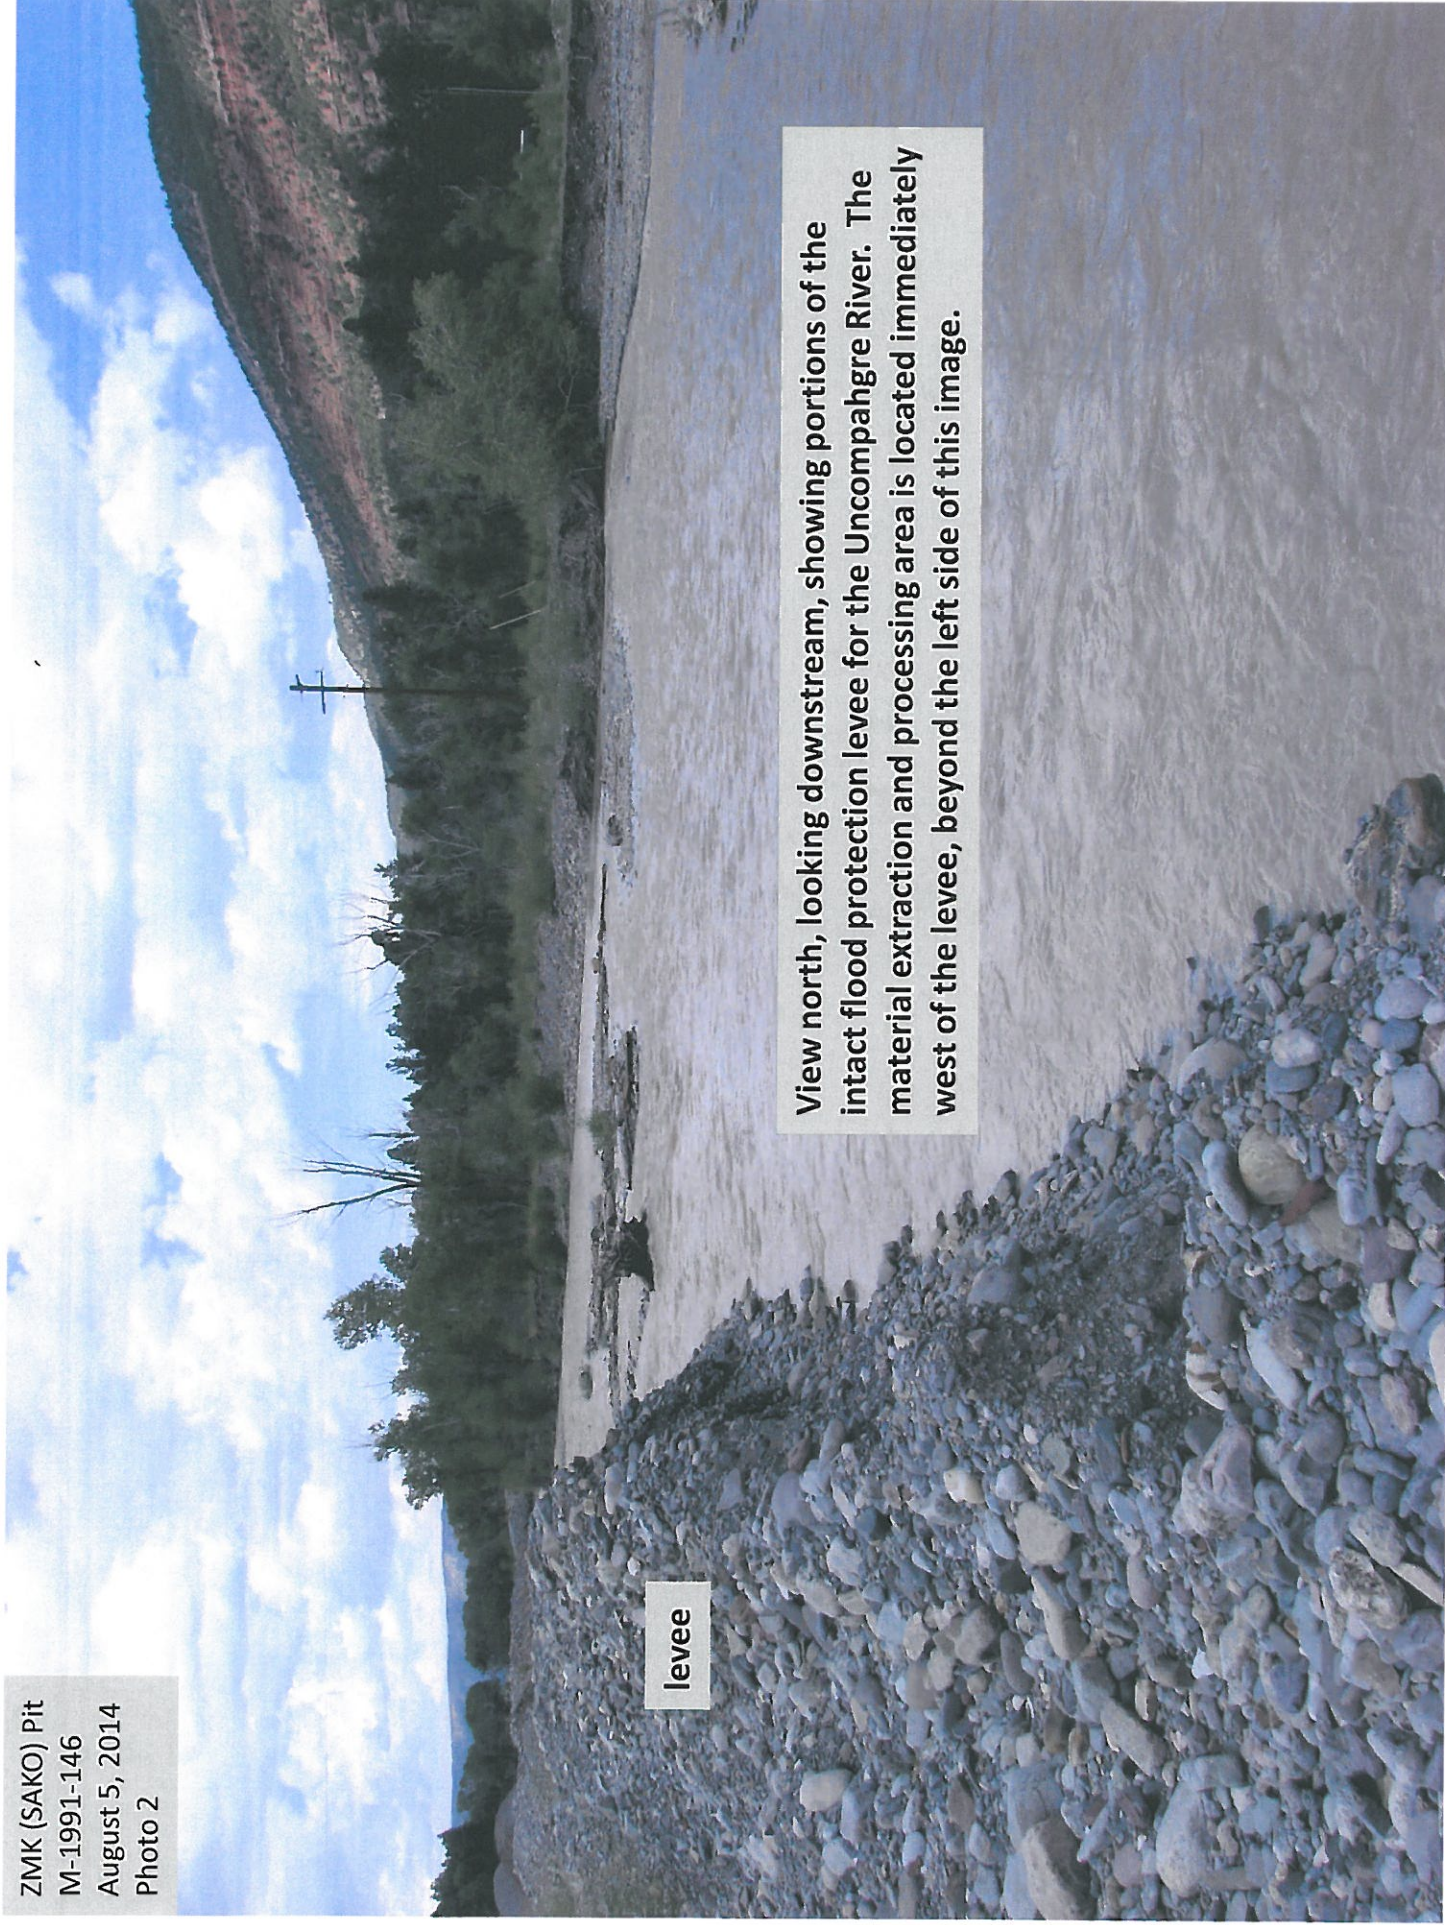
ZMK (SAKO) Pit
M-1991-146
August 5, 2014
Photo 2

View north, looking downstream, showing portions of the intact flood protection levee for the Uncompahgre River. The material extraction and processing area is located immediately west of the levee, beyond the left side of this image.

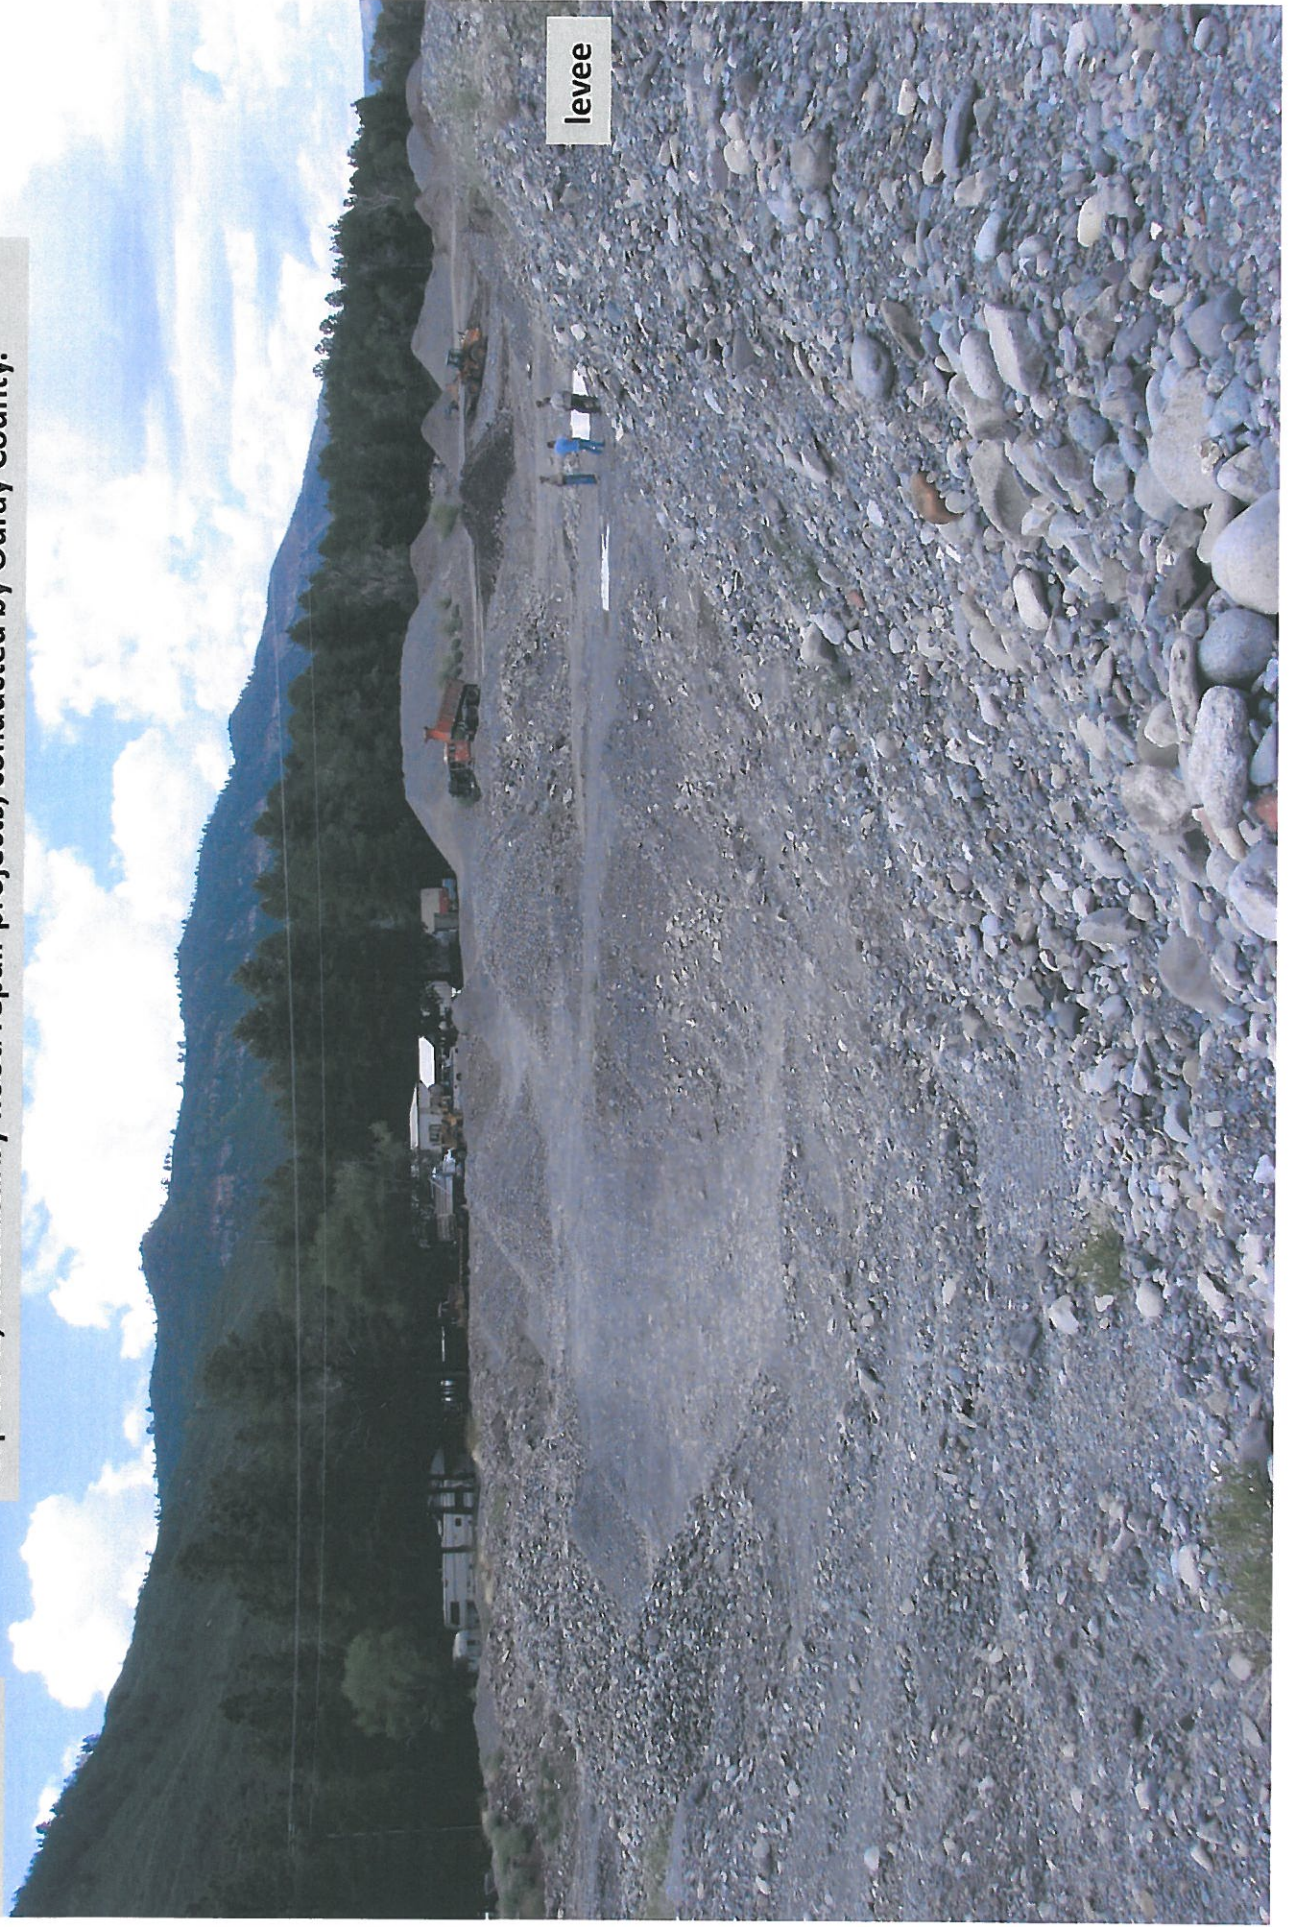
ZMK (SAKO) Pit
M-1991-146
August 5, 2014
Photo 3

View north, taken from the approximate location of Photo 2, showing portions of the material extraction and processing area. Alluvial materials were being imported, from nearby flood repair projects, conducted by Ouray County.
