COLORADO DIVISION OF RECLAMATION, MINING AND SAFETY
MINERALS PROGRAM INSPECTION REPORT
PHONE: (303) 866-3567

MINE NAME: Ruby Trust Mine	MINE/PROSPECTING ID#: M-1979-181	MINERAL: Gold and silver	COUNTY: Ouray
INSPECTION TYPE: Multi Person Inspection	INSPECTOR(S): Wallace H. Erickson, Lucas West	INSP. DATE: August 5, 2014	INSP. TIME: 17:40
OPERATOR: Walker Ruby Mining Company, Inc.	OPERATOR REPRESENTATIVE: Charles Ponchak	TYPE OF OPERATION: 110(2) - Hard Rock Limited Impact	
REASON FOR INSPECTION: Normal I&E Program	BOND CALCULATION TYPE: Partial Bond	BOND AMOUNT: \$18,738.00	
DATE OF COMPLAINT: NA	POST INSP. CONTACTS: None	JOINT INSP. AGENCY: None	
WEATHER: Cloudy	INSPECTOR'S SIGNATURE:

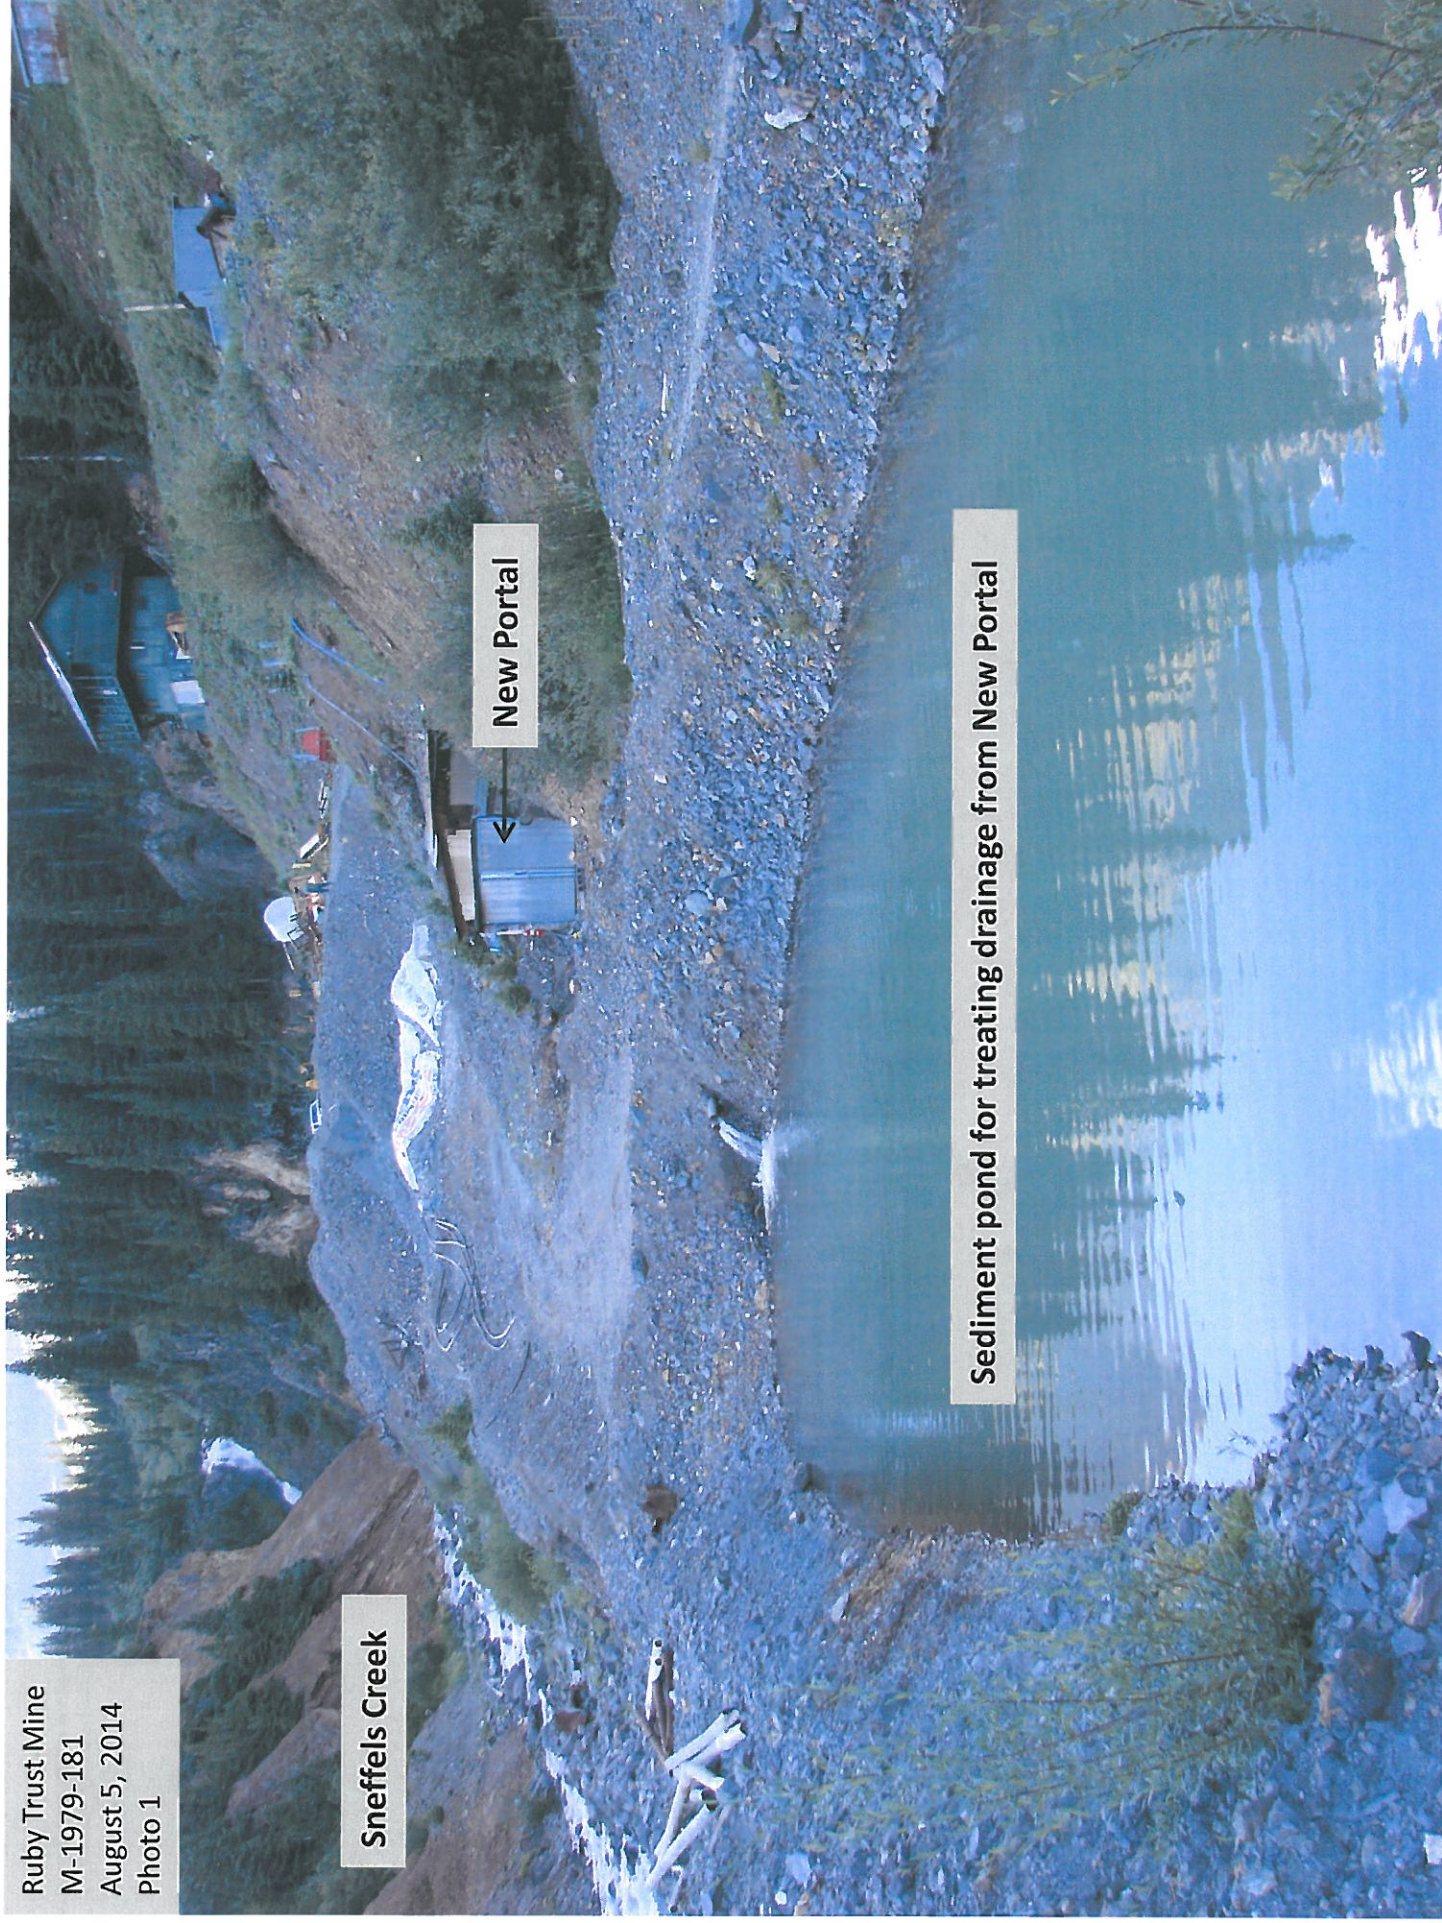
Ruby Trust Mine
M-1979-181
August 5, 2014
Photo 1

As shown in Photos 1 and 2, drainage from the new portal reported to a series of sediment ponds prior to discharge to Sneffels Creek. Discharge is regulated through CDPHE permit.

Sediment pond for treating drainage from New Portal

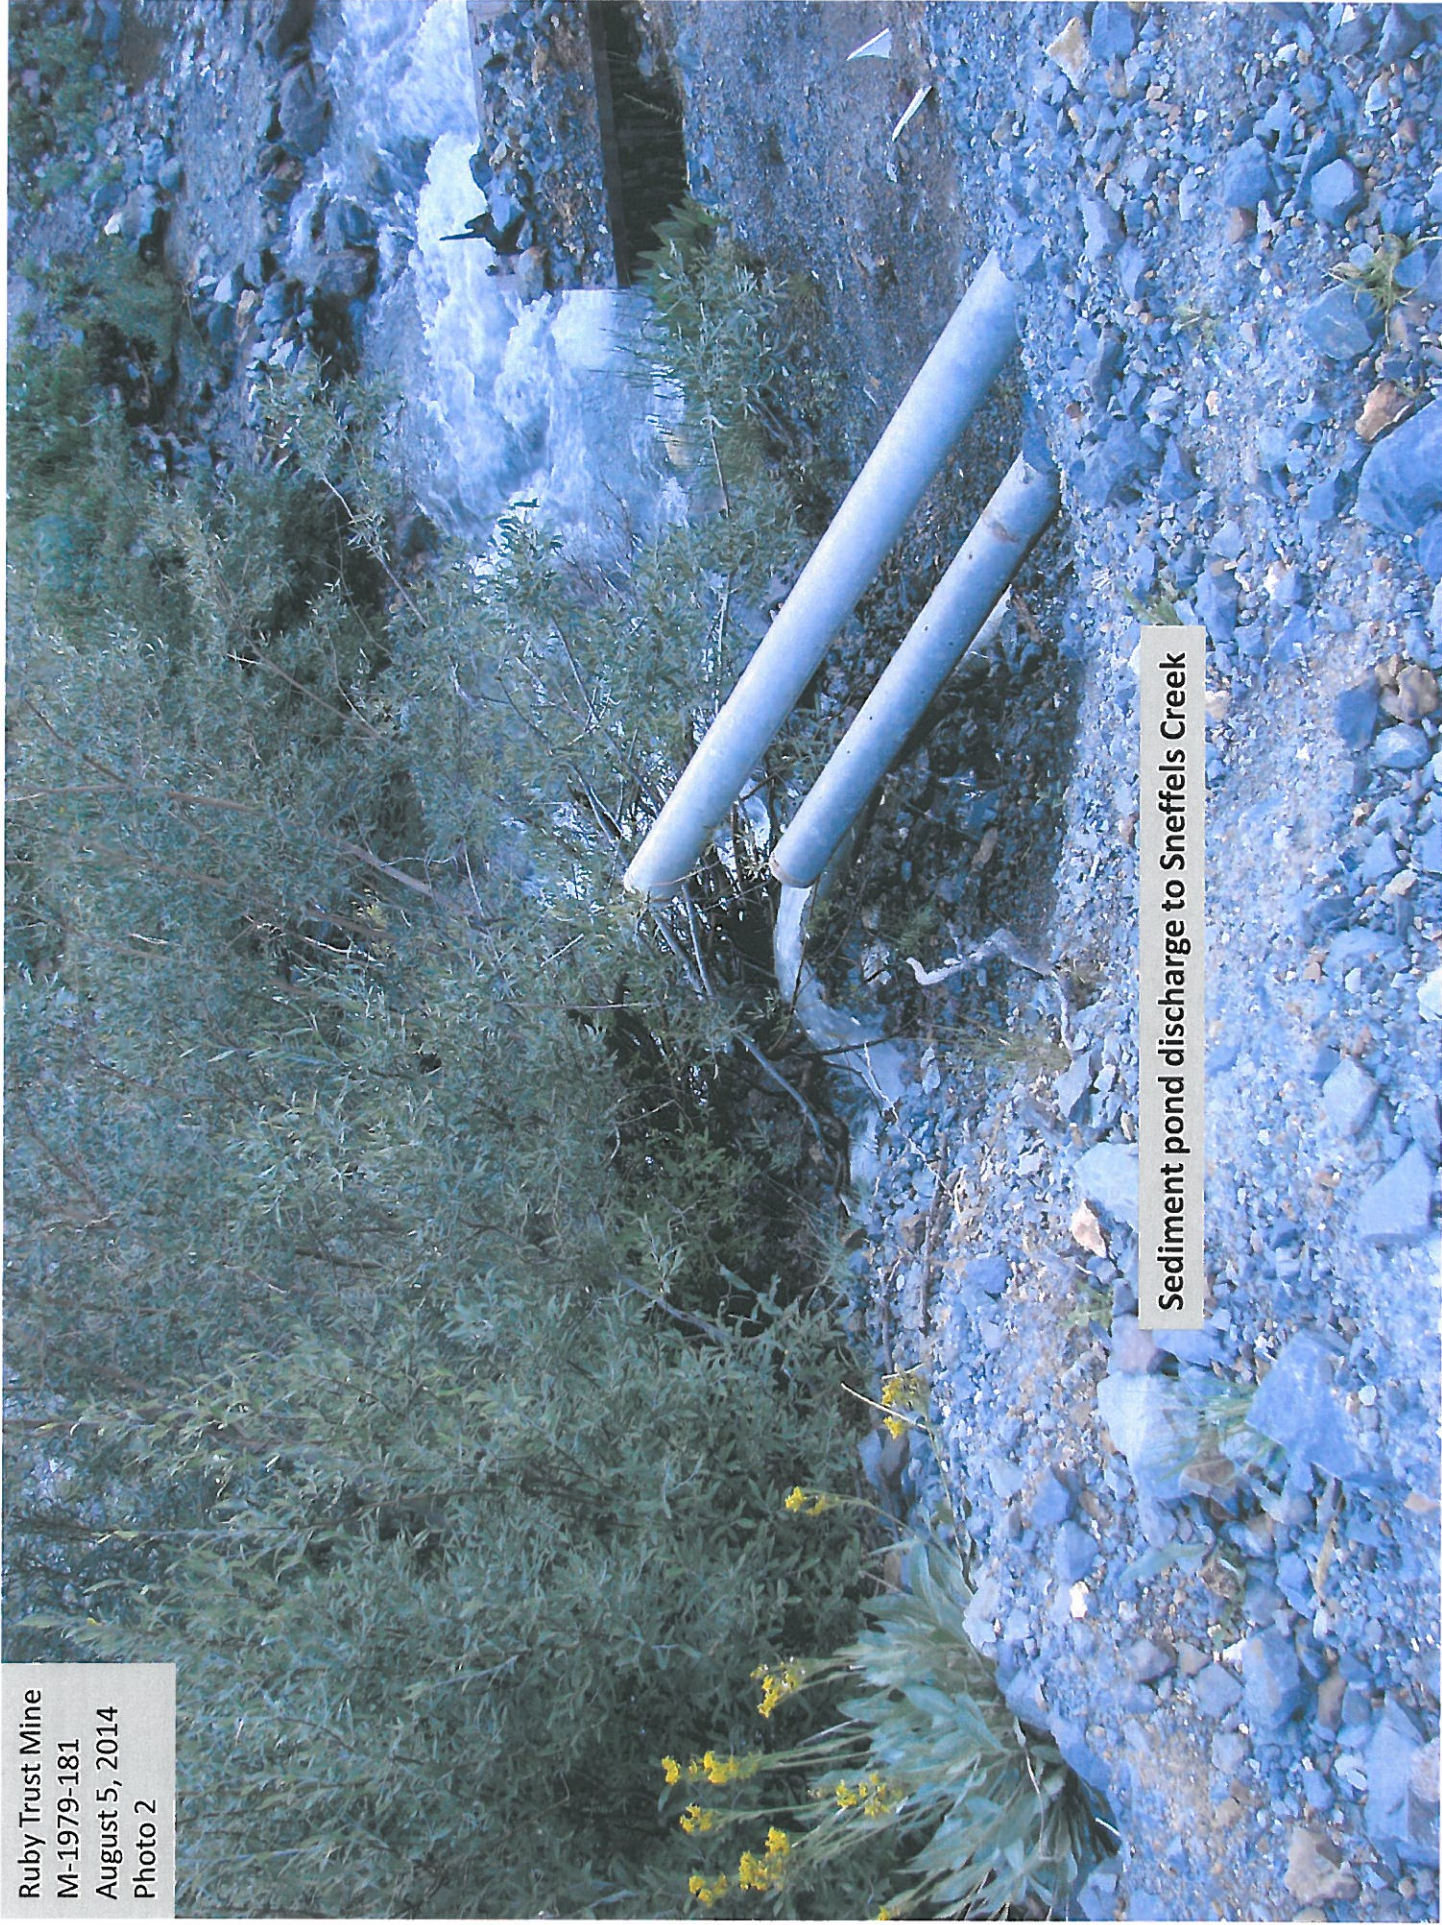
Ruby Trust Mine
M-1979-181
August 5, 2014
Photo 2

Sediment pond discharge to Sneffels Creek

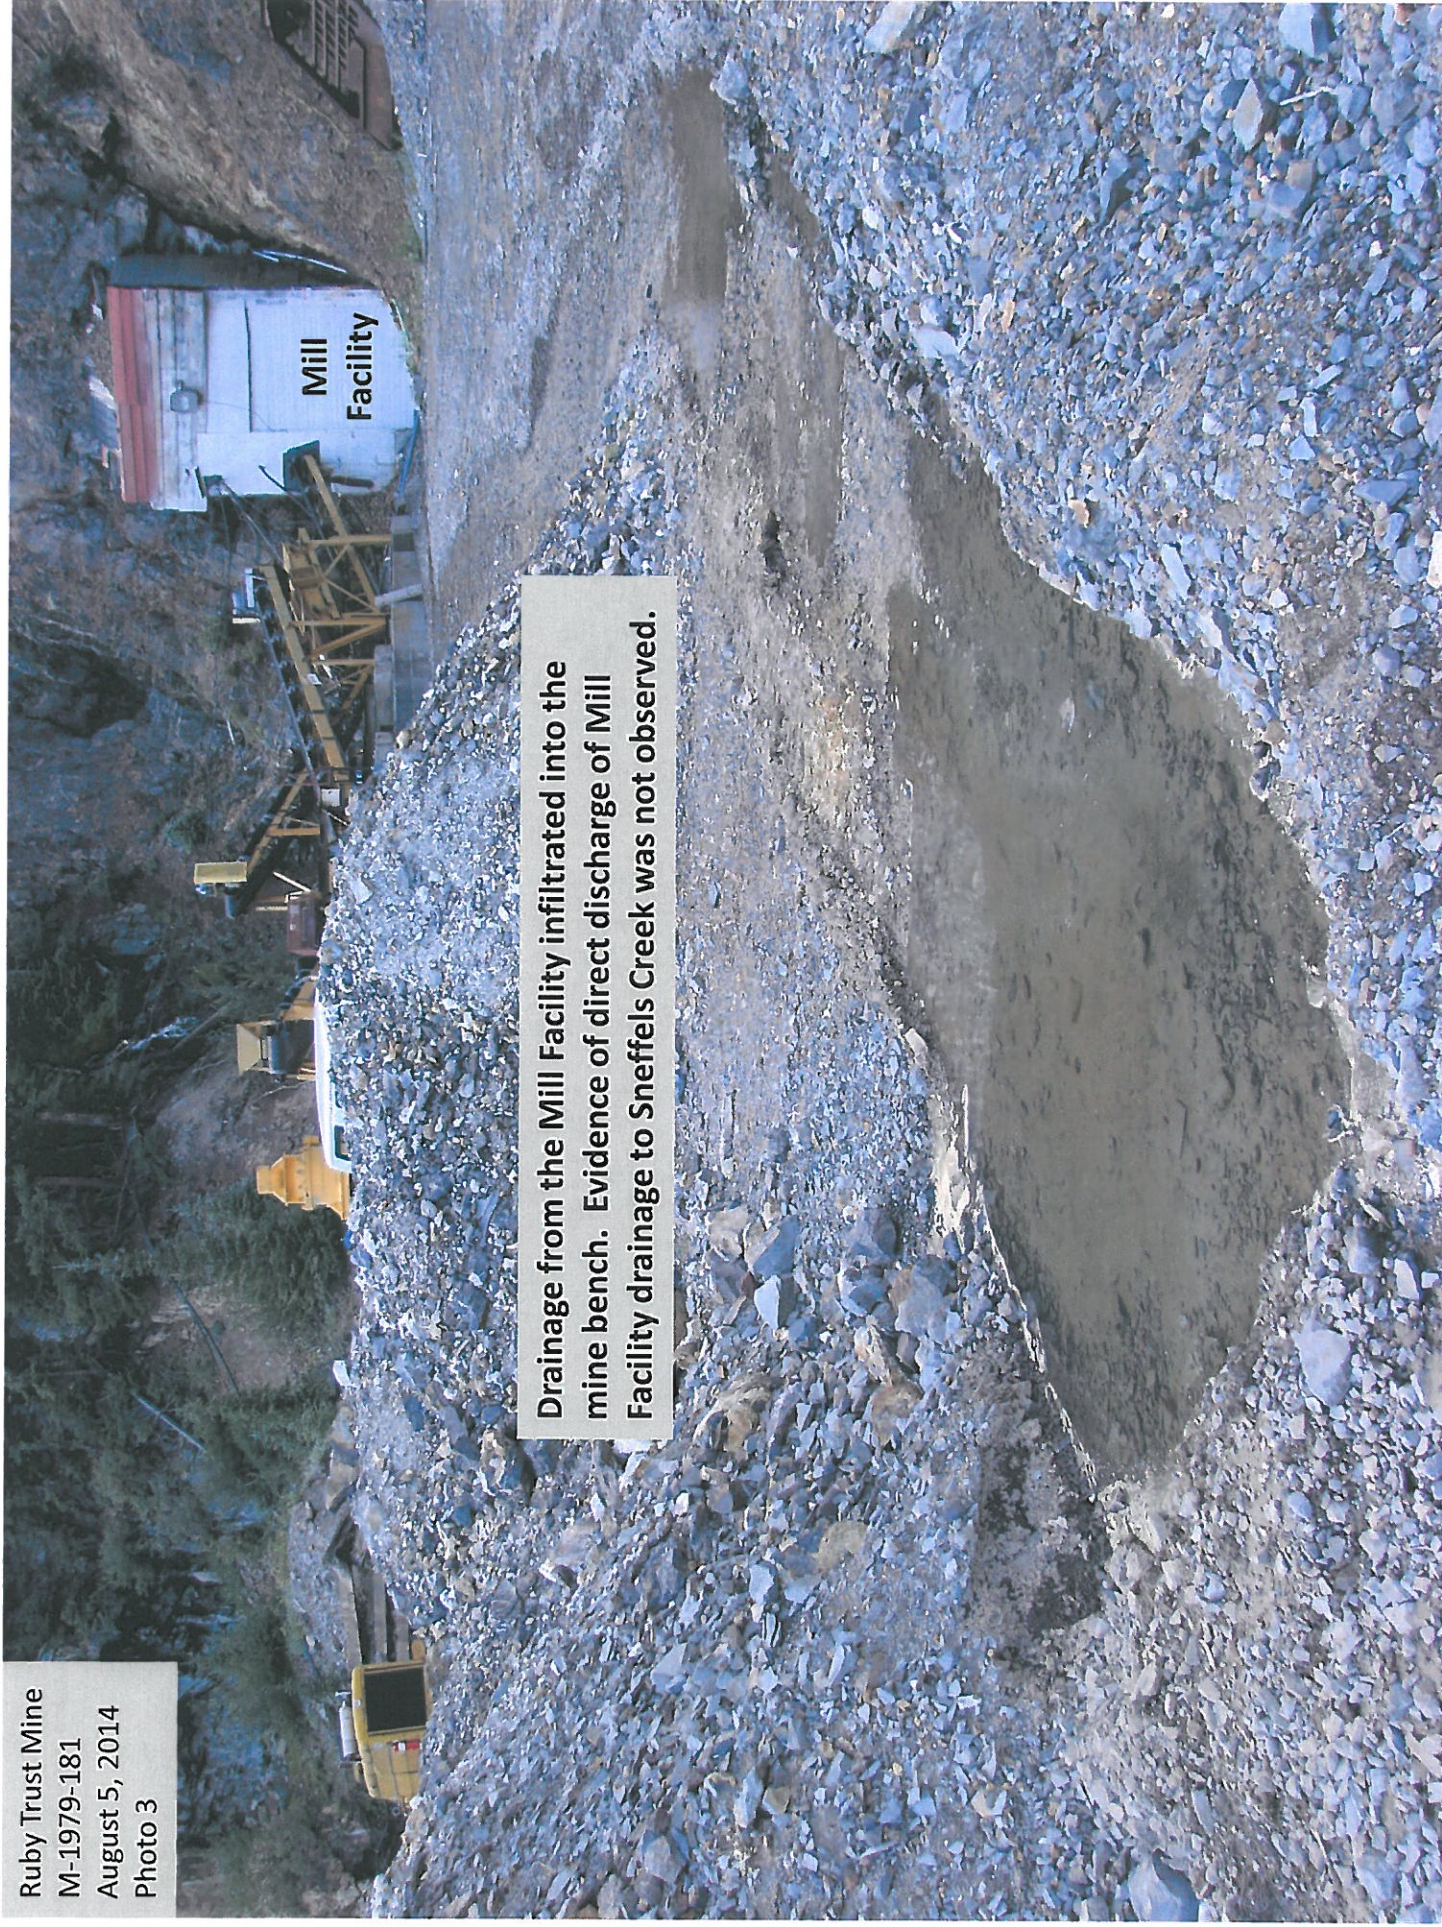
Ruby Trust Mine
M-1979-181
August 5, 2014
Photo 3

The mill facility was locked and was not inspected. As noted in the Division's inspection report generated from the September 20, 2013 inspection, the Operator had recently driven three drill holes from the underground mill facility and/or from underground locations accessible through the mill facility. The three drill holes encountered water, which was observed draining from the mill portal and infiltrated into the mine bench; no discharge to Sneffels Creek was observed. As shown in Photo 3, discharge from the mill facility persists and, as observed previously, the drainage infiltrates into the mine bench with no direct discharge to Sneffels Creek observed. The Operator's representative provided a copy of an analytical report from Grand Junction Laboratories, dated October 12, 2012, for a water sample taken September 17, 2012, from #2 Drill Hole. A copy of the lab report is enclosed. The Operator is encouraged to route the drainage from the mill facility to the settling ponds for treatment in accordance with the existing discharge permit from CDPHE.

Drainage from the Mill Facility infiltrated into the mine bench. Evidence of direct discharge of Mill Facility drainage to Sneffels Creek was not observed.
