COLORADO DIVISION OF RECLAMATION, MINING AND SAFETY
MINERALS PROGRAM INSPECTION REPORT
PHONE: (303) 866-3567

MINE NAME: McCumber Hill Pit	MINE/PROSPECTING ID#: M-2000-151	MINERAL: Sand and gravel	COUNTY: Fremont
INSPECTION TYPE: Monitoring	INSPECTOR(S): Timothy A. Cazier	INSP. DATE: November 19, 2014	INSP. TIME: 09:45
OPERATOR: Fremont Paving & Redi-Mix, Inc.	OPERATOR REPRESENTATIVE: Angela Bellantoni & Jodi Ricker	TYPE OF OPERATION: 112c - Construction Regular Operation

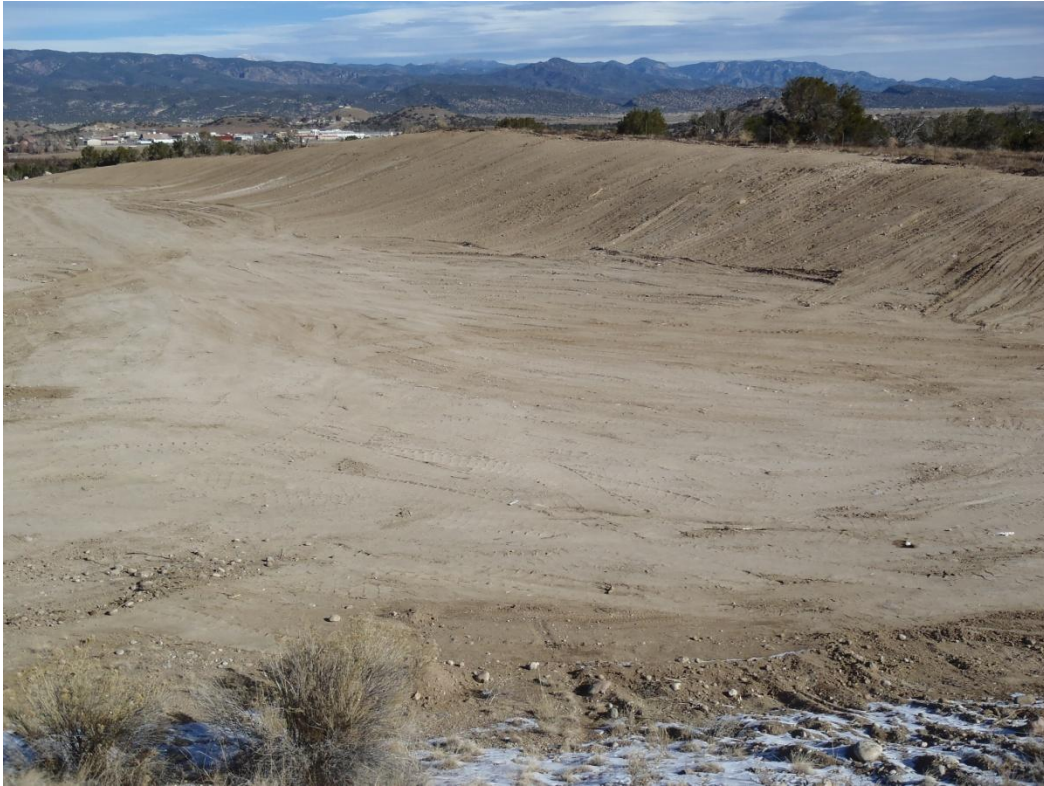
East Highwall: The highwall had been resloped and appeared to at a 3H:1V slope (see **Photos 1** and **2**). A wheeled loader was used to flatten the slopes and vertical tine marks were visible running up and down the recontoured slope. This inspector recommended track-walking the slope to reduce the potential of erosion rills forming in the short term, prior to establishing vegetation. Both Operator representatives agreed that would be accomplished.

Photo 1. Recontoured east highwall (looking ENE).

The east highwall is now in an acceptable configuration. The Division recommends track-walking the slopes for short term erosion control.

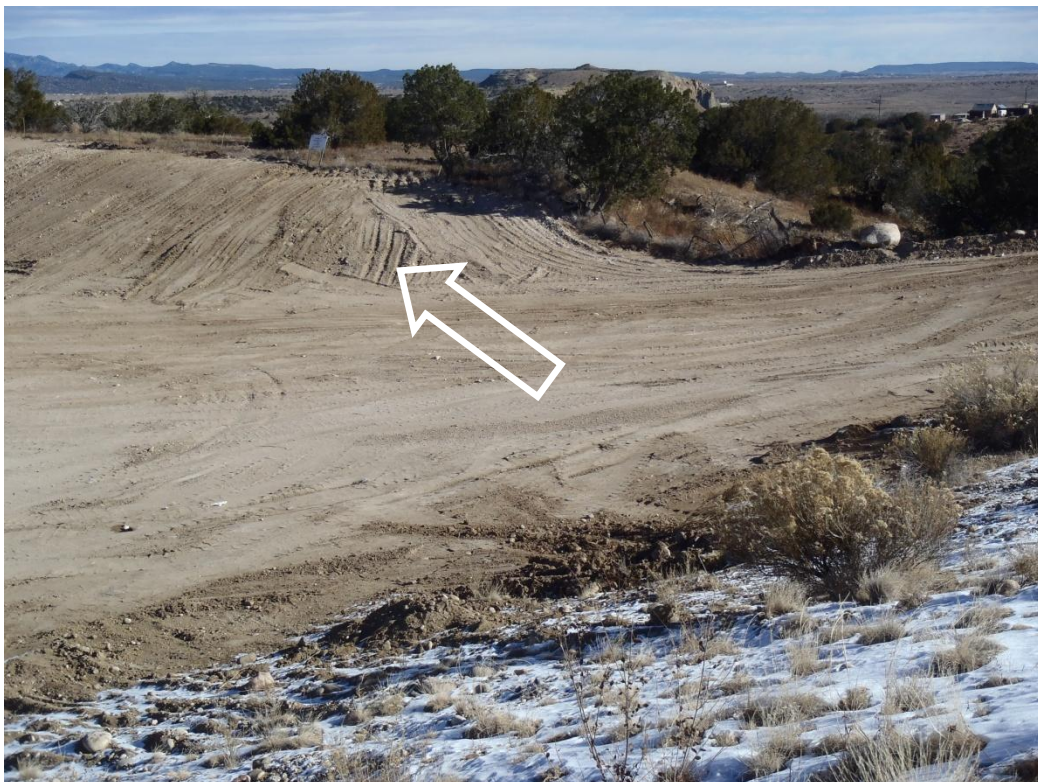
Photo 2. Recontoured east highwall (looking NE) {Note tire marks}.
